# 253 Summer Street

## Landmark Presentation

## CBI Consulting Inc.

## FACADE REPAIRS

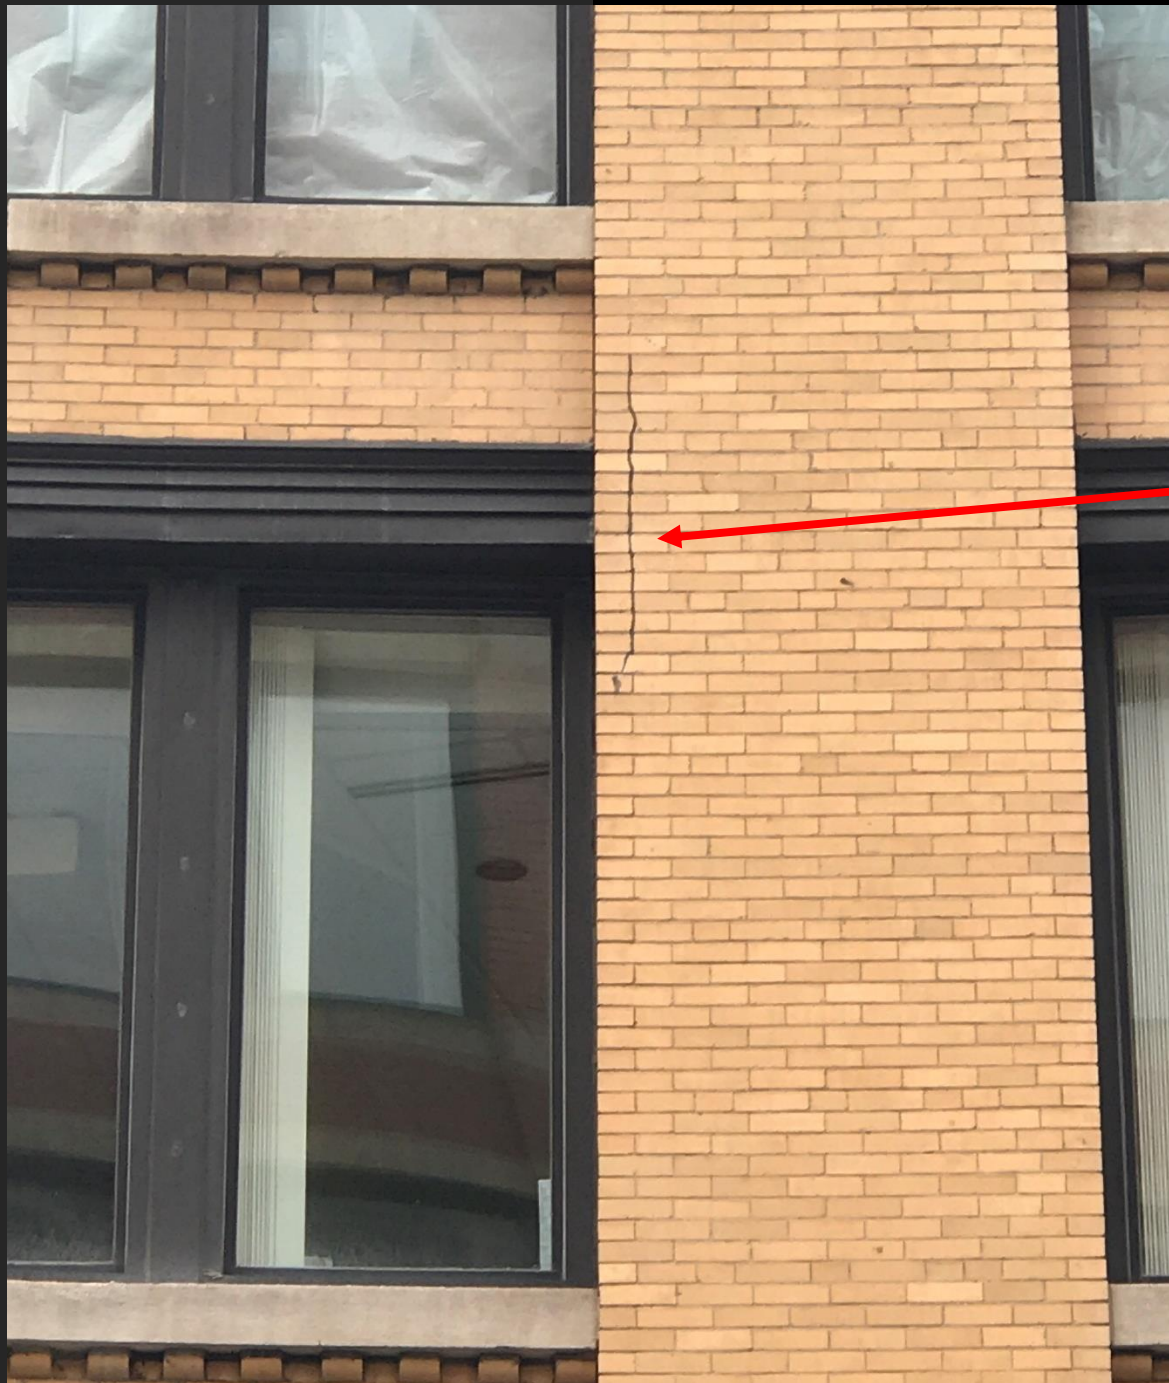
Cracked  
Brick

1 TYPICAL BRICK REPAIR DETAIL  
SCALE: 1/2" = 1'-0"

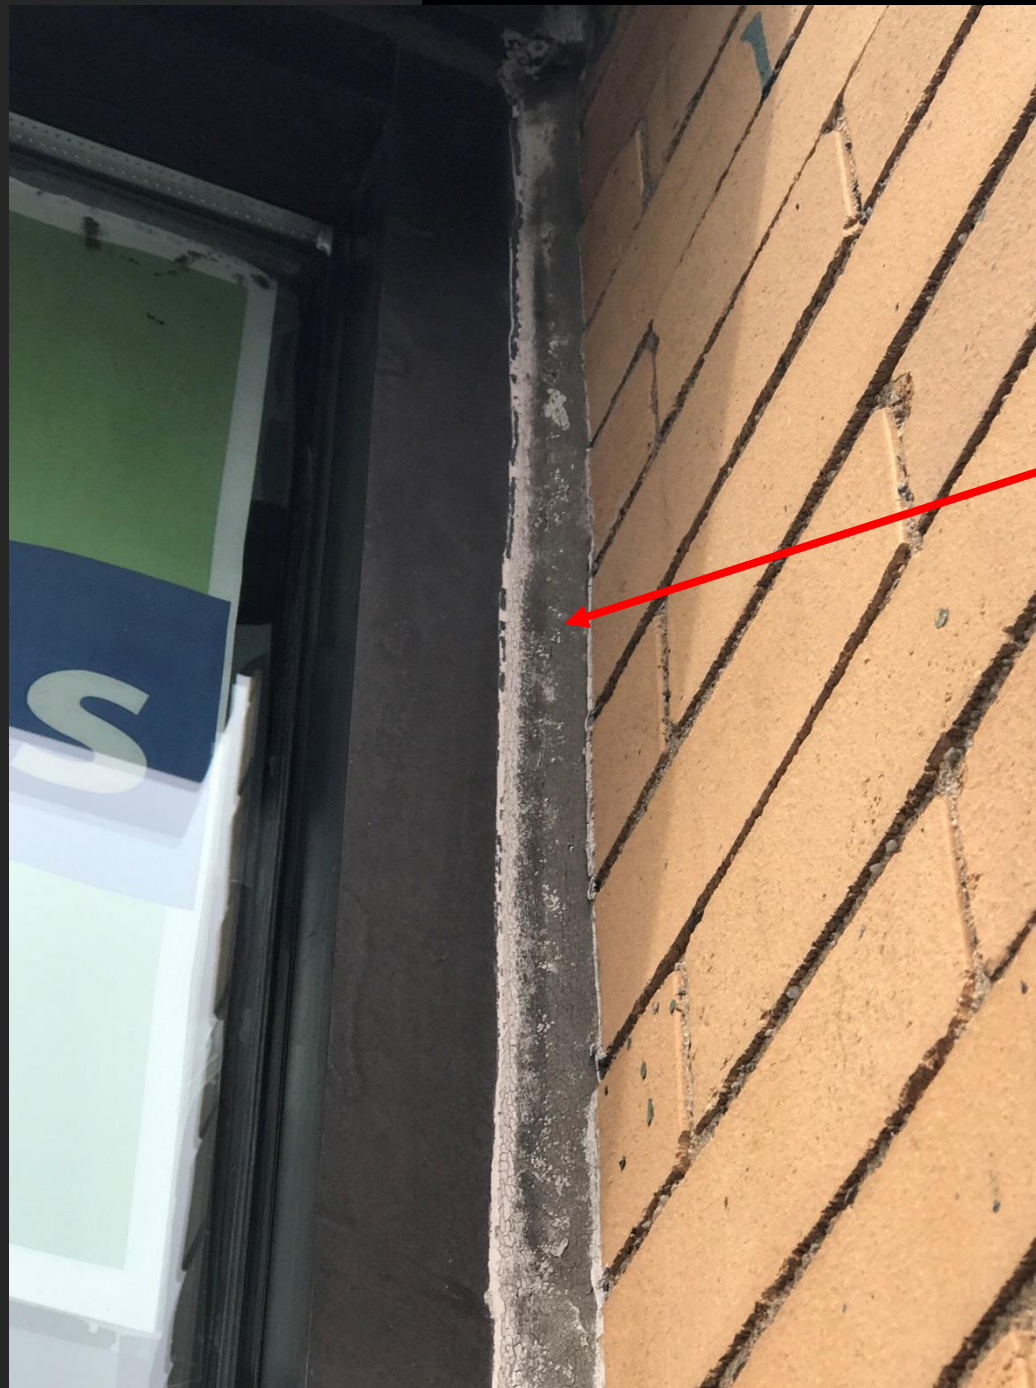
Failed  
Sealant

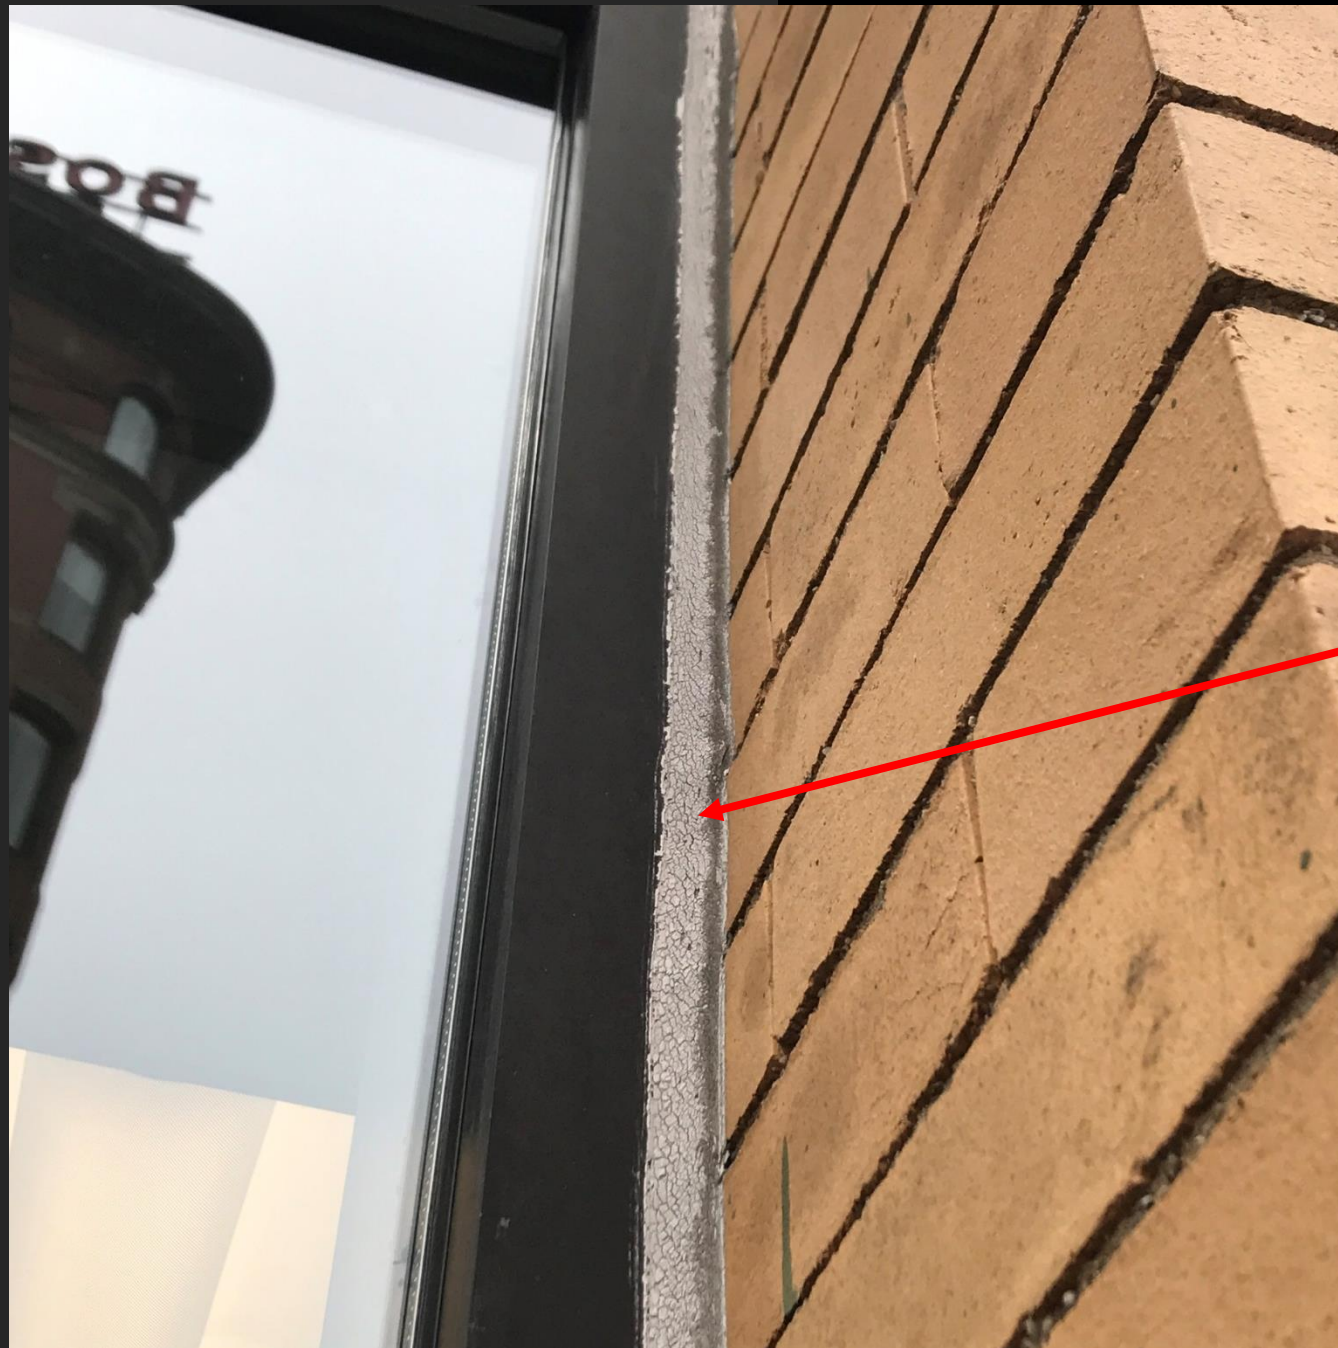
Failed  
Sealant

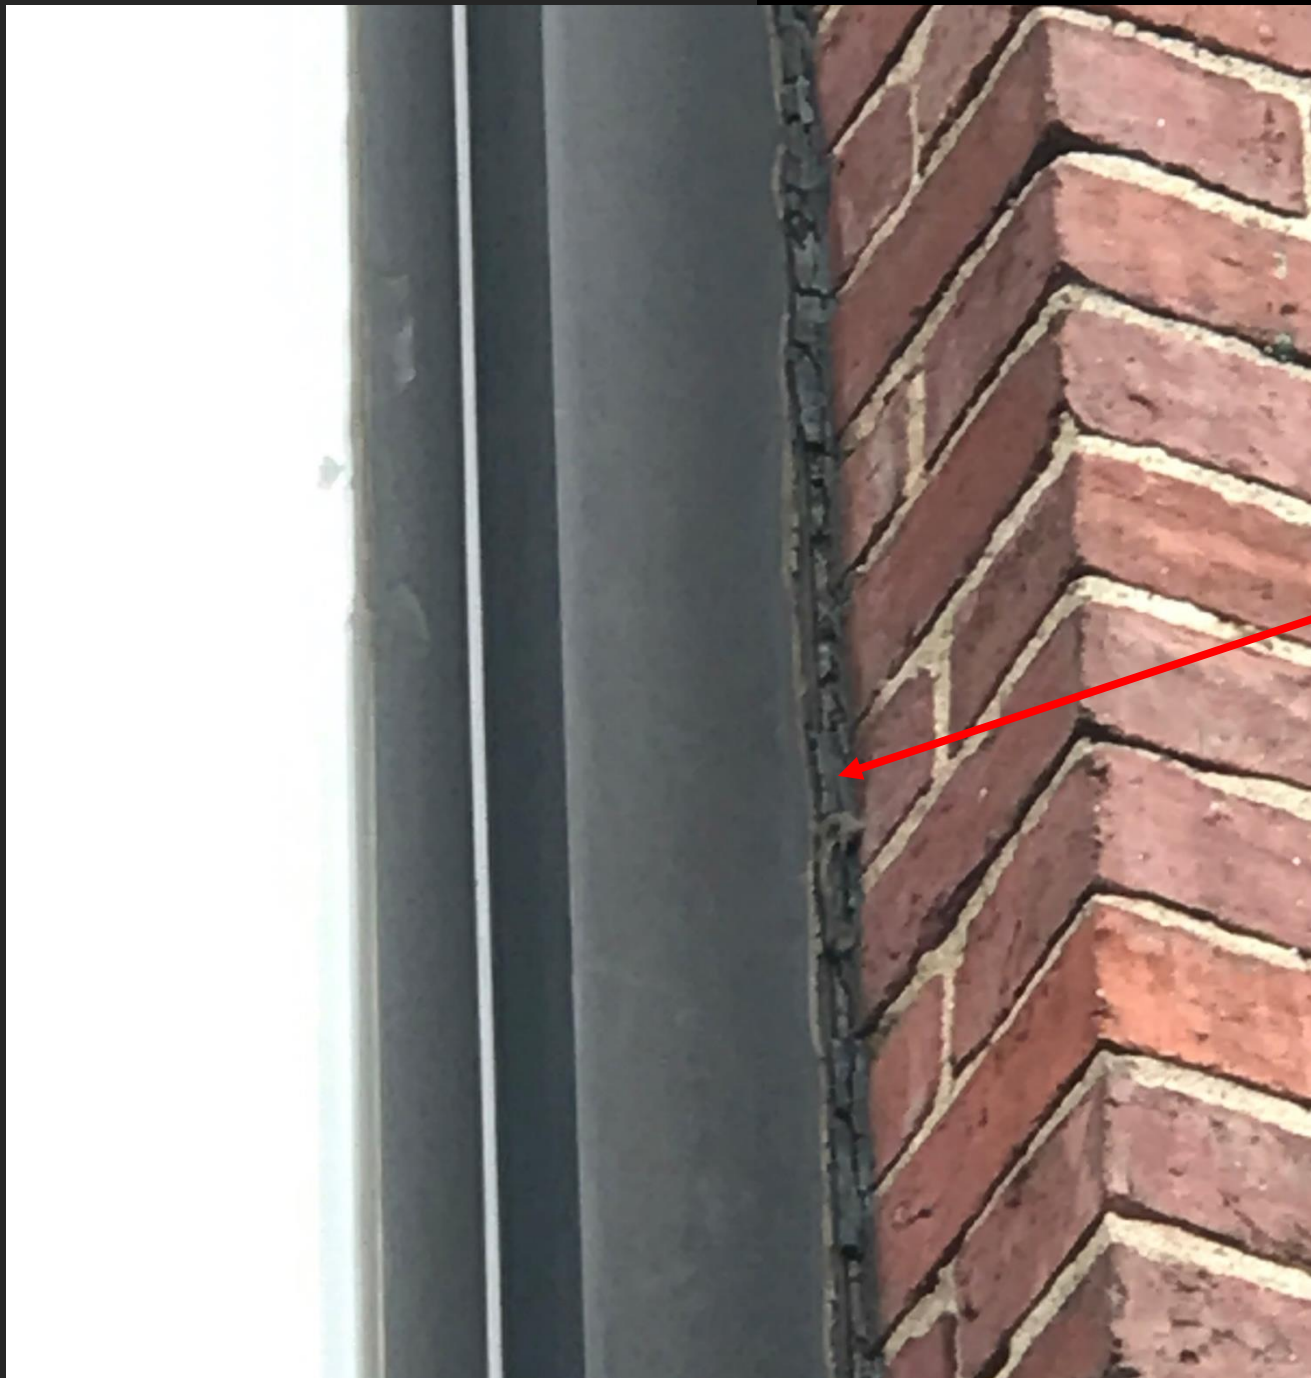
Failed  
Sealant

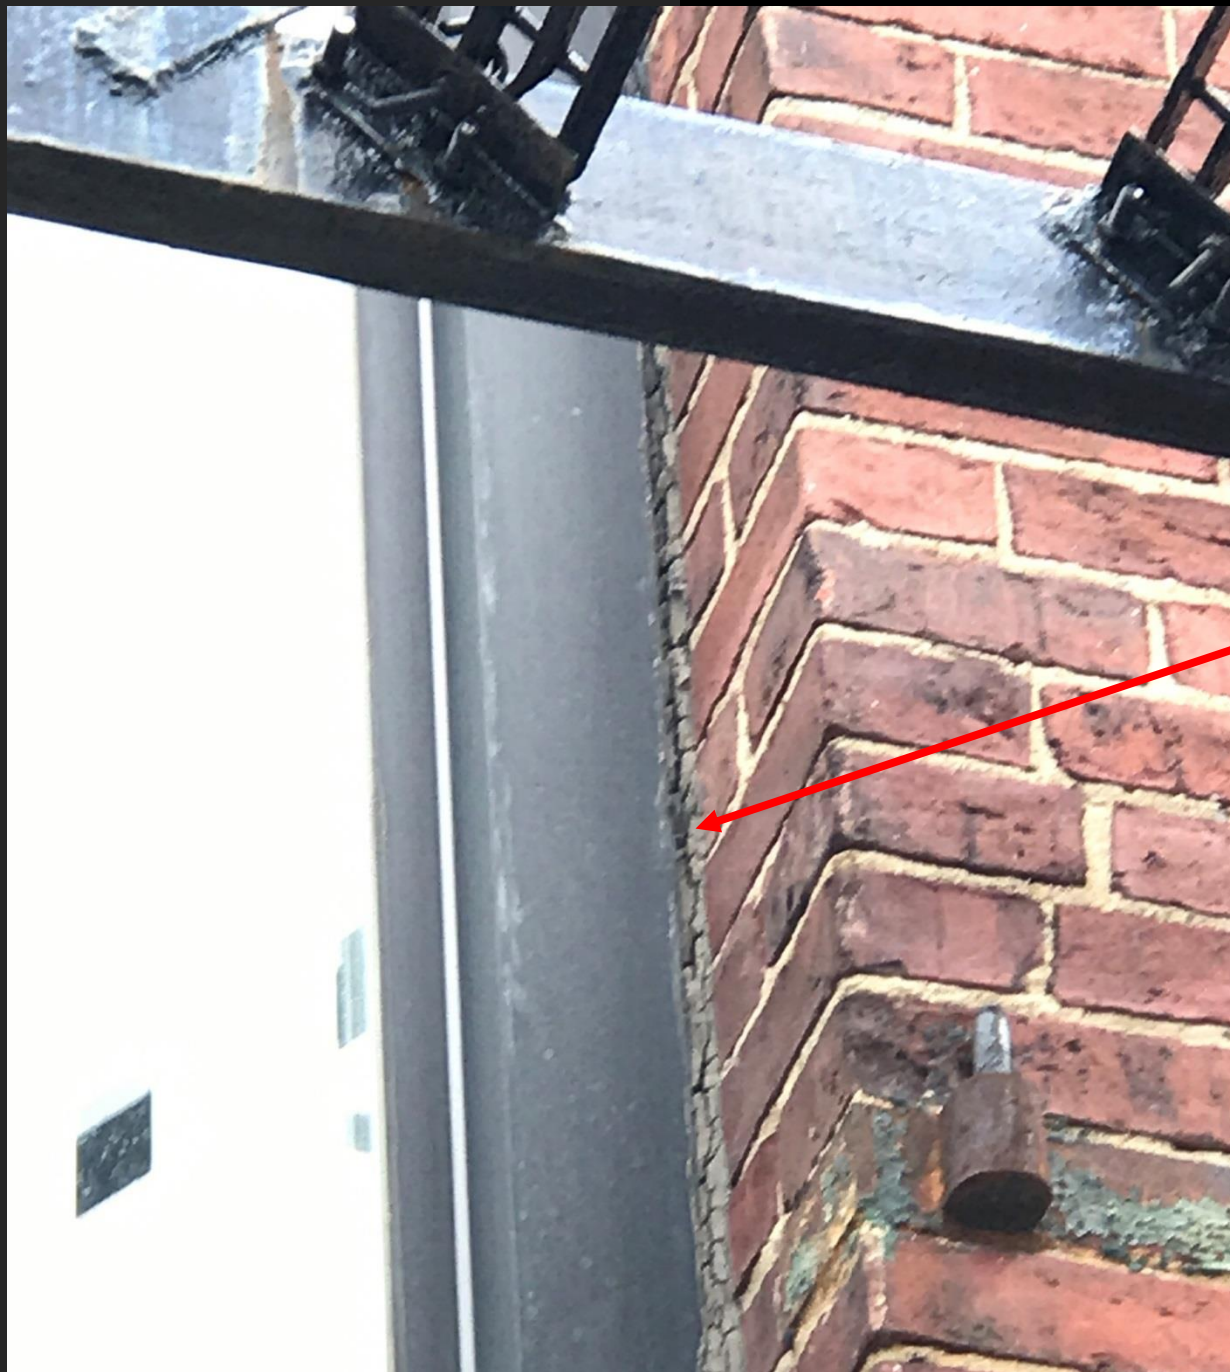
Failed  
Sealant

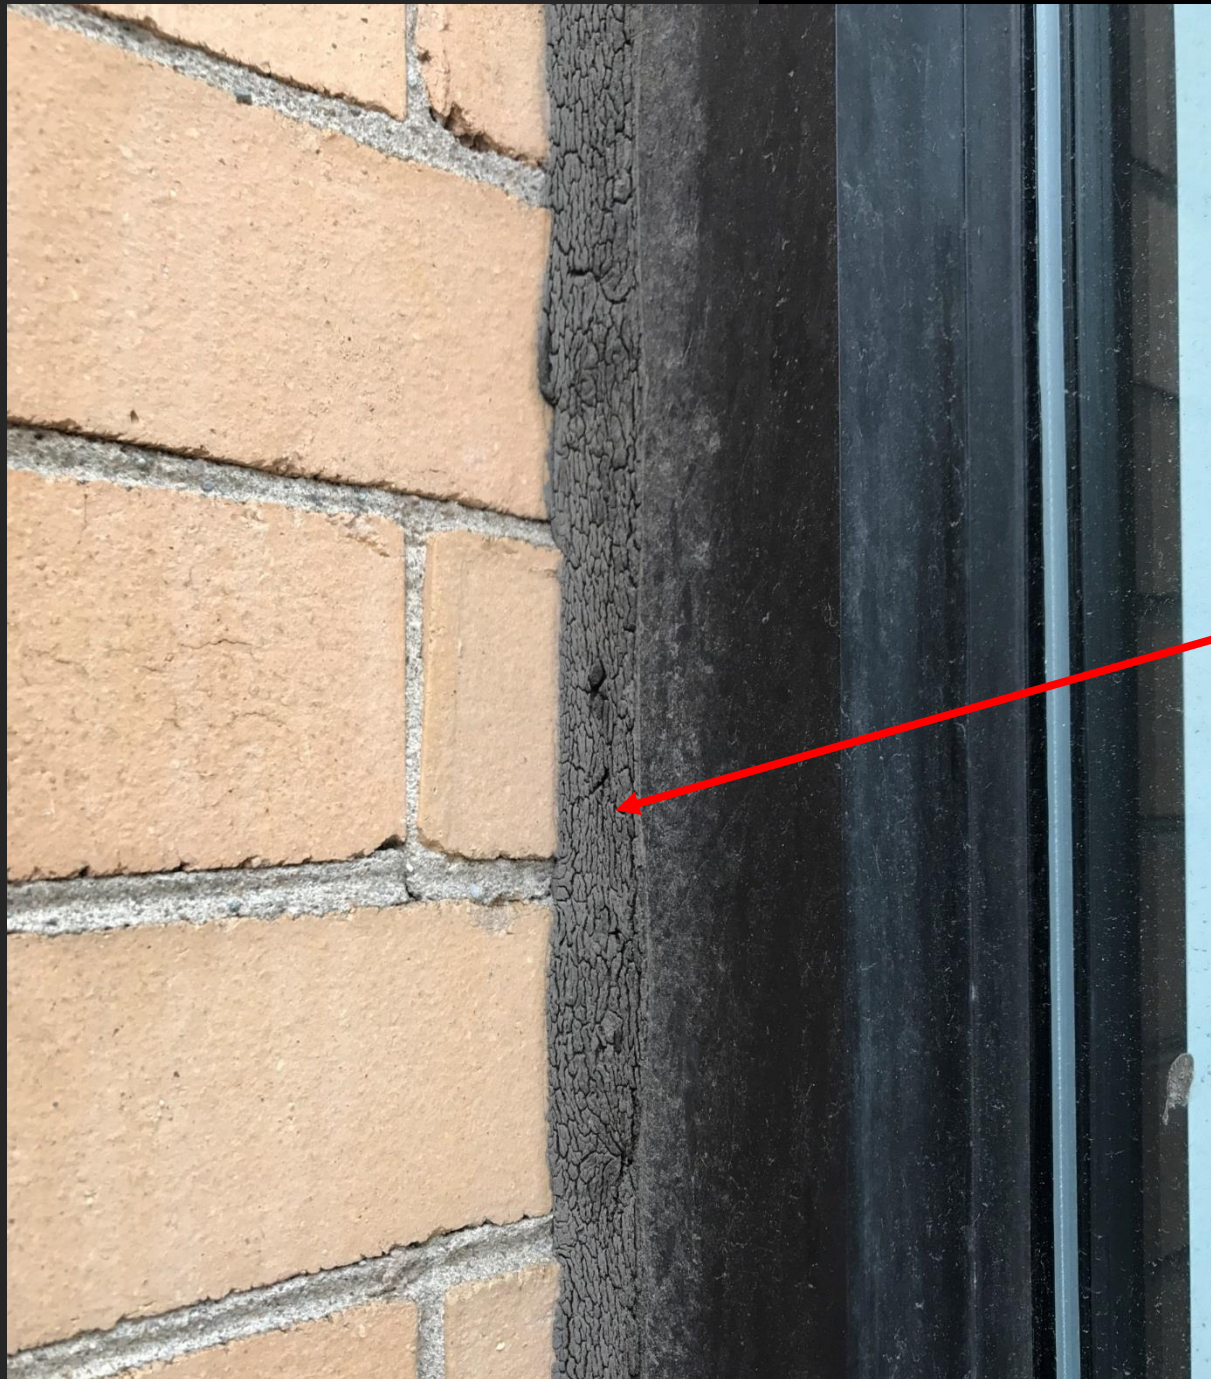
Failed  
Sealant

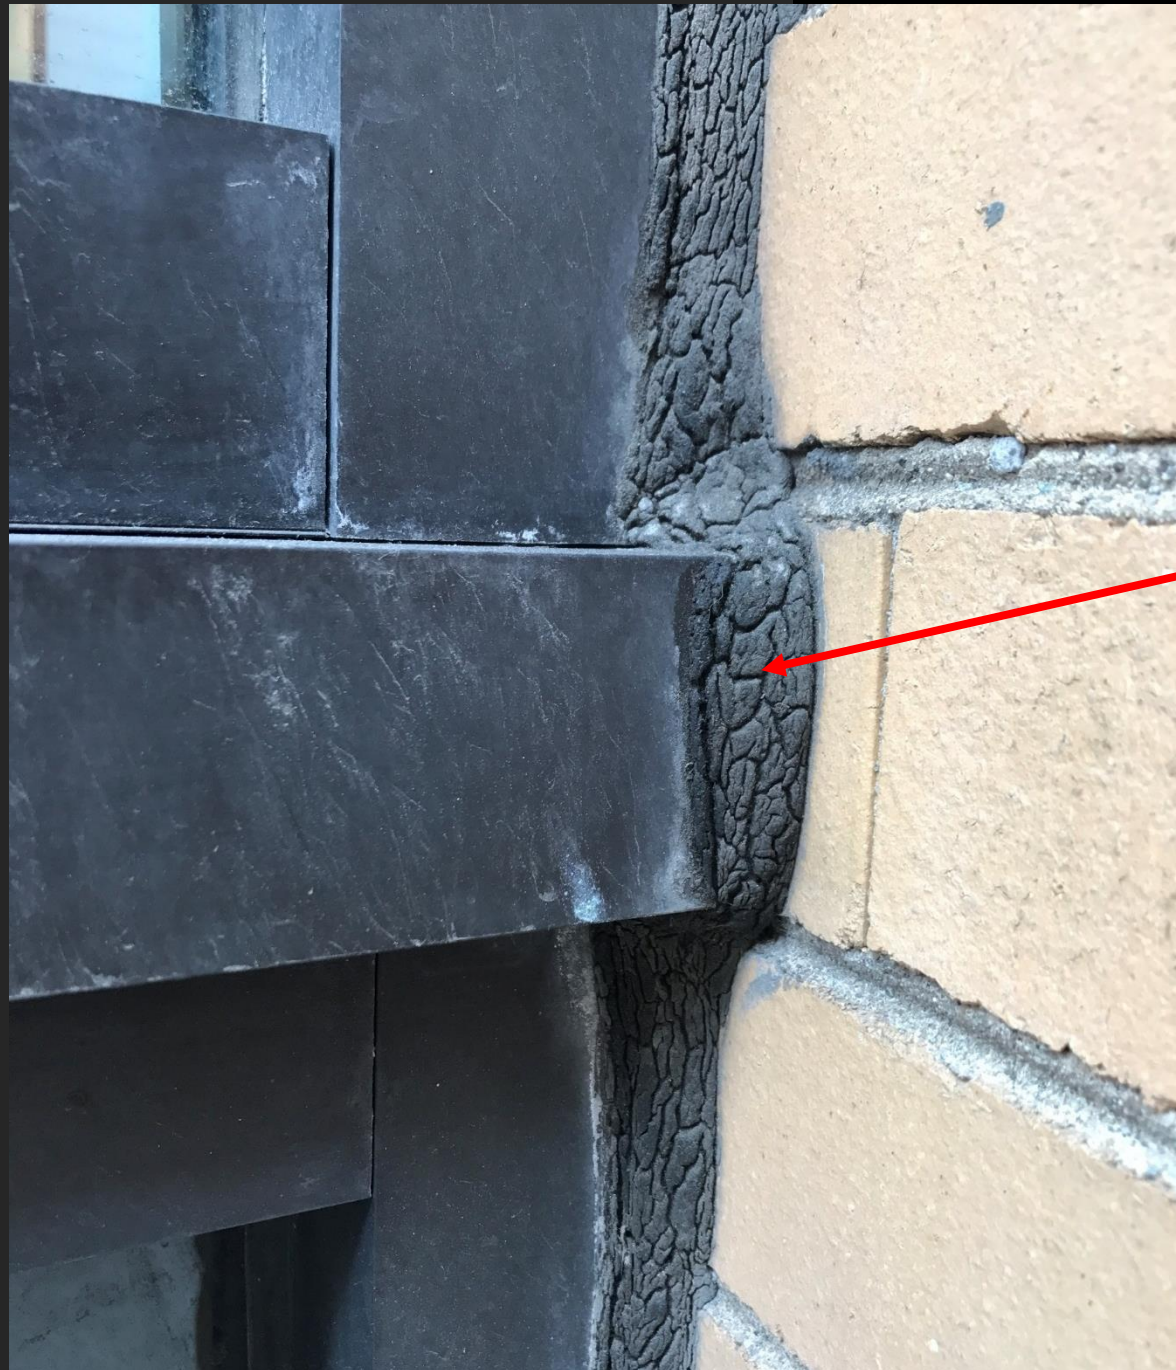
Failed  
Sealant

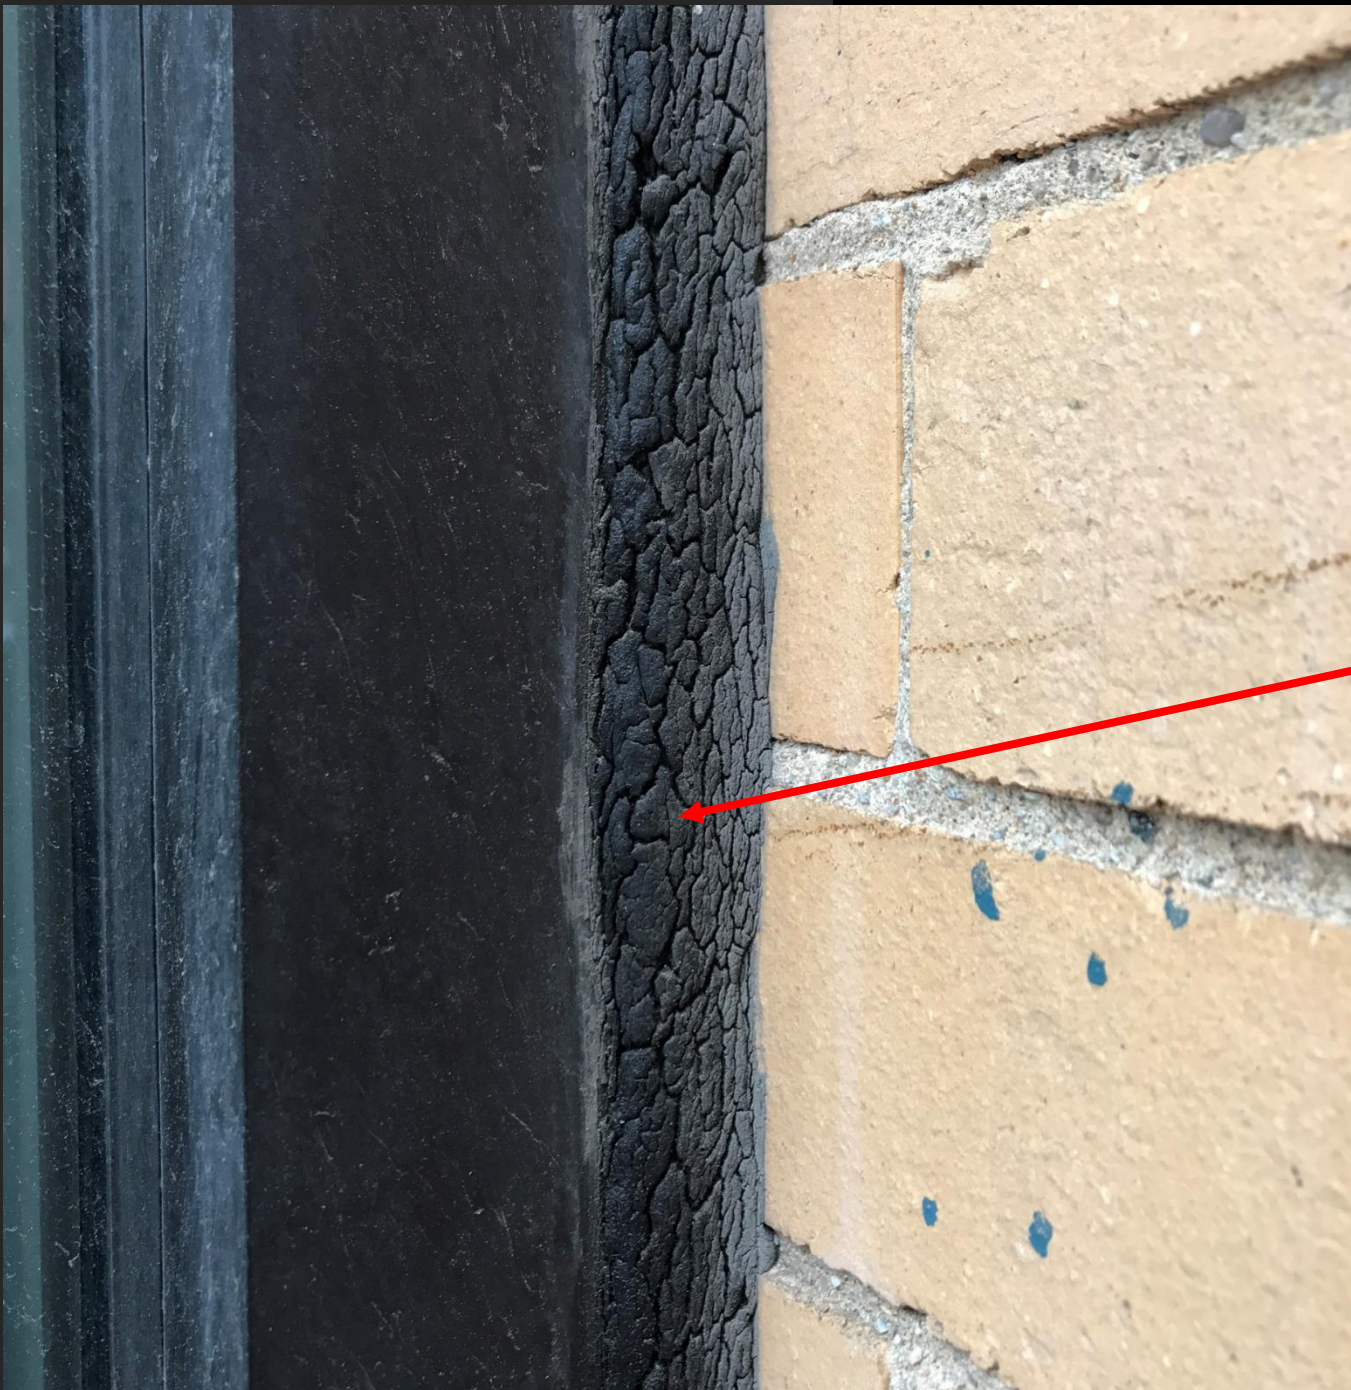
Failed  
Sealant

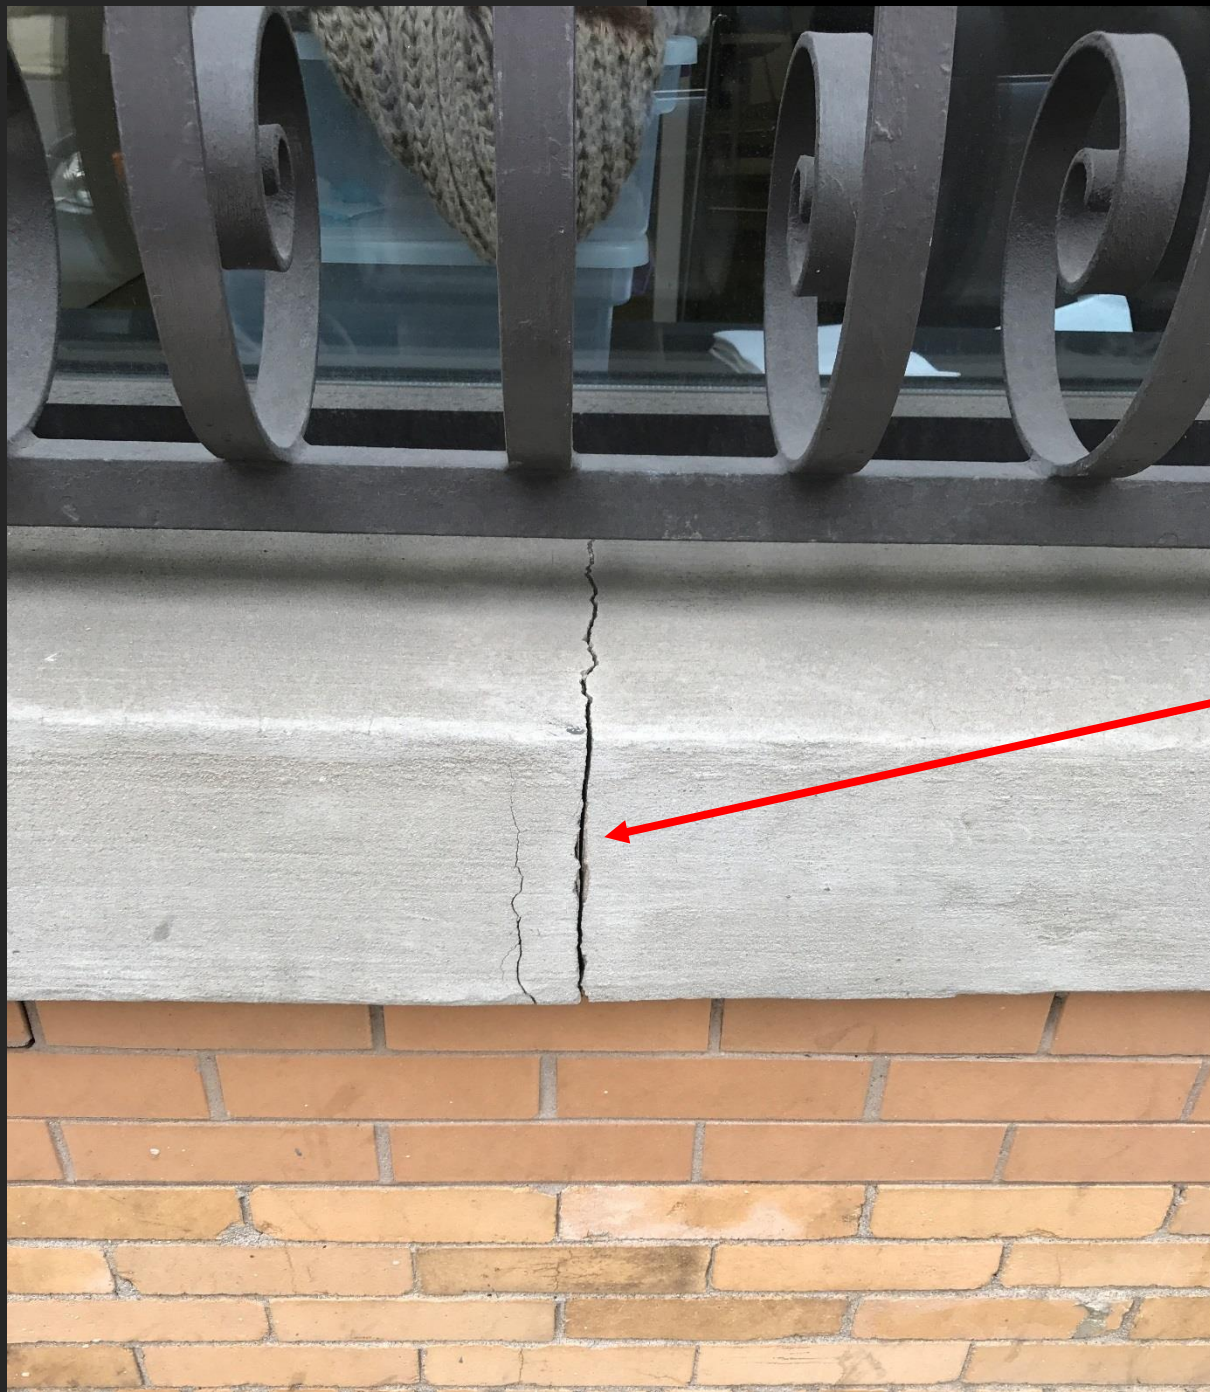
Cracked  
Sill Stone

2 REPAIR OF CRACKED STONE SILL OR BANDS (TOP SURFACE SHOWN) IF NEEDED AS DIRECTED BY ENGINEER IN THE FIELD  
SCALE: N.T.S.

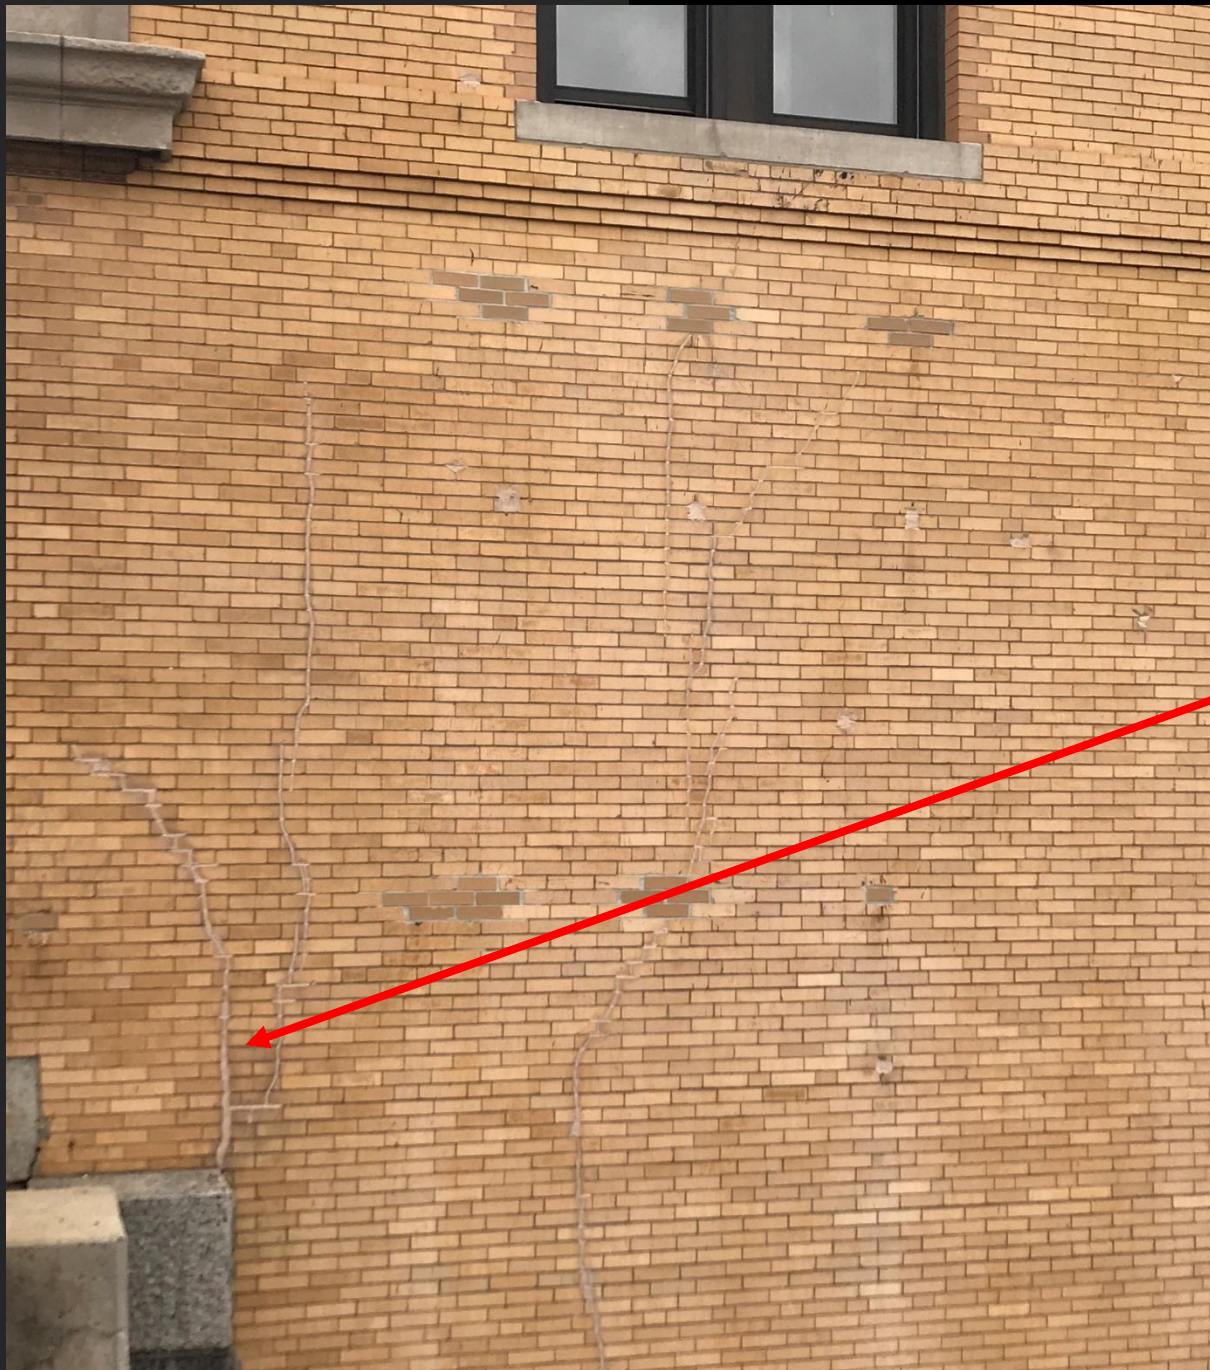
Sealant over  
Cracked Brick

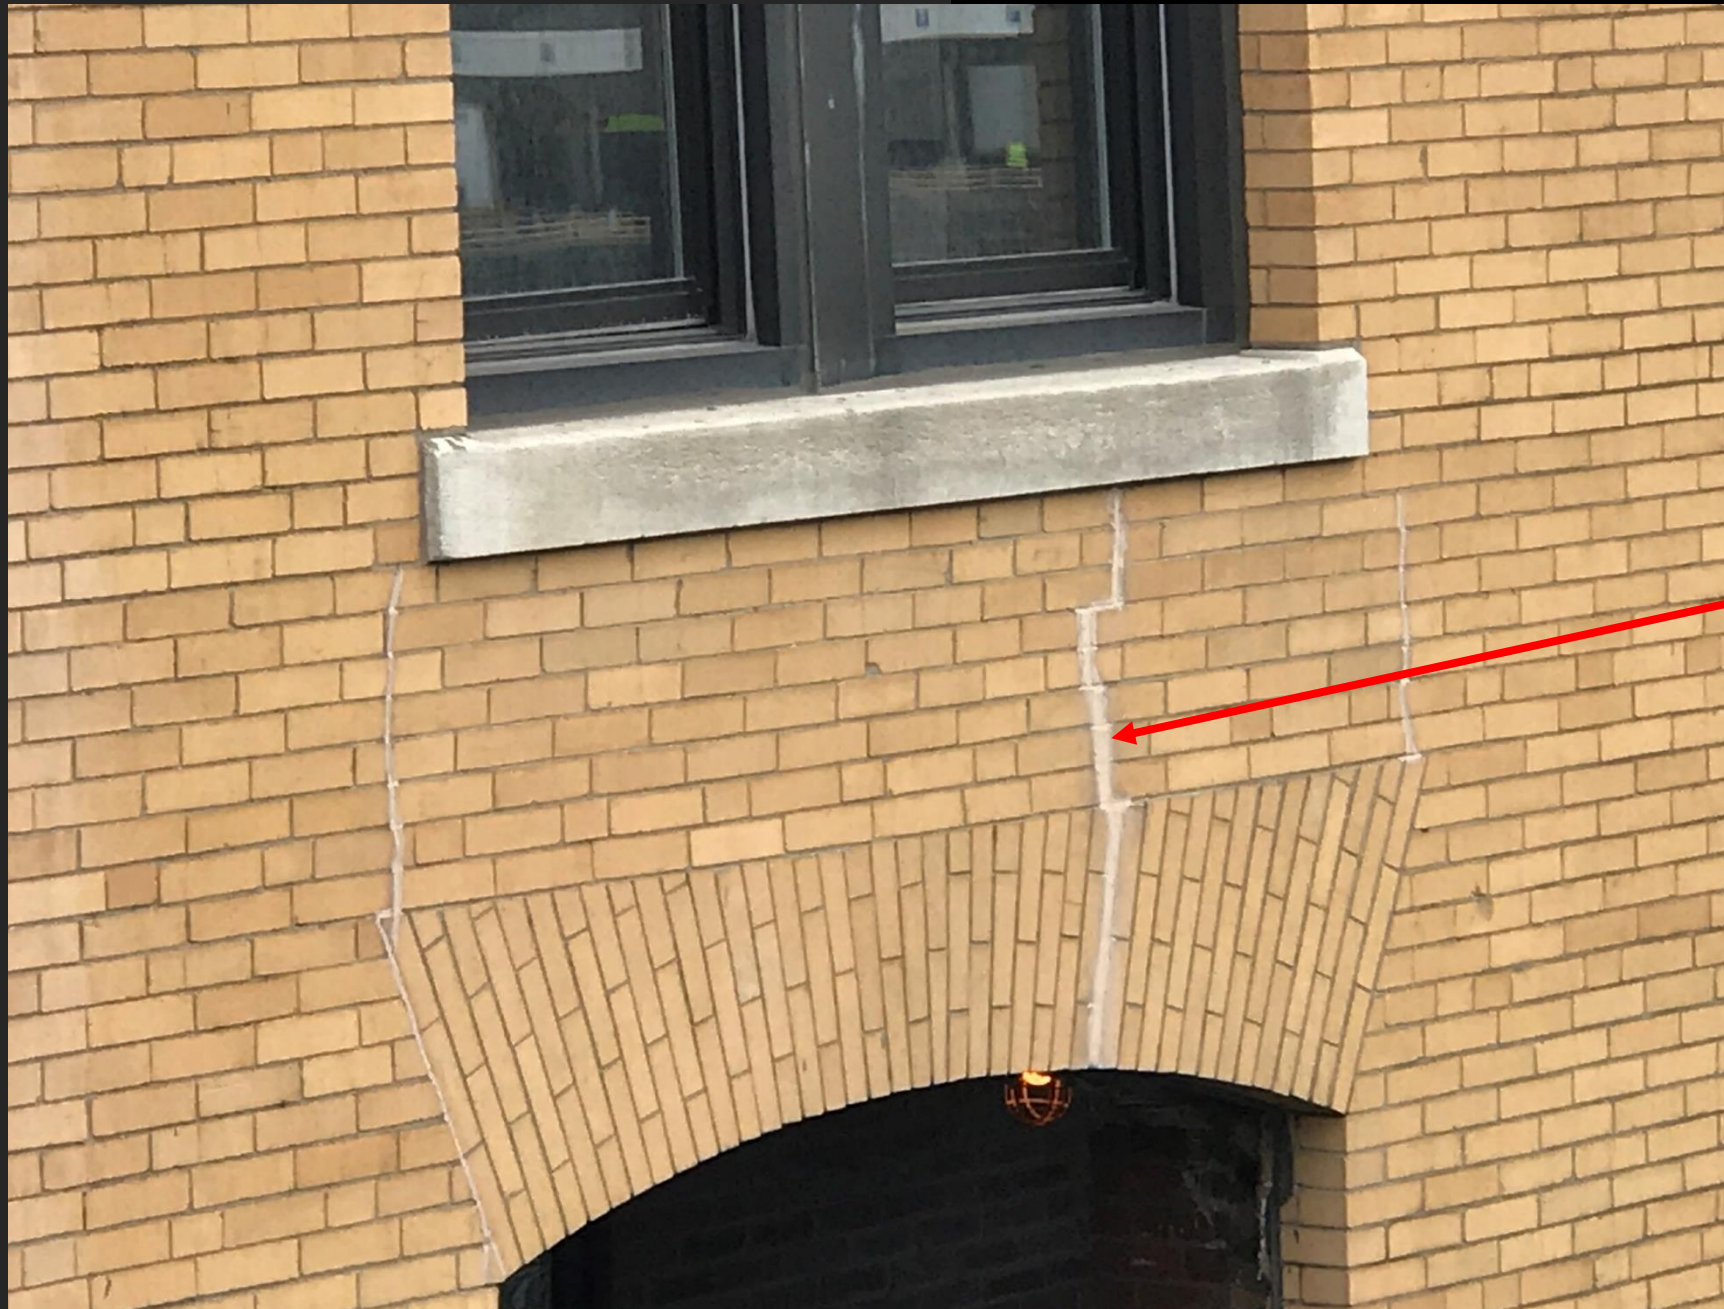
Typical Sealant over Cracked Brick

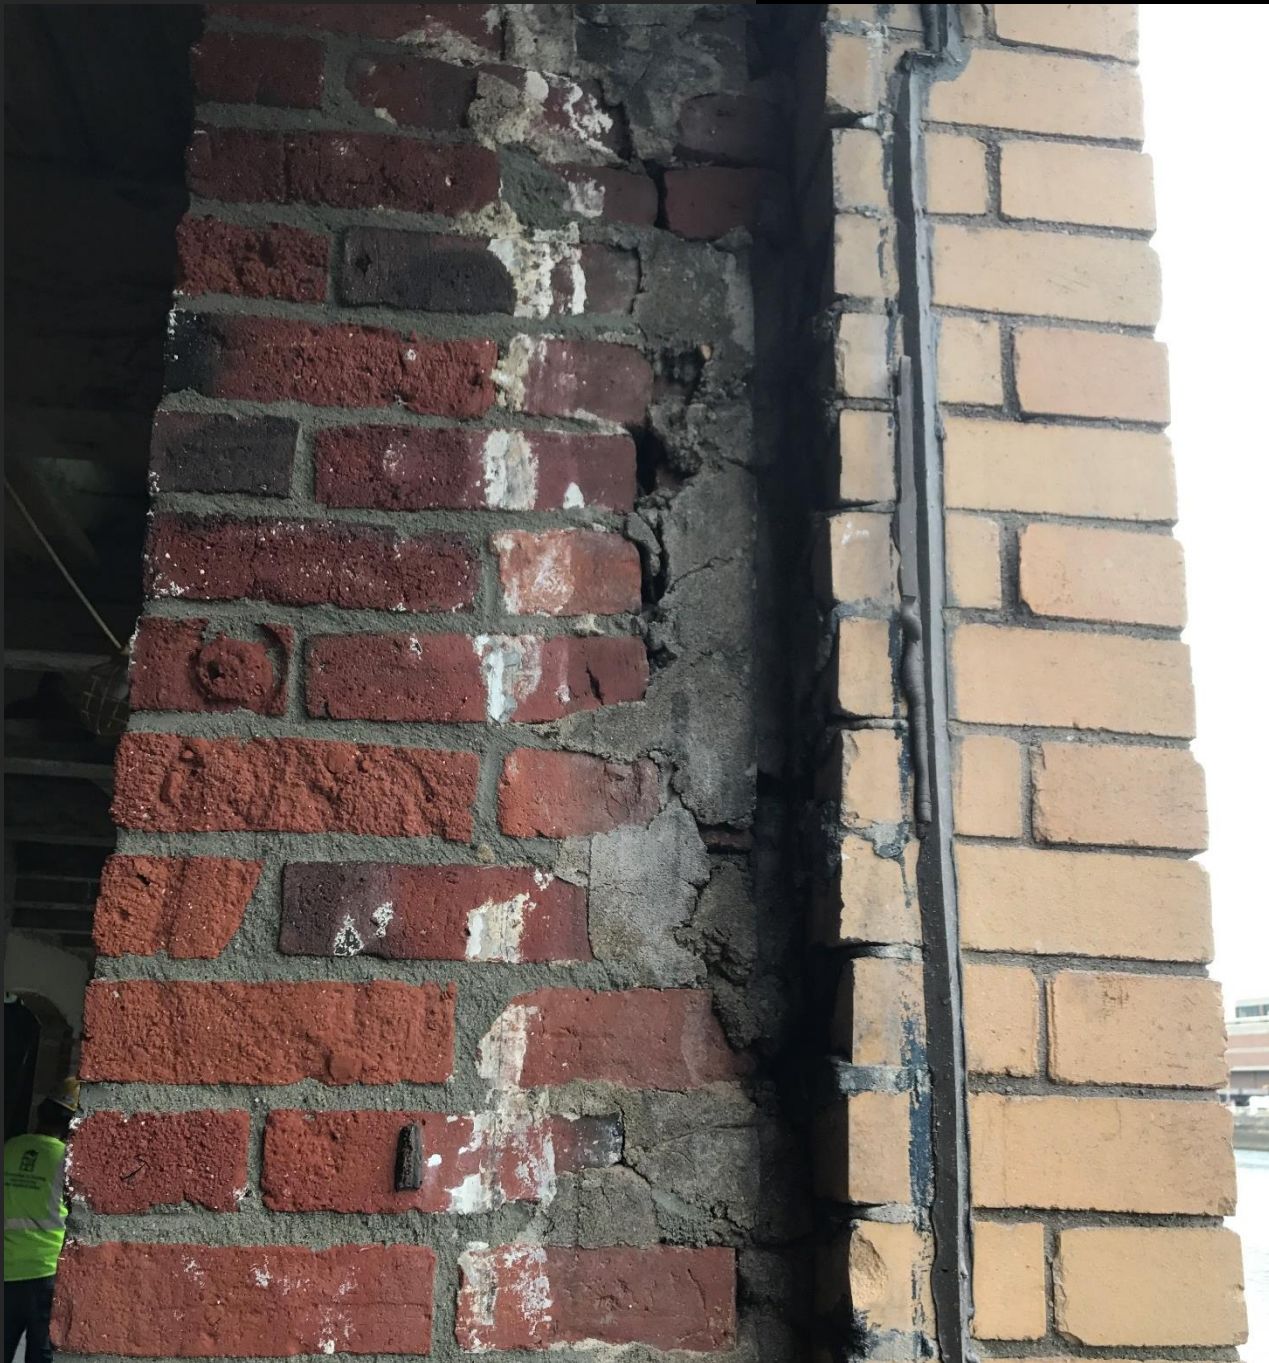
Existing Jamb  
Condition at  
Harbor Walk

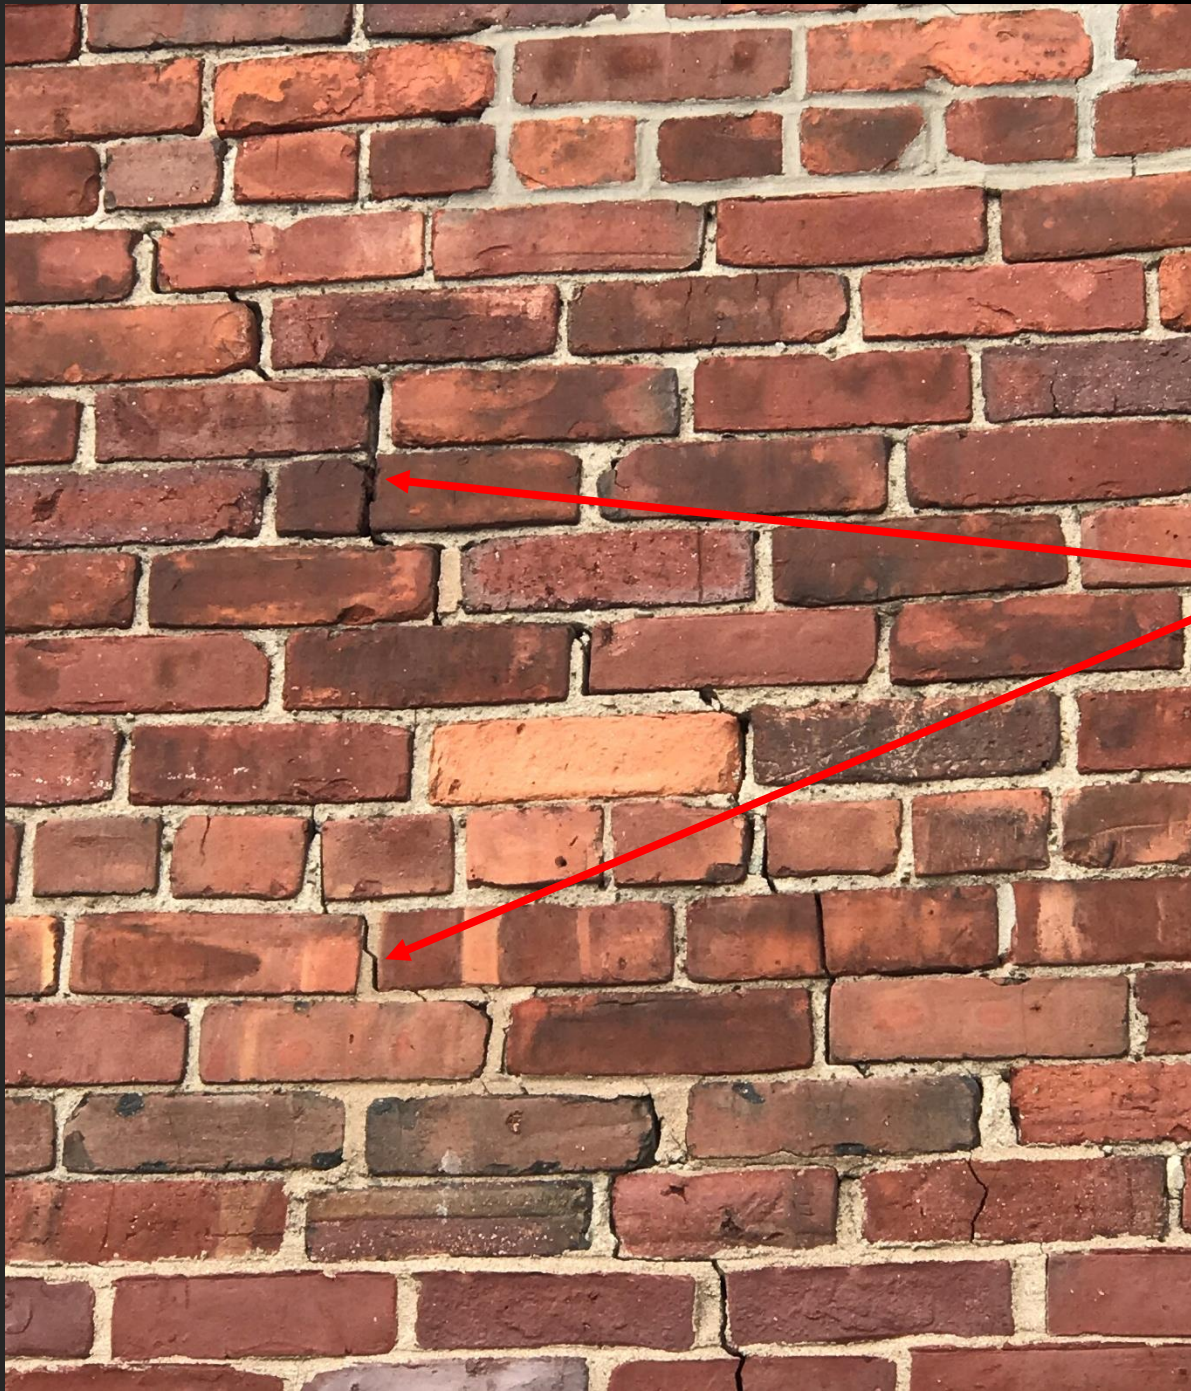
Typical Step  
crack
