# 253 Summer Street

## Landmark Presentation

## CBI Consulting Inc.

## FACADE REPAIRS

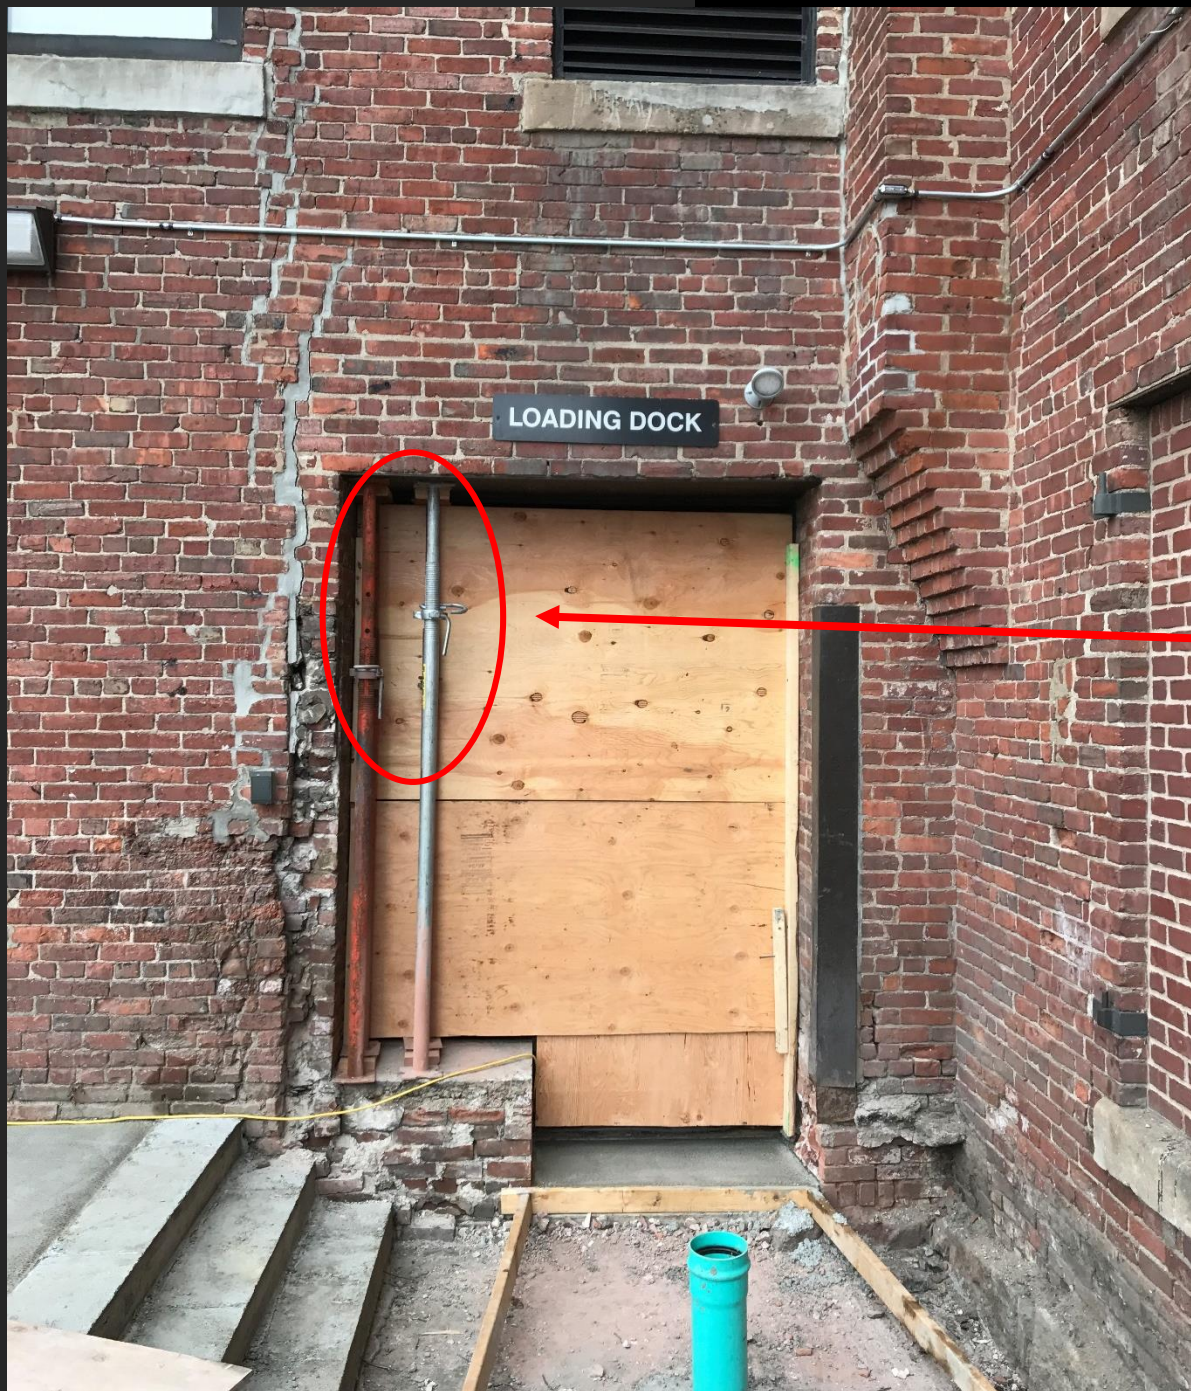
Temporary  
Shoring Due to  
Structural  
Concerns

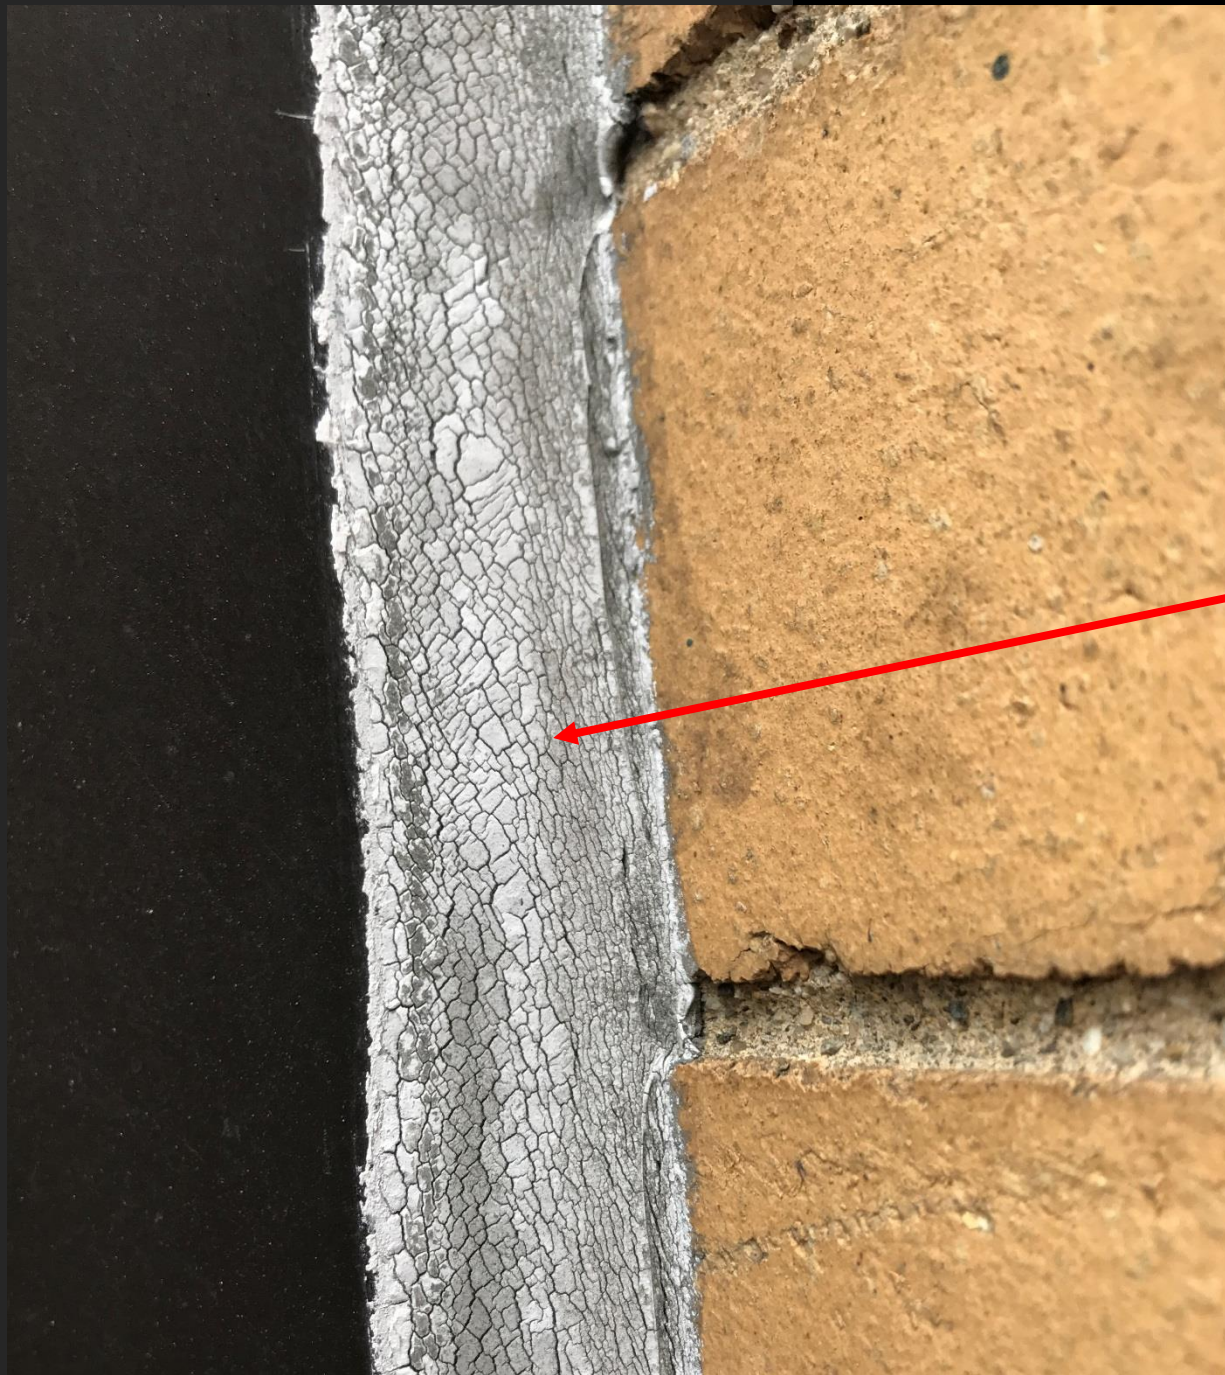
Failed  
Sealant

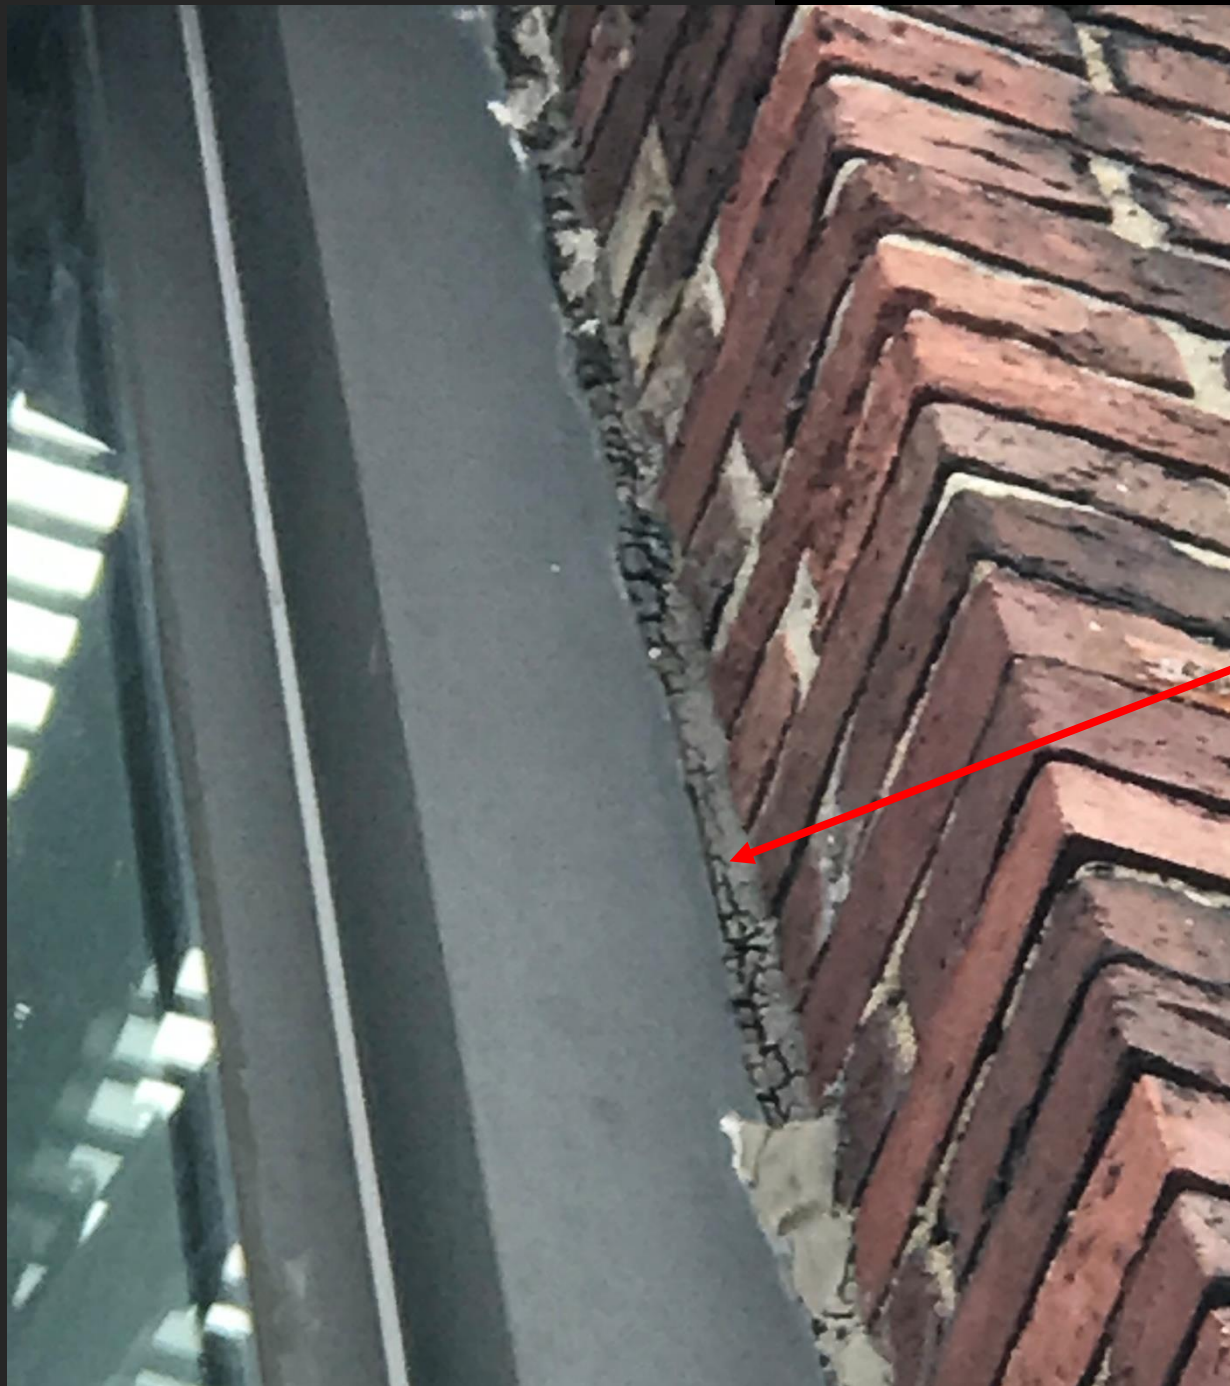
Failed  
Sealant
