## 24 Joy Street - VIO.BH.71: Before June 2011

24 Joy Street, Boston, MA

Cracked Door Lintel Steel Beam Additions

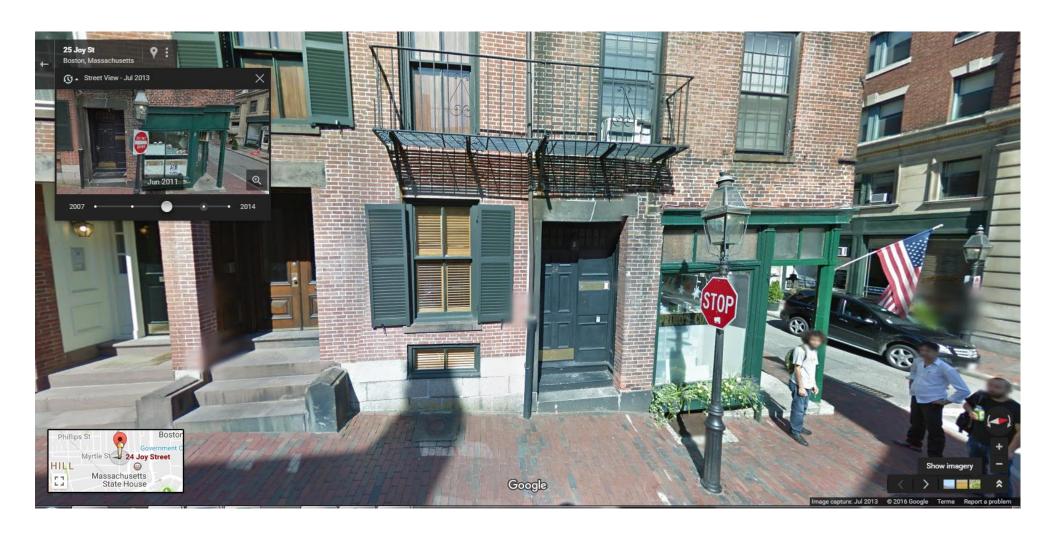
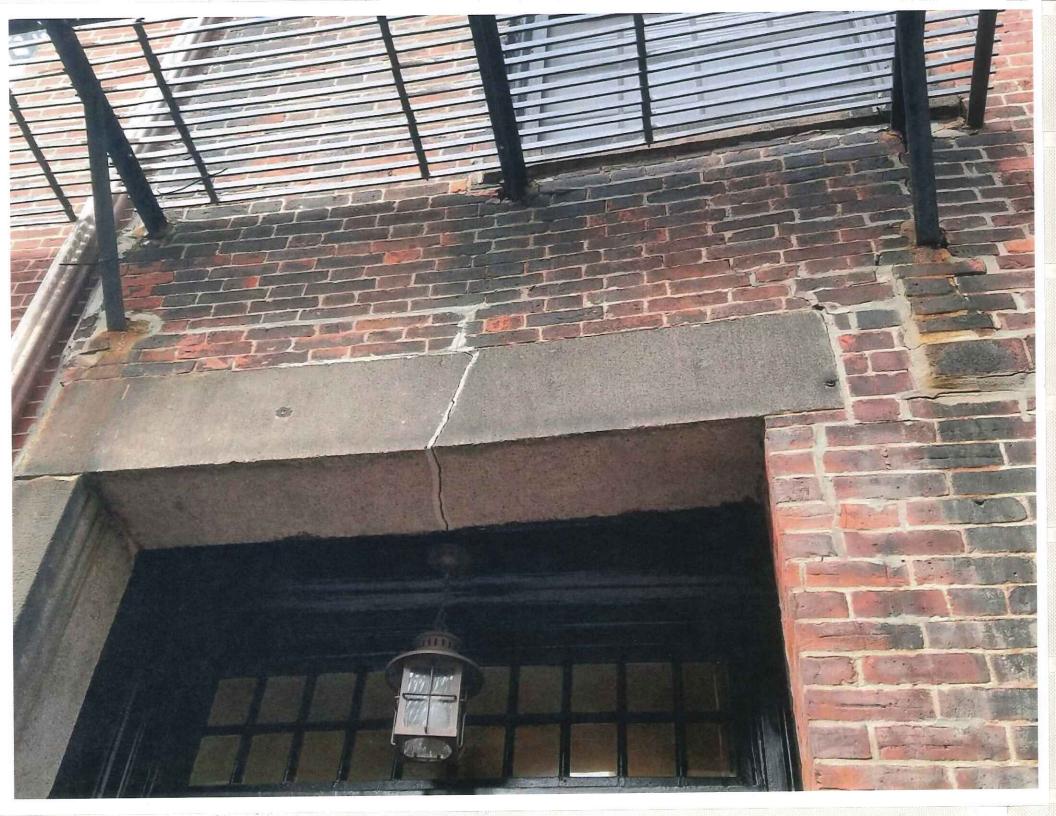
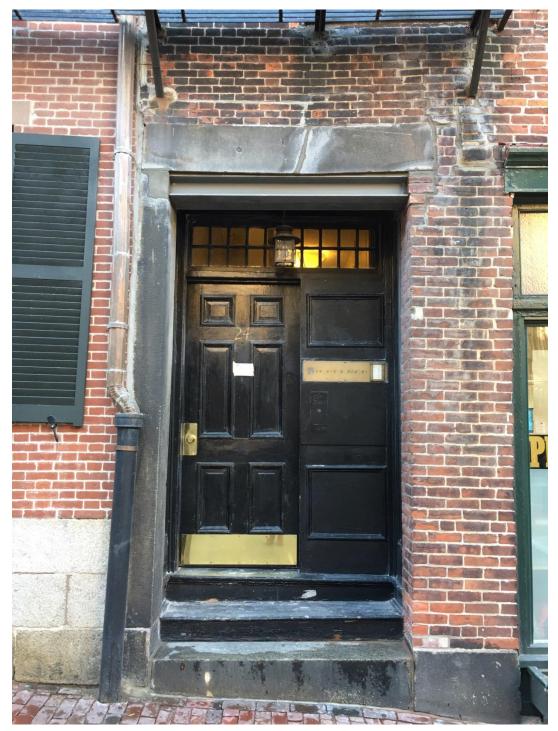
As a result of my field observation of the existing conditions surrounding the cracked lintel, it was clear to me that the section of exterior wall, around and above the cracked door lintel, was in questionable condition. The brick above, which supports a significant portion of wall, floors and roof structures, is of poor quality, with numerous cracked joints and weather deterioration, and has undergone significant distortion due to the sagging of the cracked lintel. Additionally, that section of wall is isolated from the adjacent building wall construction which could have helped redistribute loads from above.
