GARCELON'S PARK STABLES

NEIGHBORHOOD CONTEXT

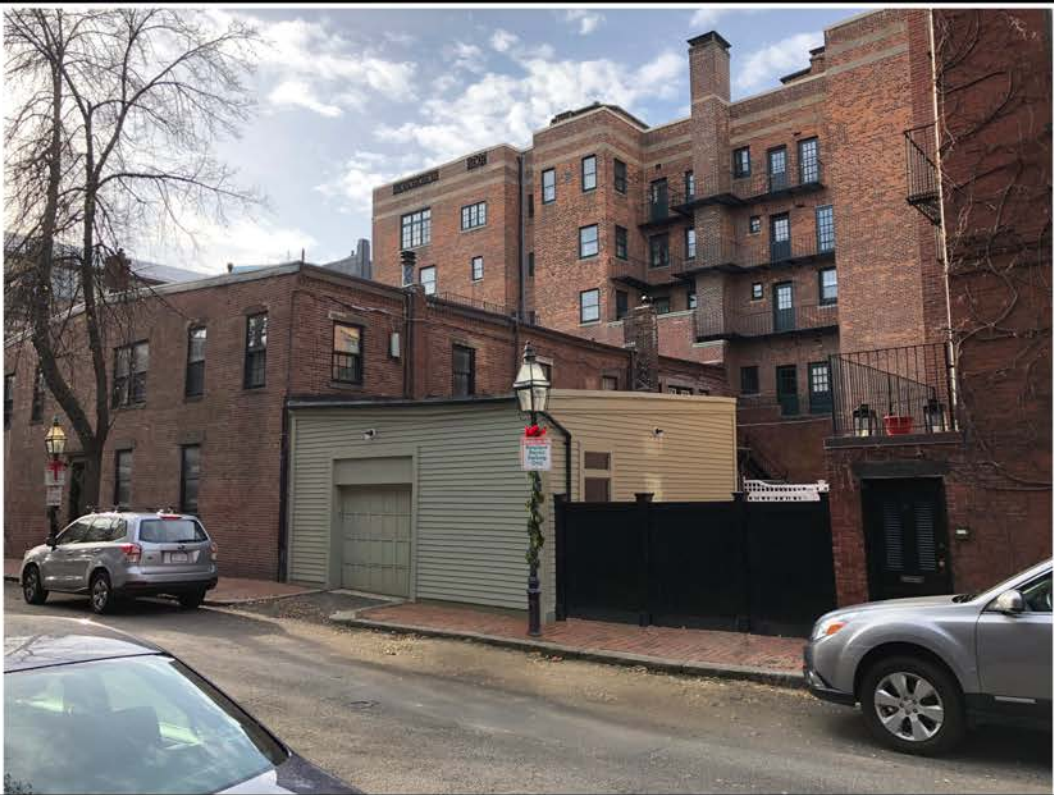
Photograph of Existing Conditions at Rear One-Story Structure

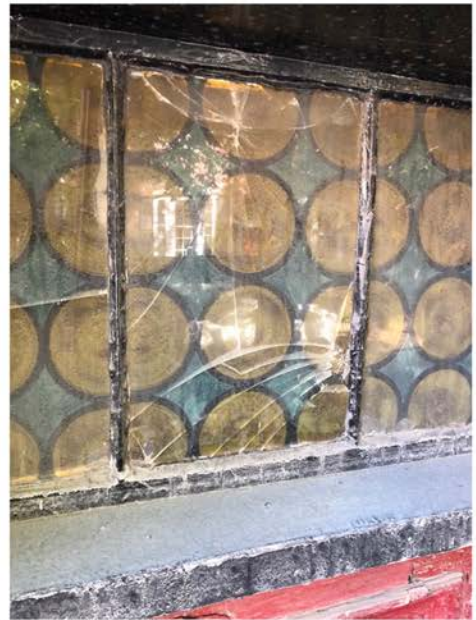
180712-IMG_8854.jpg

*Glass Transom Sash to be Repaired; Broken Glass to be
Replaced with Restoration Glass; Interior Decorative
Panel of Faux Stained Glass to be Removed*

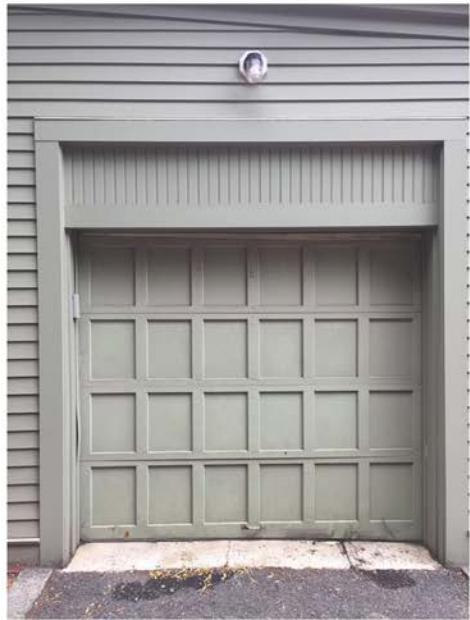
170608-IMG_6548.JPG

*Contemporary Garage Door at One-Story Addition with
Paneling above Transom Bar; Door to be Replaced with
Fixed Door to Match Main Garage Door on Chestnut St;
Transom Panel to be Replaced with 6-Light Glass Sash*

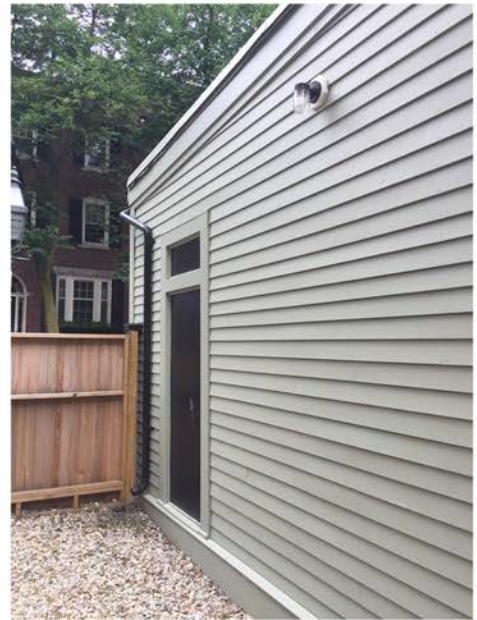
170608-IMG_6563.JPG

*North Elevation of One-Story Garage with Service Door
Opening and Transom (No Door or Transom at Present);
Door & Transom to be Provided into Rear Yard as
Replication of Missing Components*

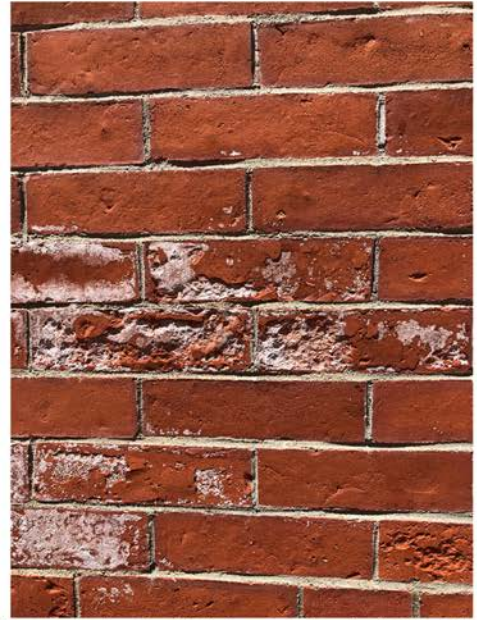
180718-IMG_8993.jpg

Selective Deteriorated Bricks on Chestnut Street Facade to be Replaced in Kind Where Needed

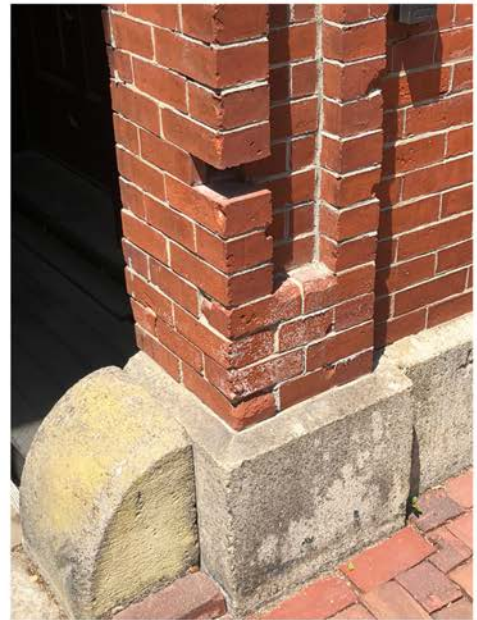
180526-IMG_8549.jpg

Missing & Chipped Bricks at Chestnut Street Portico; Granite Plinth and Wheel Guard

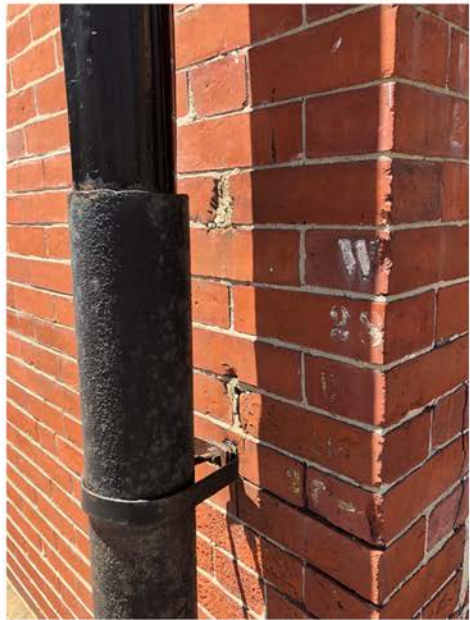
180718-IMG_8995.jpg

Damaged Bricks at Rain Leader by SE Corner

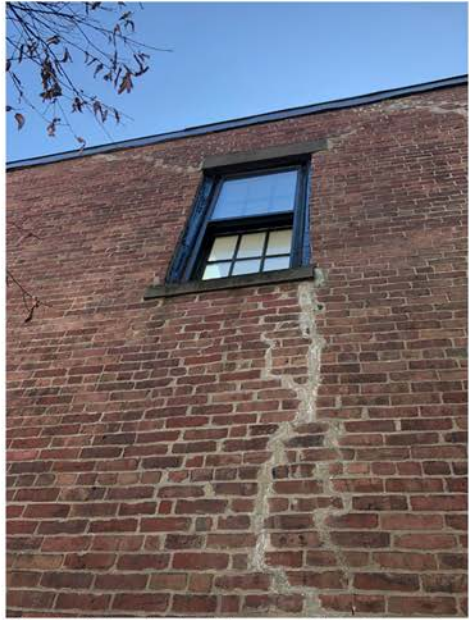
180712-IMG_8792.jpg

*Vertical Cracks in Brimmer Street Facade;
Damage was Prior to Foundation Repairs*

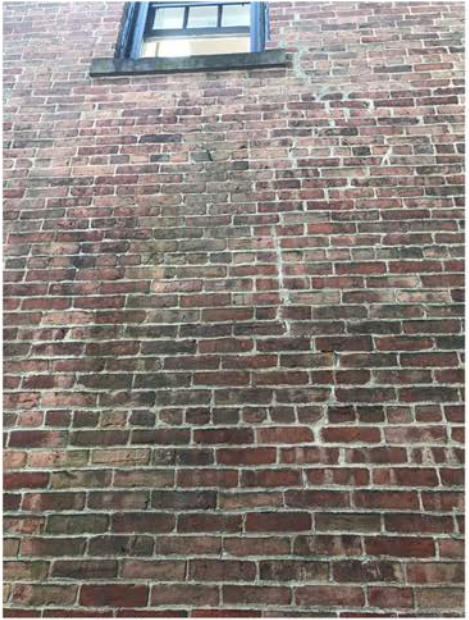
180526-IMG_8534.jpg

*Smaller Vertical Cracks on Brimmer Street;
Repairs and Repointing to be Performed
Followed by Gentle Masonry Restoration Cleaning*

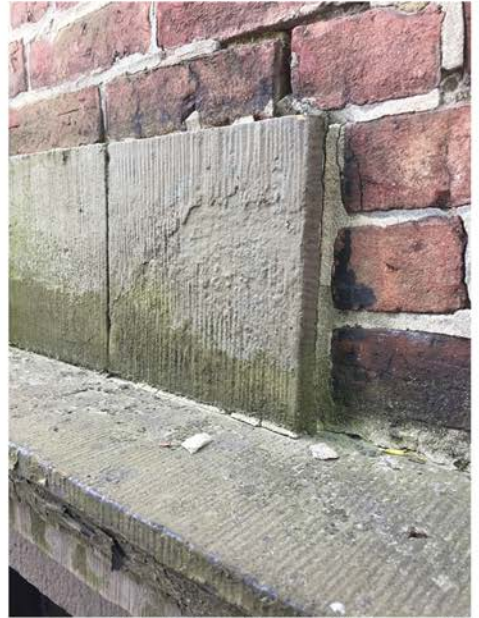
170608-IMG_6539.JPG

Brownstone Lintel Above Hooded Entrance Lintel; Deteriorated Two-Piece Lintel to be Replaced

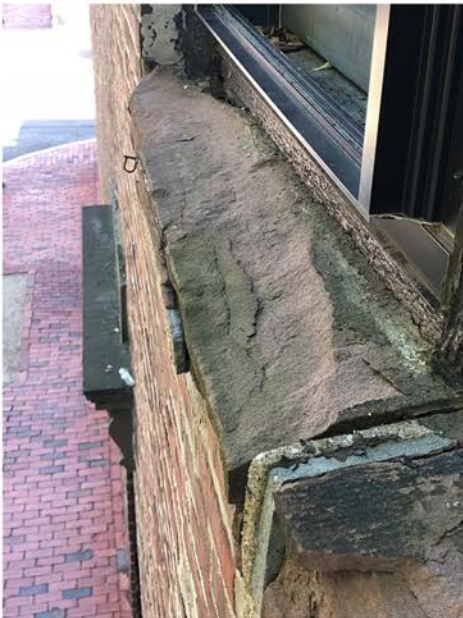
180712-IMG_8838.jpg

Severely Deteriorated Brownstone Sill at Second Floor

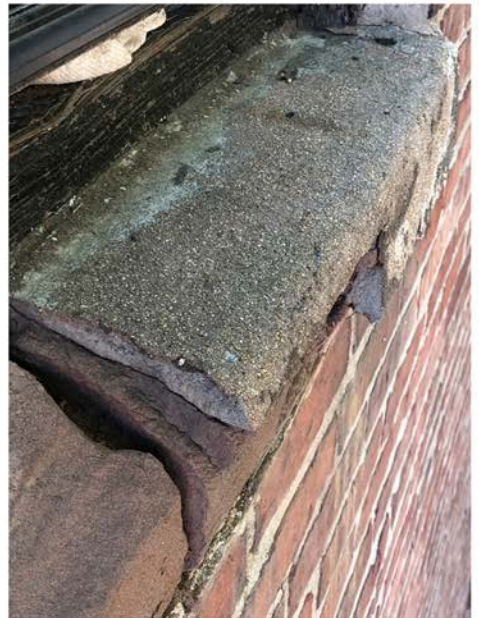
180712-IMG_8839.jpg

Failing Patch at Severely Deteriorated Brownstone Sill

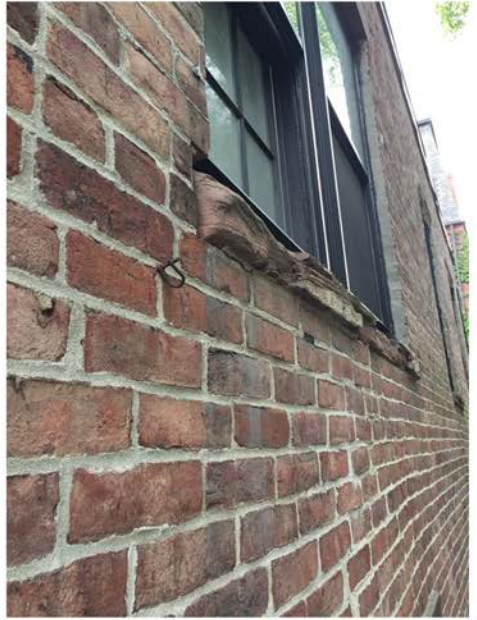
170608-IMG_6543.JPG

Deteriorated Brownstone Sills to be Replaced

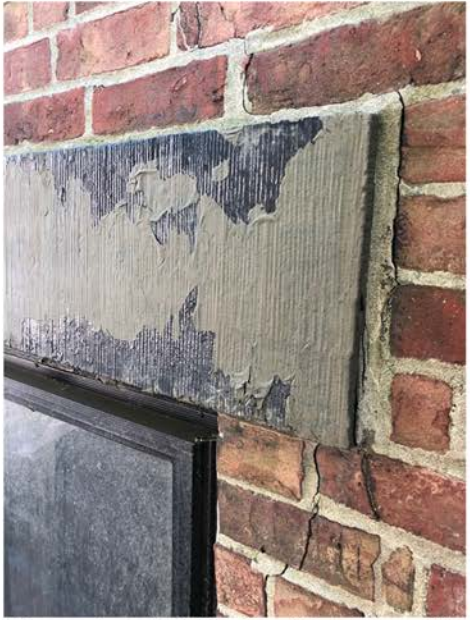
180712-IMG_8846.jpg

Brownstone Lintel in Good Condition with Two Iterations of Paint (Black & Brown); Re-Set & Replacement Lintels to be Unpainted

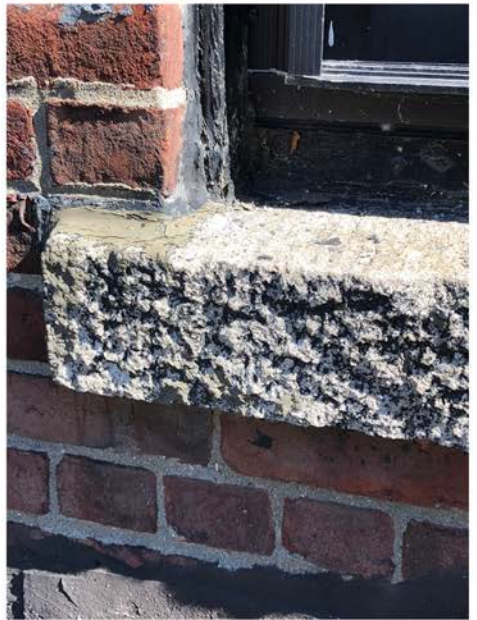
180712-IMG_8837.jpg

Replacement Granite Sill on North Facade of Second Floor to be Reused and Painted to Match Color of Brownstone

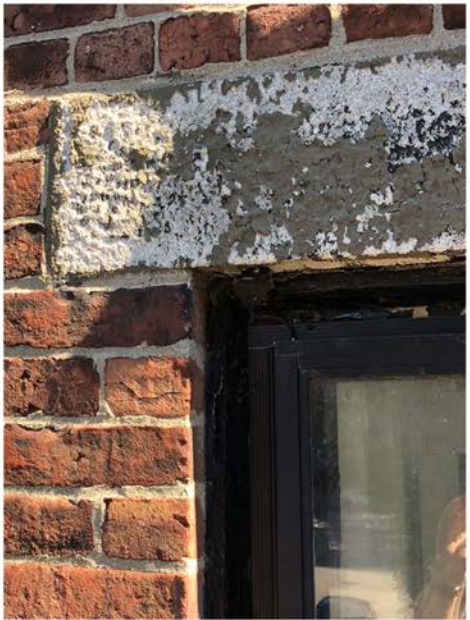
180712-IMG_8836.jpg

Replacement Granite Lintel on North Facade of Second Floor to be Reused and Painted to Match Color of Brownstone

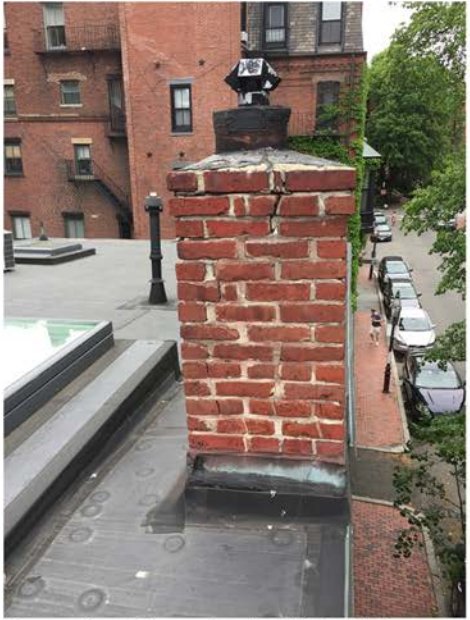
170608-IMG_6580.JPG

*Reconstruct Upper Part of Main Chimney &
Replace Dryer Vent with Chimney Pot*

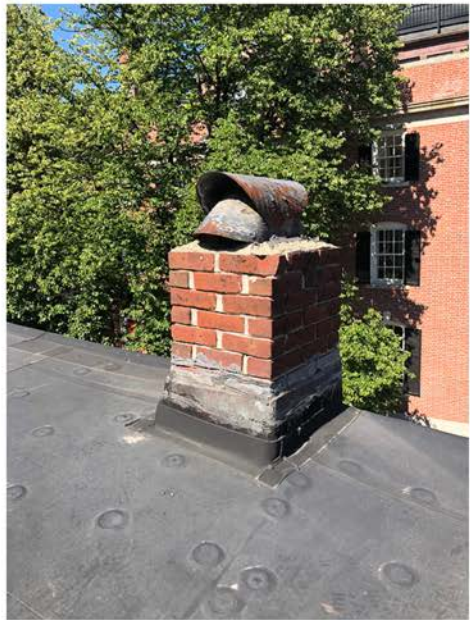
180712-IMG_8825.jpg

*Secondary Chimney on Brimmer Street Near
Chestnut Street at SE Corner; Deteriorated
Metal Cap to be Replicated in Gray Copper*

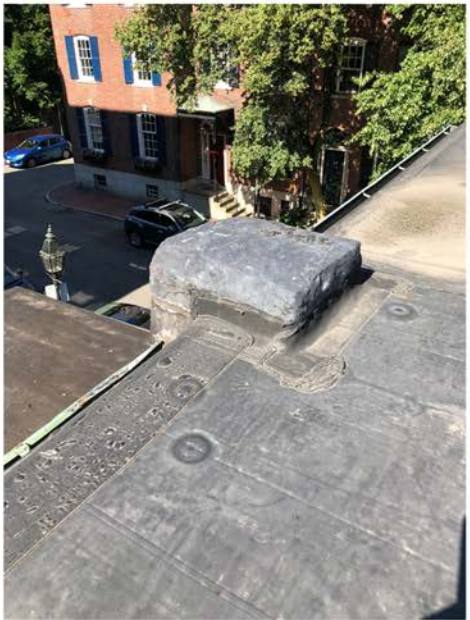
180712-IMG_8827.jpg

*Remnant of Removed Chimney at North Facade;
Missing Upper Portion to be Reconstructed with
Metal Cap to Match Other Secondary Chimney*

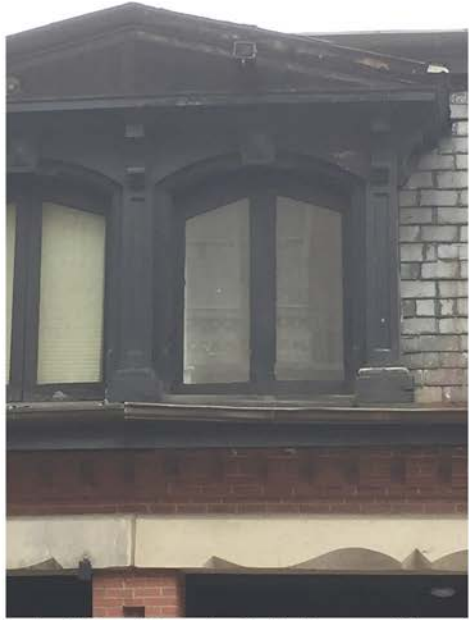
170608-IMG_6596.JPG

Chestnut Street Facade Gable Dormer Shared by Adjacent Buildings (Right Side is 57 Brimmer Street Bldg.); In-Swing Casement Window to be Repaired

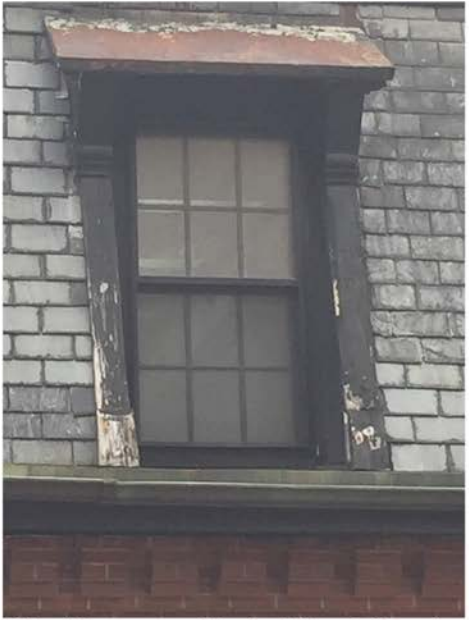
170608-IMG_6595.JPG

Shed Dormer on Chestnut Street Facade; Sash & Frame to be Retained; Storm Window to be Replaced; Wood Surround to be Repaired; Rusted Metal Roof to be Replaced

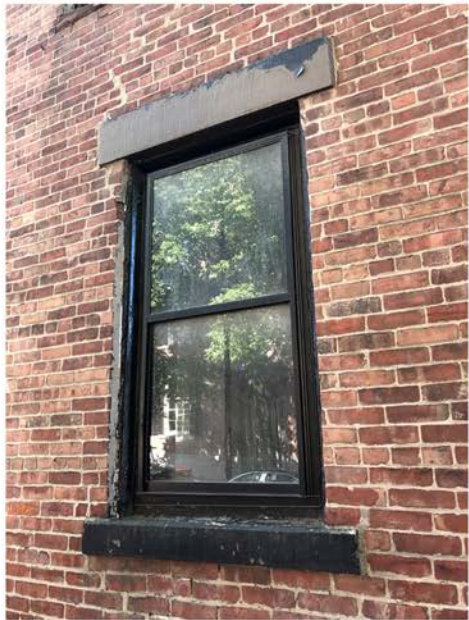
180712-IMG_8803.jpg

First of Two 2-over-2 Sash on Brimmer Street Facade; Sash to be Repaired; Frame & Storm Window Replaced; Brownstone Sill & Lintel to be Re-Set and Paint Removed

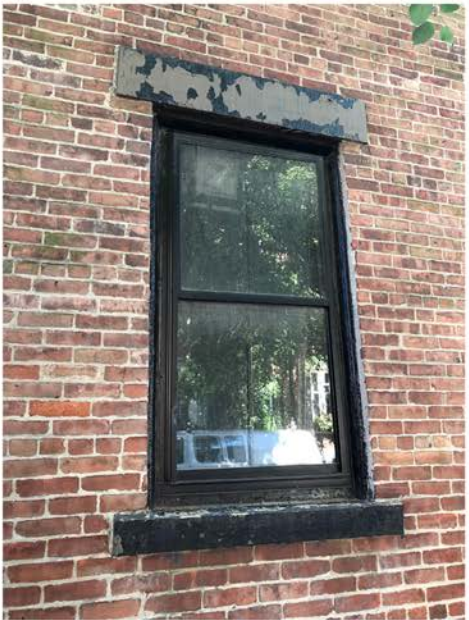
180712-IMG_8804.jpg

Second of Two 2-over-2 Sash on Brimmer Street Facade; Sash to be Repaired; Frame & Storm Window Replaced; Brownstone Sill & Lintel to be Re-Set and Paint Removed

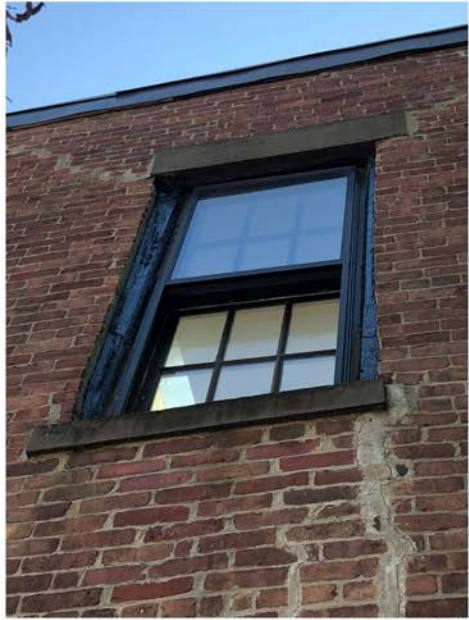
180712-IMG_8793.jpg

Second Floor Windows are 6-over-6 True-Divided Lights; Sash to be Reused; Frames & Storms to be Replaced; Brownstone Lintels & Sills in Good Condition to be Re-Set, or Replaced in Locations Where Severely Deteriorated

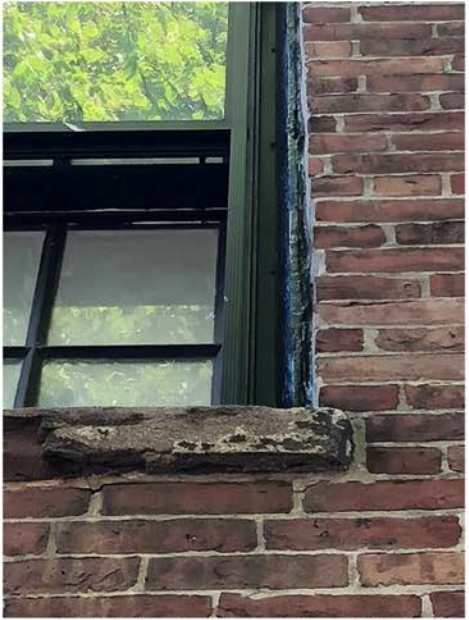
180712-IMG_8800.jpg

Severely Deteriorated Brownstone Window Sill; Wood Sills and Frames Also in Poor Condition; Replacements to Match Profiles, Colors & Materials

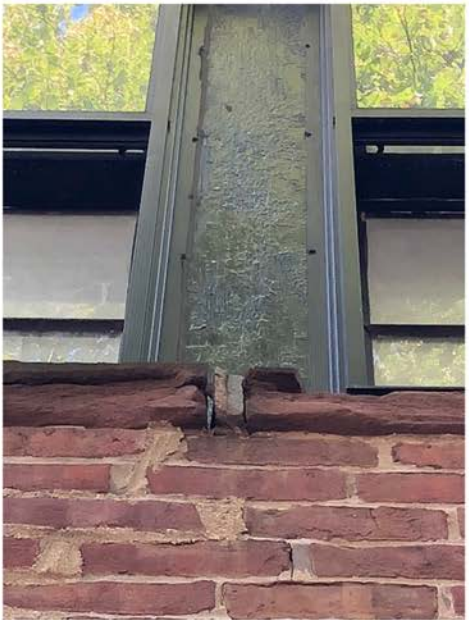
180712-IMG_8799.jpg

Deteriorated Brownstone Sill at Second Floor Window

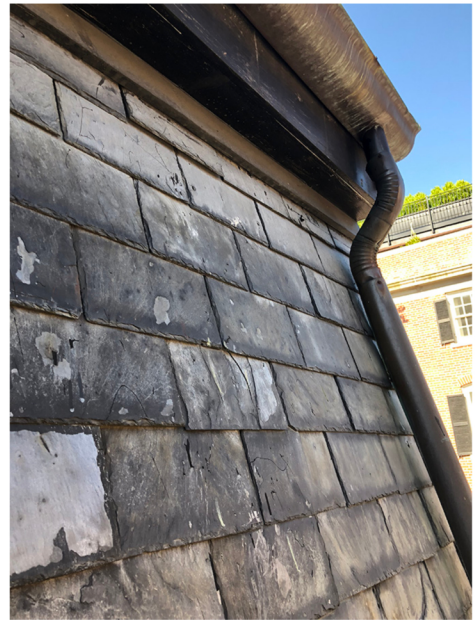
180712-IMG_8844.jpg

Deteriorated Dark Gray Slate Roof with Copper Gutter, Copper Rain Leader and Painted Wood Fascia

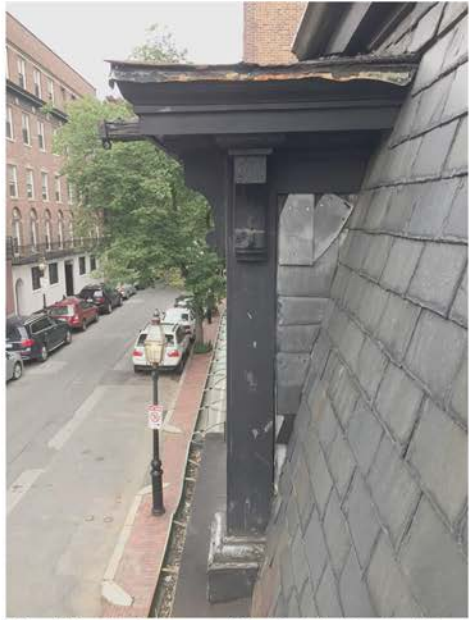
170608-IMG_6598.JPG

Looking West at Mansard to Gable Roofed Dormer Shared with Neighboring Twin Property; Disrupted Slates on Sidewall & Rusting Metal Roof

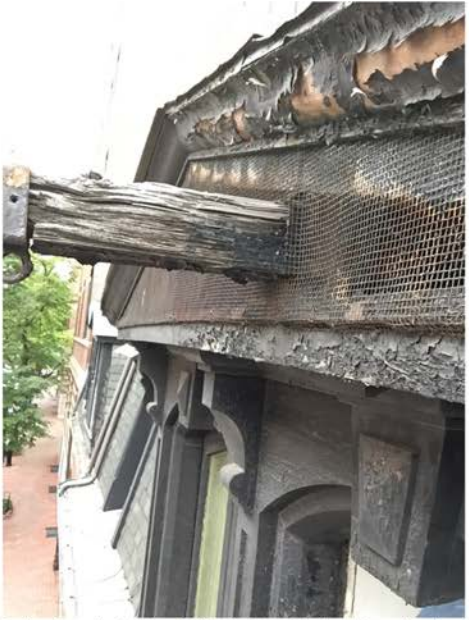
170608-IMG_6601.JPG

Deteriorated Hayloft Timber to be Replicated; Painted Metal Bird Screening to be Replaced with More Subtle Nylon Mesh Recessed into Gable

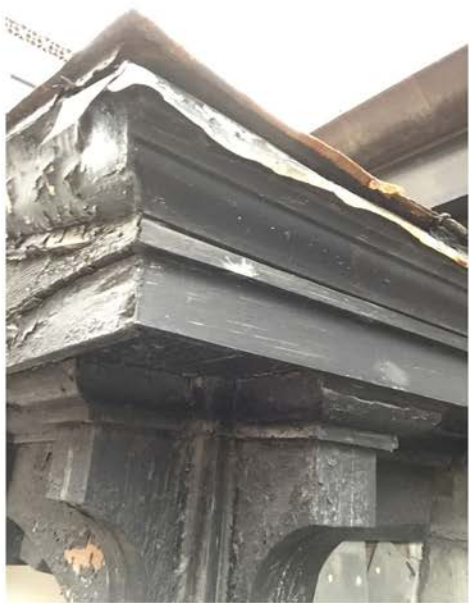
170608-IMG_6600.JPG

Wood Cornice, Rake, Fascia & Brackets; Rusted Metal Roofing to be Replaced in Copper to Match Profiles

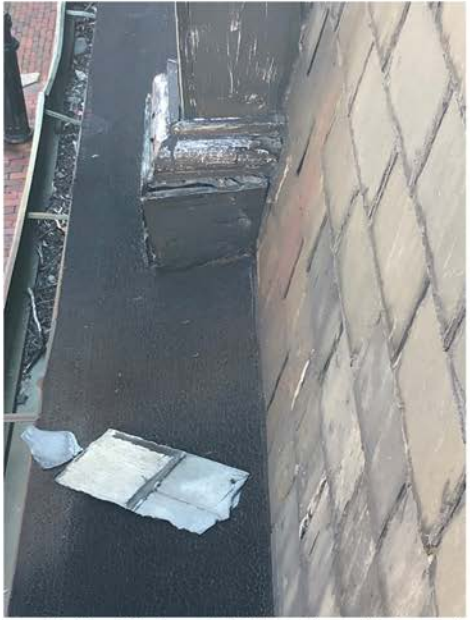
180712-IMG_8845.jpg

Loose, Fallen Slate on Roll Roofing at Eave Flare; Slates to be Replaced & Eave to be Copper

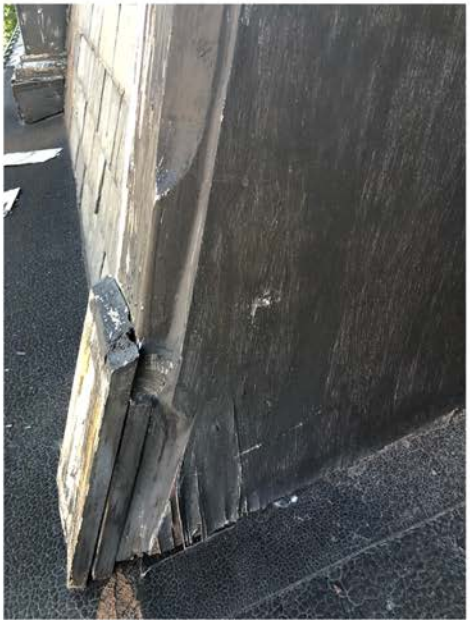
180712-IMG_8840.jpg

Deteriorated Plywood Jambs at Shed Dormer; Loose Replacement Plinth at Outer Casings; All Carpentry to be Replicated, Flashed & Painted

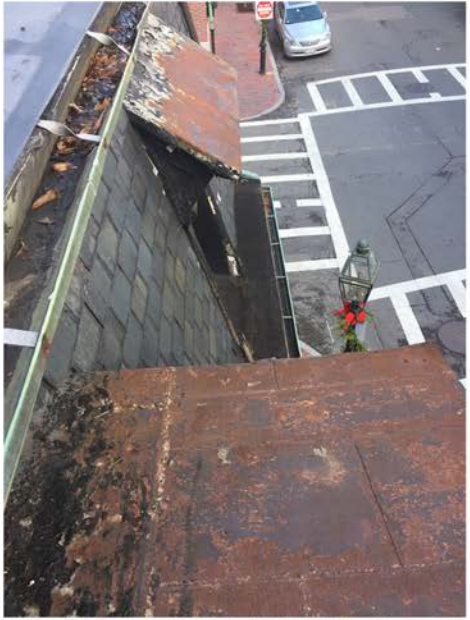
161227-IMG_5971.jpg

Aerial View of Rusted Metal Roofing at Gable (Foreground) and Shed (Background) Dormers

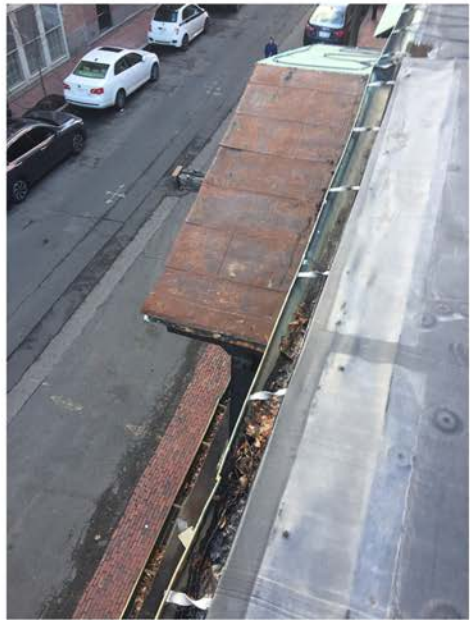
161227-IMG_5968.jpg

Rusted Gable Dormer Roofing; Copper Gutter at High Rubber Roofing Attached with Galvanized Steel Straps (Dissimilar Metals Inappropriate)

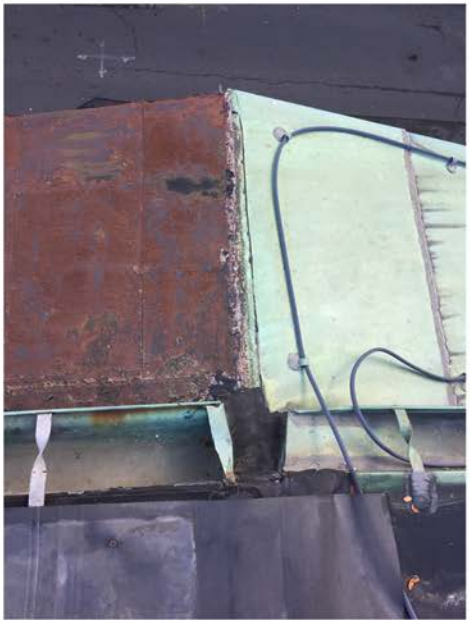
161227-IMG_5970.jpg

Abutter's Copper Roof at Gable Dormer to Right; 57 Brimmer's Rusted Metal Roofing at Left
