*Aerial View of 55-57 Brimmer at
Northwest Corner of Brimmer and Chestnut Streets*

NEIGHBORHOOD CONTEXT

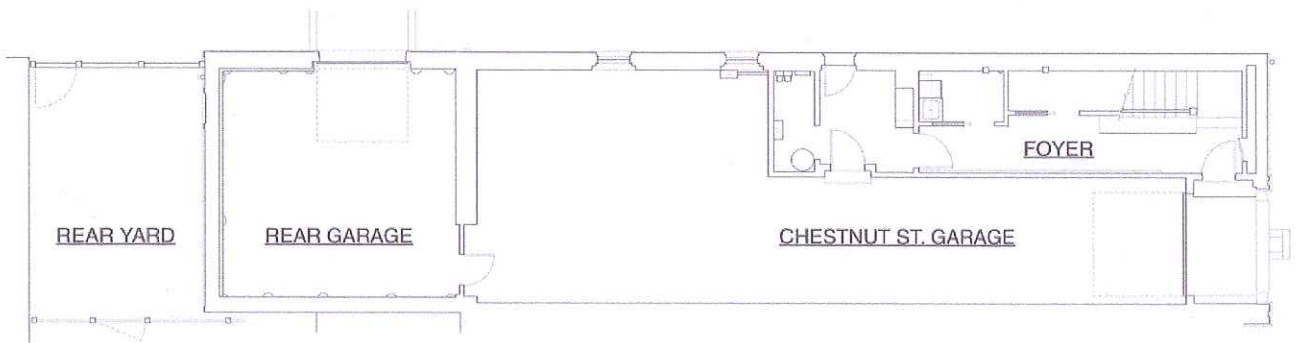
*EXISTING FIRST FLOOR (Chestnut Street at Right; Brimmer Street Above);
Chestnut Street Garage Portico and Interior Has Repaired Pile Foundations & Recently Constructed Wood-Framed Foyer;
Rear Garage Deteriorated with Cracked Slab, Sonotube Piers and Pressure-Treated Sills at Grade*

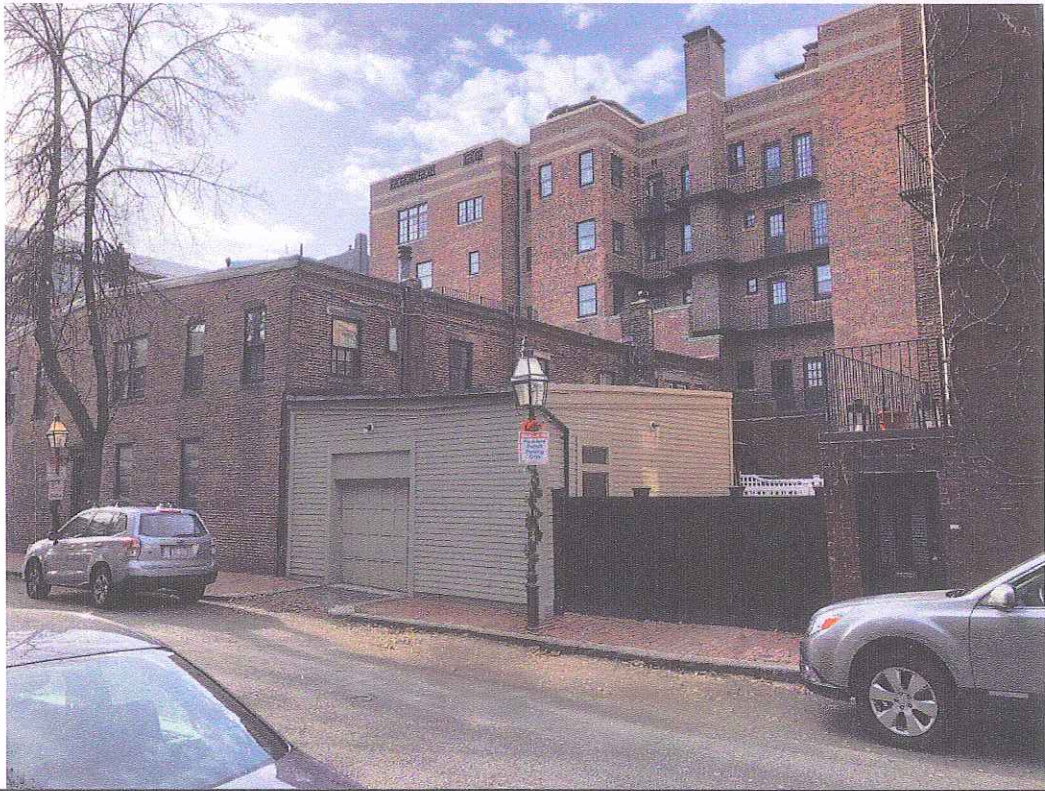
Photograph of Existing Conditions at Rear One-Story Structure

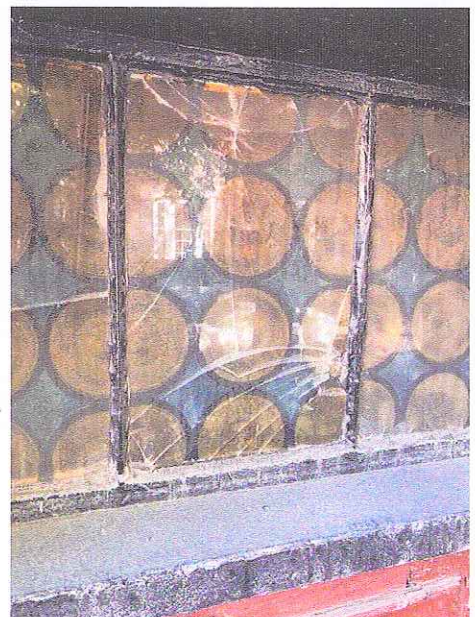
180712-IMG_8854.jpg

*Glass Transom Sash to be Repaired; Broken Glass to be
Replaced with Restoration Glass; Interior Decorative
Panel of Faux Stained Glass to be Removed*

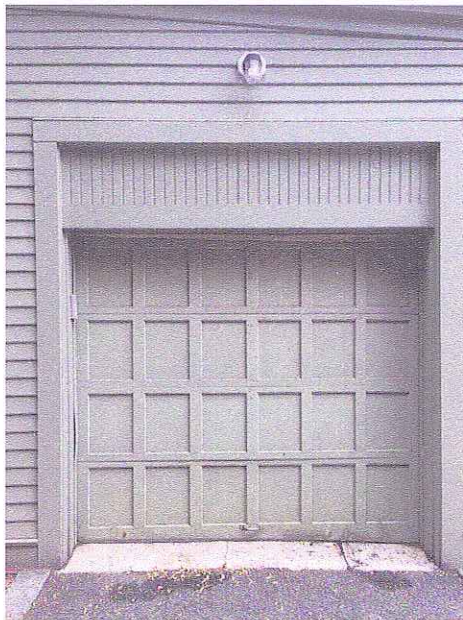
170608-IMG_6548.JPG

*Contemporary Garage Door at One-Story Addition with
Paneling above Transom Bar; Door to be Replaced with
Fixed Door to Match Main Garage Door on Chestnut St;
Transom Panel to be Replaced with 6-Light Glass Sash*

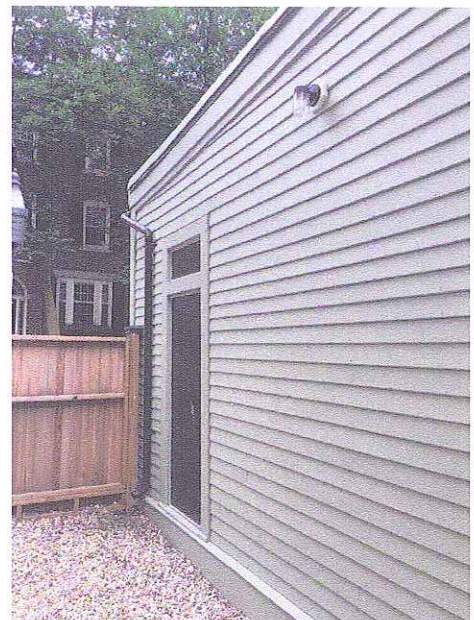
170608-IMG_6563.JPG

*North Elevation of One-Story Garage with Service Door
Opening and Transom (No Door or Transom at Present);
Door & Transom to be Provided into Rear Yard as
Replication of Missing Components*

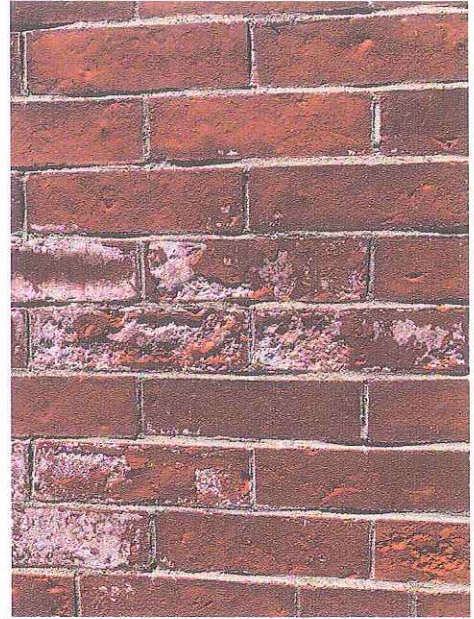
180718-IMG_8993.jpg

*Selective Deteriorated Bricks on Chestnut Street Facade
to be Replaced in Kind Where Needed*

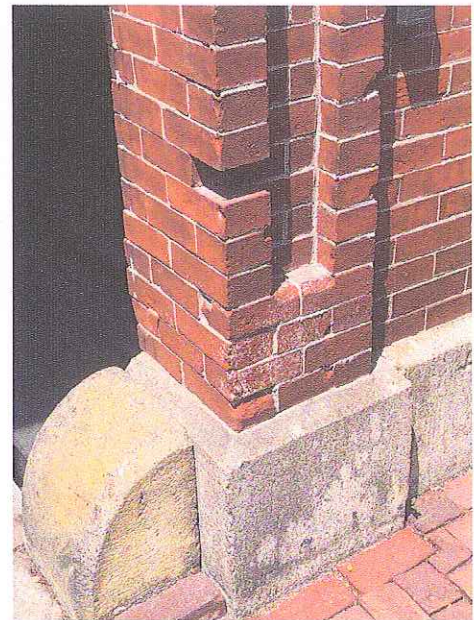
180526-IMG_8549.jpg

*Missing & Chipped Bricks at Chestnut Street Portico;
Granite Plinth and Wheel Guard*

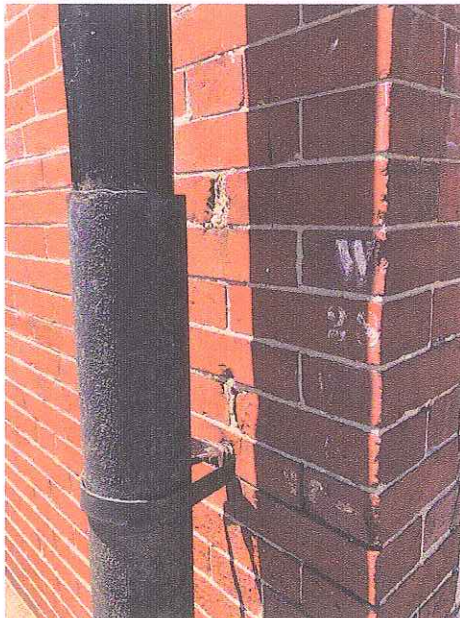
180718-IMG_8995.jpg

Damaged Bricks at Rain Leader by SE Corner

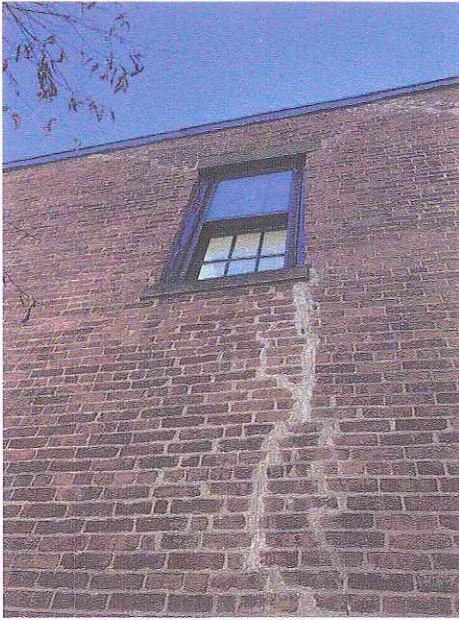
180712-IMG_8792.jpg

*Vertical Cracks in Brimmer Street Facade;
Damage was Prior to Foundation Repairs*

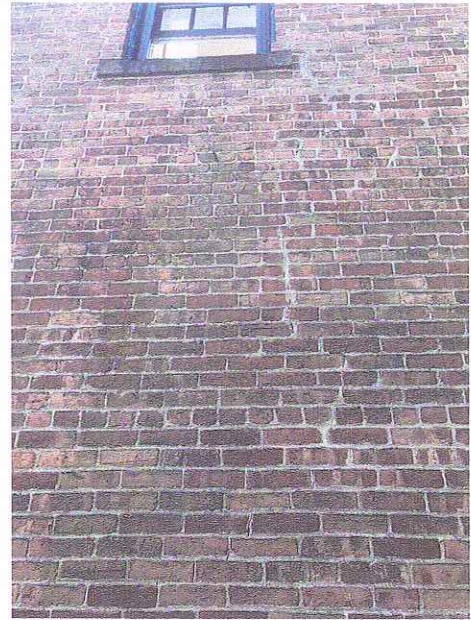
180526-IMG_8534.jpg

*Smaller Vertical Cracks on Brimmer Street;
Repairs and Repointing to be Performed
Followed by Gentle Masonry Restoration Cleaning*

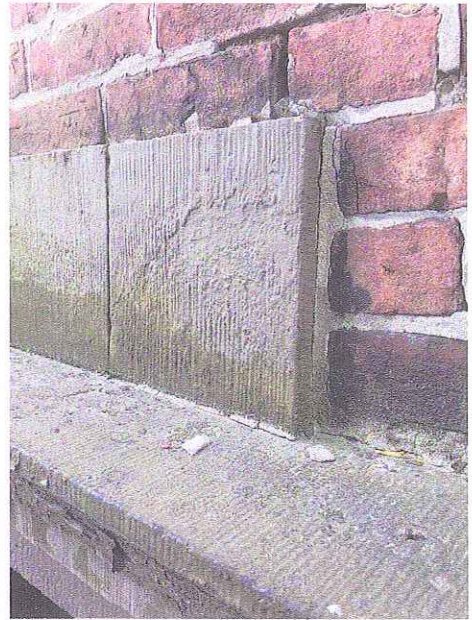
170608-IMG_6539.JPG

Brownstone Lintel Above Hooded Entrance Lintel; Deteriorated Two-Piece Lintel to be Replaced

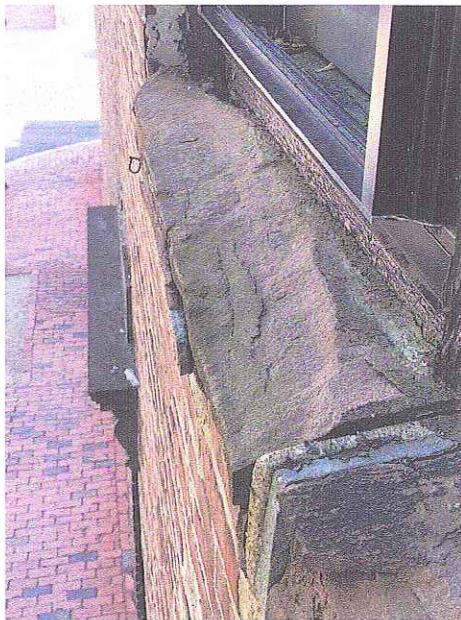
180712-IMG_8838.jpg

Severely Deteriorated Brownstone Sill at Second Floor

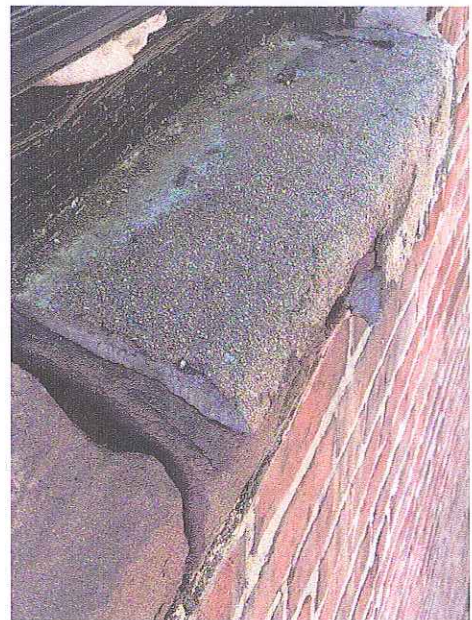
180712-IMG_8839.jpg

Failing Patch at Severely Deteriorated Brownstone Sill

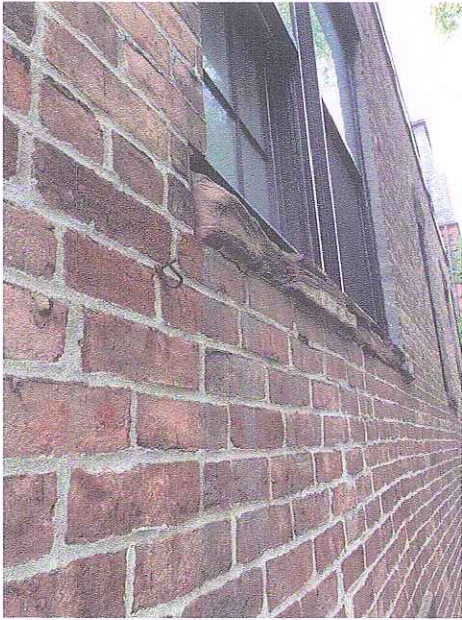
170608-IMG_6543.JPG

Deteriorated Brownstone Sills to be Replaced

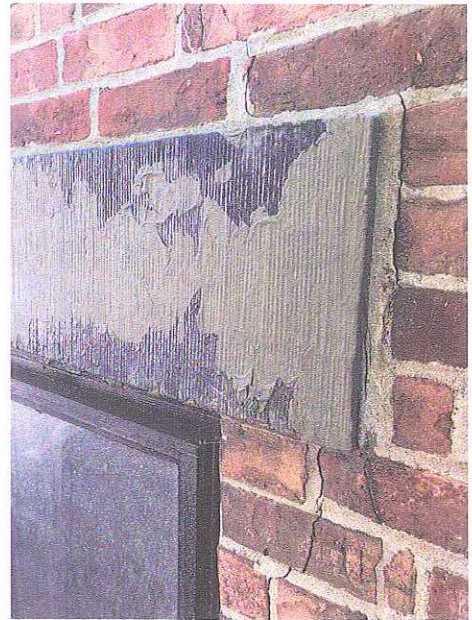
180712-IMG_8846.jpg

Brownstone Lintel in Good Condition with Two Iterations of Paint (Black & Brown); Re-Set & Replacement Lintels to be Unpainted

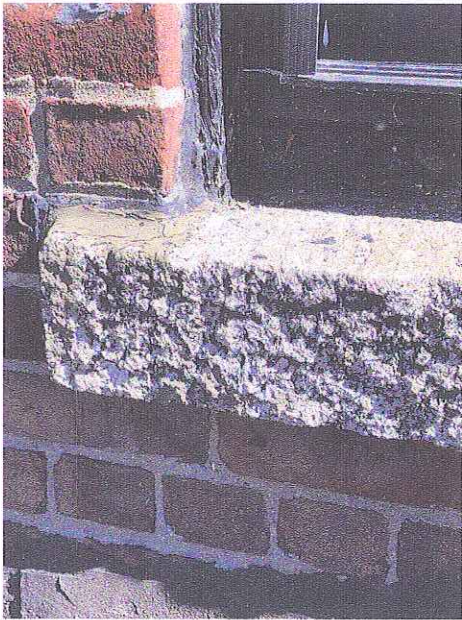
180712-IMG_8837.jpg

Replacement Granite Sill on North Facade of Second Floor to be Reused and Painted to Match Color of Brownstone

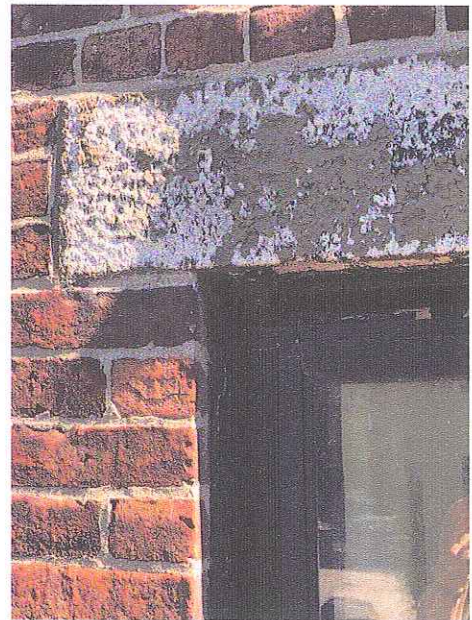
180712-IMG_8836.jpg

Replacement Granite Lintel on North Facade of Second Floor to be Reused and Painted to Match Color of Brownstone

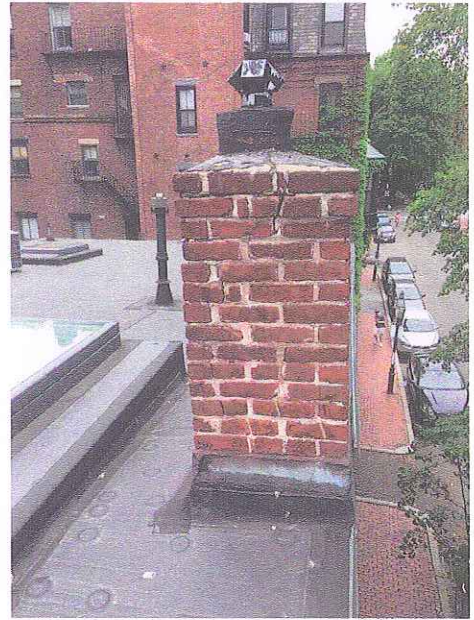
170608-IMG_6580.JPG

*Reconstruct Upper Part of Main Chimney &
Replace Dryer Vent with Chimney Pot*

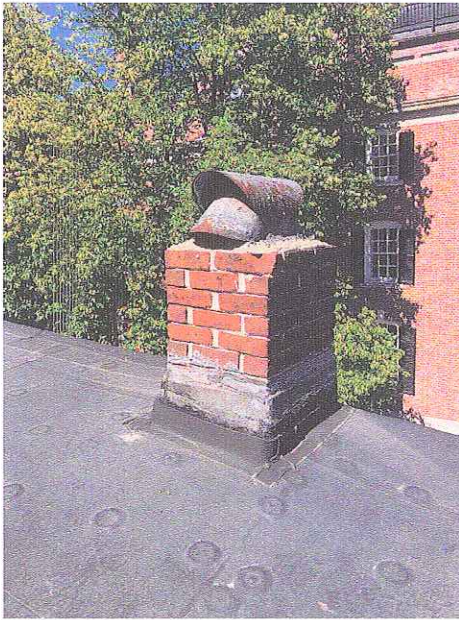
180712-IMG_8825.jpg

*Secondary Chimney on Brimmer Street Near
Chestnut Street at SE Corner; Deteriorated
Metal Cap to be Replicated in Gray Copper*

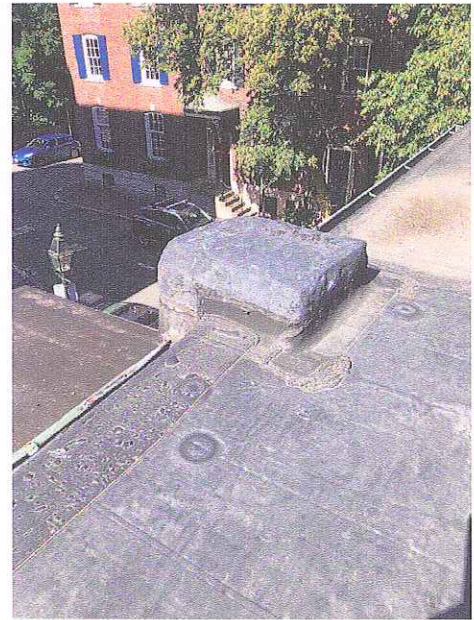
180712-IMG_8827.jpg

*Remnant of Removed Chimney at North Facade;
Missing Upper Portion to be Reconstructed with
Metal Cap to Match Other Secondary Chimney*

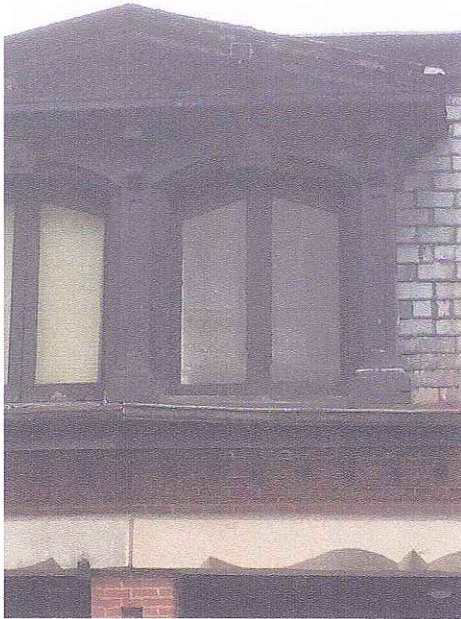
170608-IMG_6596.JPG

*Chestnut Street Facade Gable Dormer Shared by
Adjacent Buildings (Right Side is 57 Brimmer Street Bldg.);
In-Swing Casement Window to be Repaired*

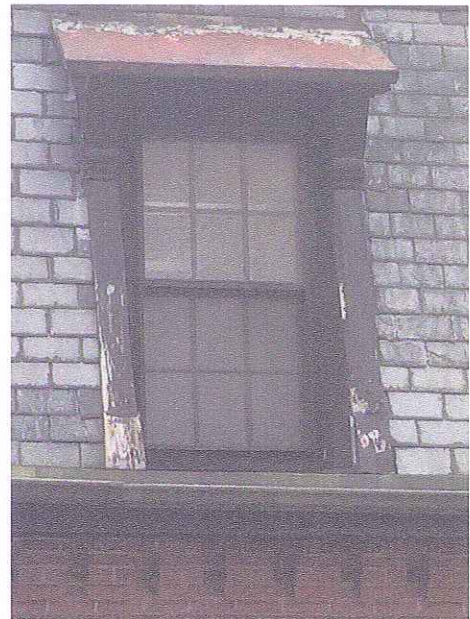
170608-IMG_6595.JPG

*Shed Dormer on Chestnut Street Facade;
Sash & Frame to be Retained; Storm Window to be
Replaced; Wood Surround to be Repaired;
Rusted Metal Roof to be Replaced*

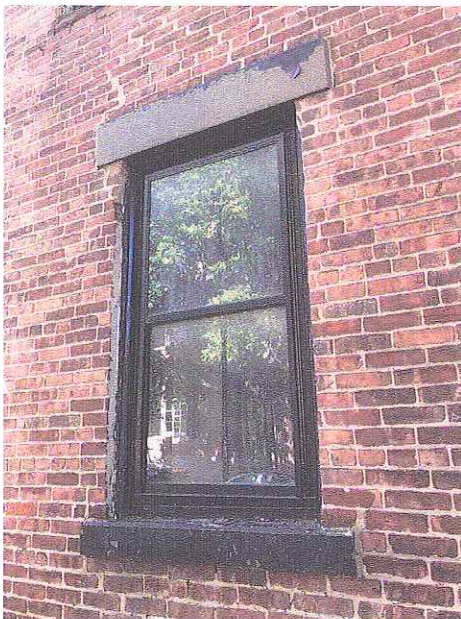
180712-IMG_8803.jpg

*First of Two 2-over-2 Sash on Brimmer Street Facade;
Sash to be Repaired; Frame & Storm Window Replaced;
Brownstone Sill & Lintel to be Re-Set and Paint Removed*

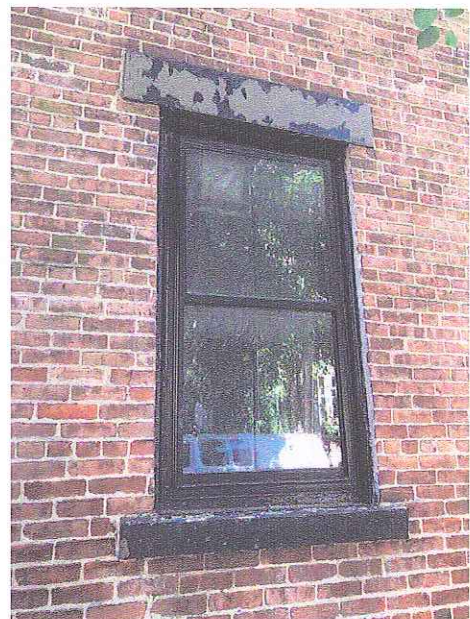
180712-IMG_8804.jpg

*Second of Two 2-over-2 Sash on Brimmer Street Facade;
Sash to be Repaired; Frame & Storm Window Replaced;
Brownstone Sill & Lintel to be Re-Set and Paint Removed*

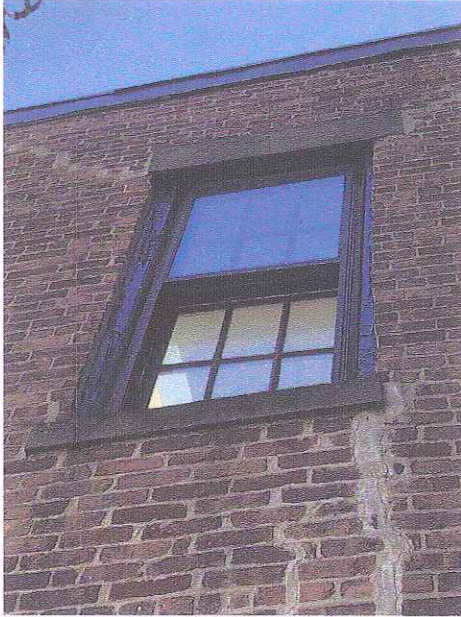
180712-IMG_8793.jpg

Second Floor Windows are 6-over-6 True-Divided Lights; Sash to be Reused; Frames & Storms to be Replaced; Brownstone Lintels & Sills in Good Condition to be Re-Set, or Replaced in Locations Where Severely Deteriorated

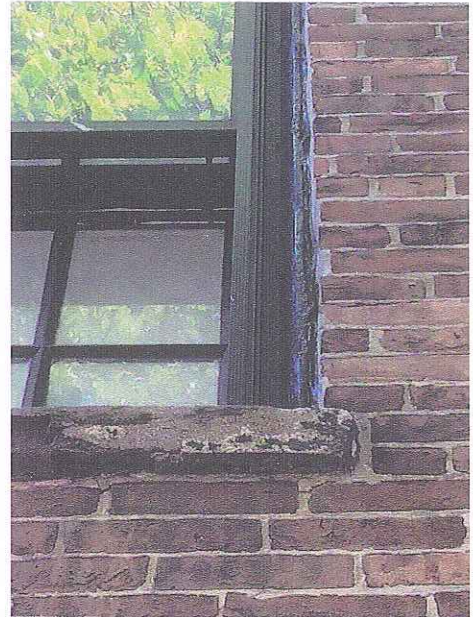
180712-IMG_8800.jpg

Severely Deteriorated Brownstone Window Sill; Wood Sills and Frames Also in Poor Condition; Replacements to Match Profiles, Colors & Materials

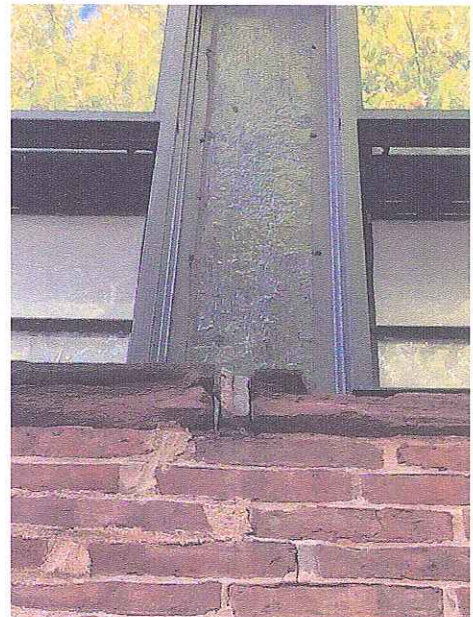
180712-IMG_8799.jpg

Deteriorated Brownstone Sill at Second Floor Window

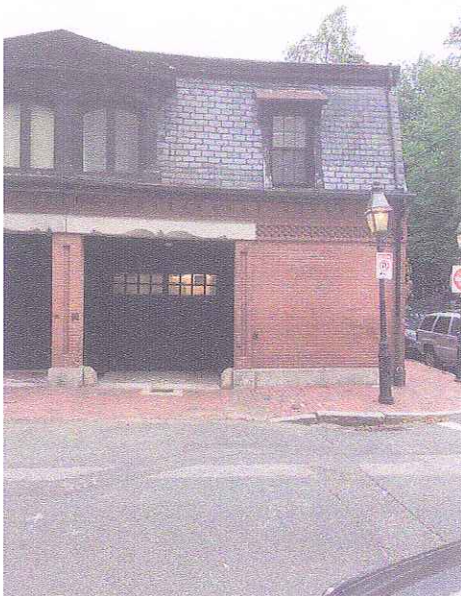
170608-IMG_6594.JPG

South Facade at Chestnut Street with Mansard Roof Above Brick Street Level Facade & Garage Portico; In-Kind Repair and Restoration Intended for Facade

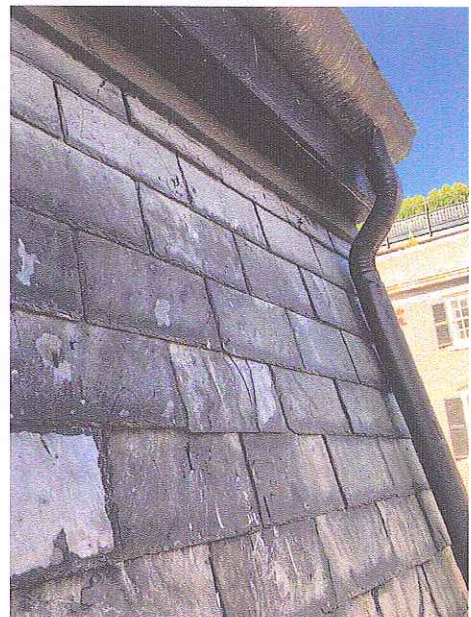
180712-IMG_8844.jpg

Deteriorated Dark Gray Slate Roof with Copper Gutter, Copper Rain Leader and Painted Wood Fascia

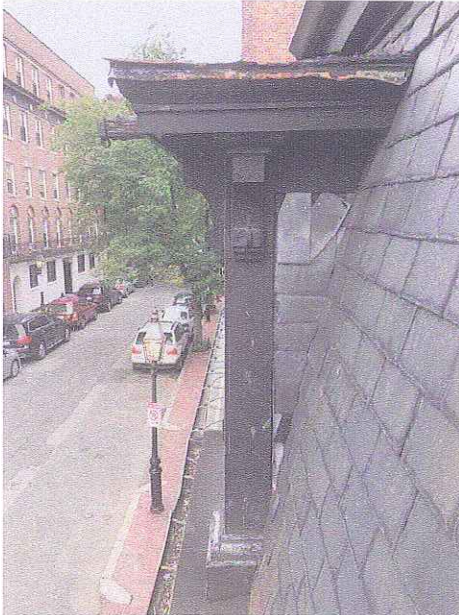
170608-IMG_6598.JPG

Looking West at Mansard to Gable Roofed Dormer Shared with Neighboring Twin Property; Disrupted Slates on Sidewall & Rusting Metal Roof

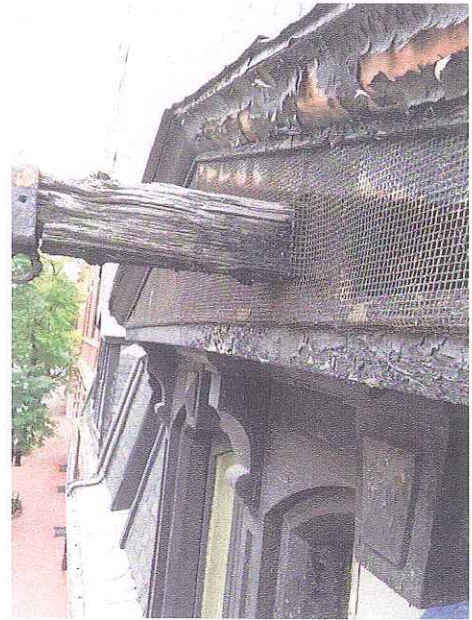
170608-IMG_6601.JPG

Deteriorated Hayloft Timber to be Replicated; Painted Metal Bird Screening to be Replaced with More Subtle Nylon Mesh Recessed into Gable

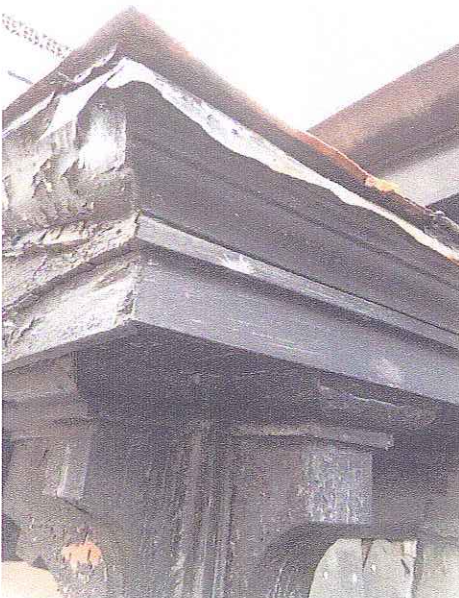
170608-IMG_6600.JPG

Wood Cornice, Rake, Fascia & Brackets; Rusted Metal Roofing to be Replaced in Copper to Match Profiles

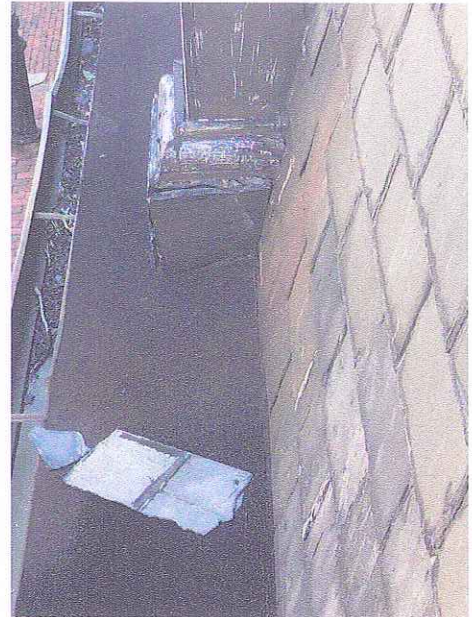
180712-IMG_8845.jpg

Loose, Fallen Slate on Roll Roofing at Eave Flare; Slates to be Replaced & Eave to be Copper

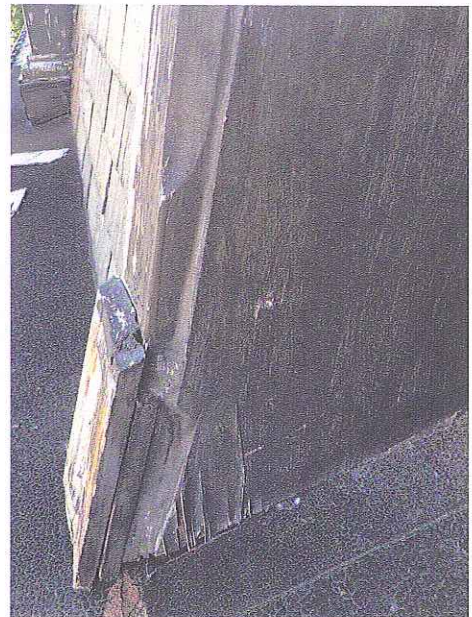
180712-IMG_8840.jpg

Deteriorated Plywood Jambs at Shed Dormer; Loose Replacement Plinth at Outer Casings; All Carpentry to be Replicated, Flashed & Painted

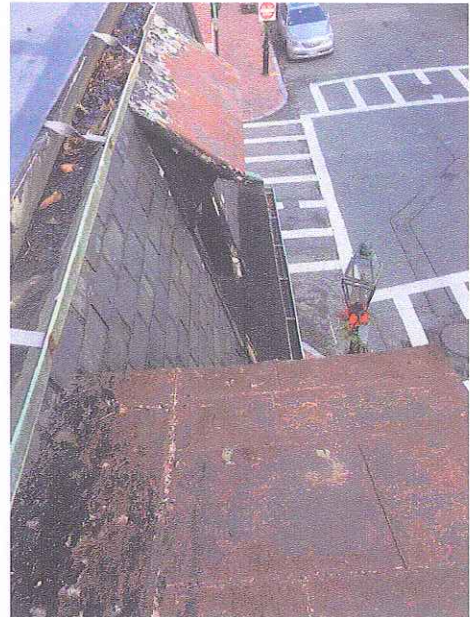
161227-IMG_5971.jpg

Aerial View of Rusted Metal Roofing at Gable (Foreground) and Shed (Background) Dormers

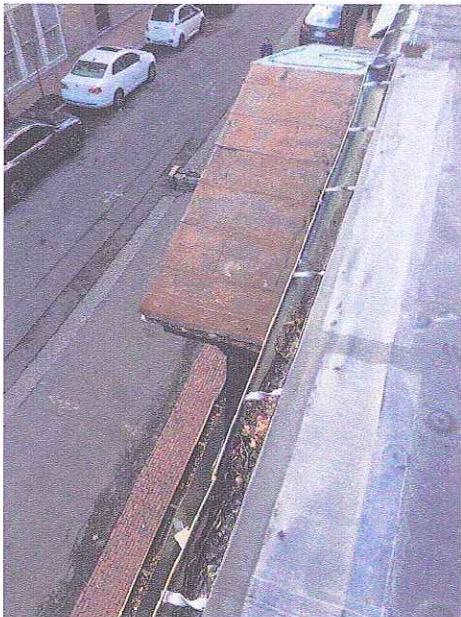
161227-IMG_5968.jpg

Rusted Gable Dormer Roofing; Copper Gutter at High Rubber Roofing Attached with Galvanized Steel Straps (Dissimilar Metals Inappropriate)

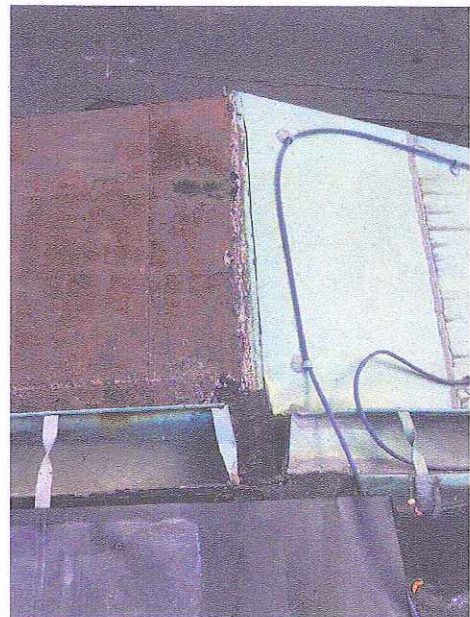
161227-IMG_5970.jpg

Abutter's Copper Roof at Gable Dormer to Right; 57 Brimmer's Rusted Metal Roofing at Left
