Pier 4 Charlestown Navy Yard Culvert and Sinkhole Repairs Boston, Massachusetts

Re: **Notice of Intent**
Boston Planning & Development Agency
Pier 4 Culvert and Sinkhole Repairs
Charlestown Navy Yard
Boston, MA
(Pare Project No. 18228.00)

Re: **Charlestown Navy Yard Pier 4 Sinkhole Repairs
Investigation Findings Report
Boston, MA**
(Pare Project No.: 18228.00)

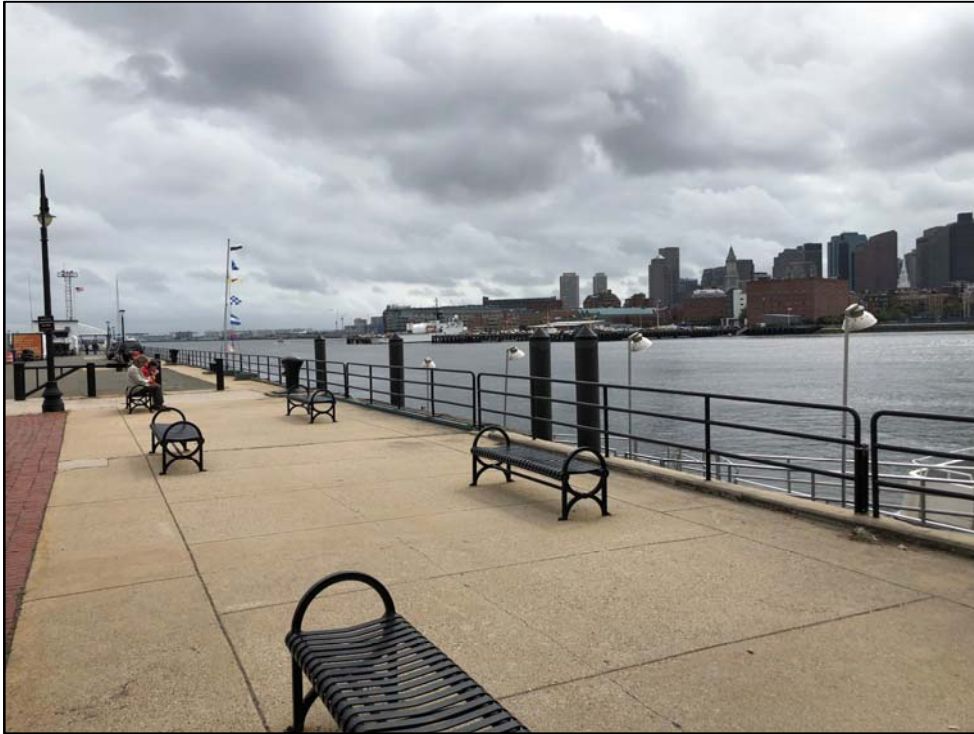
Photo No. 1: Overview of the west side of Pier 4.

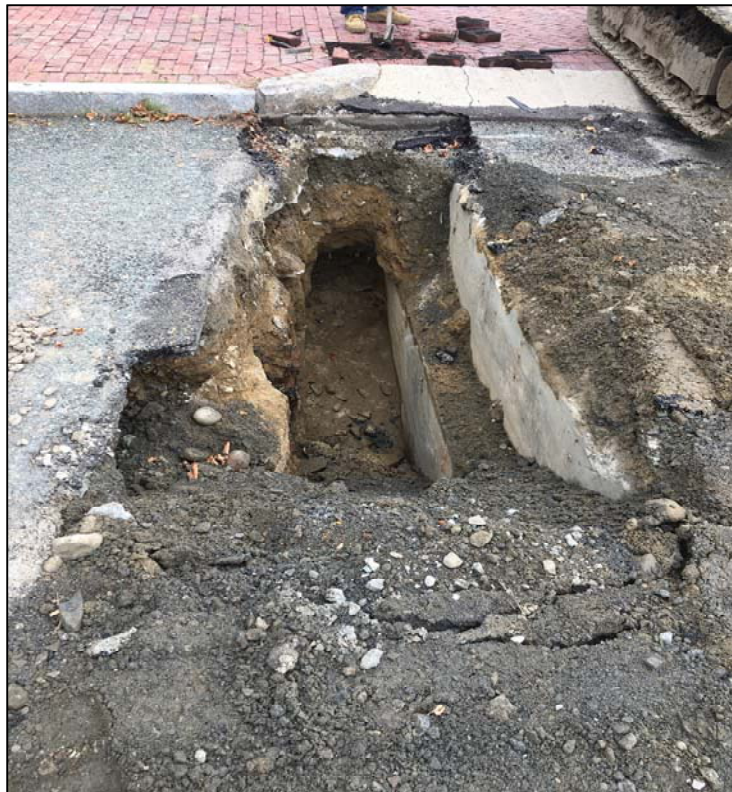
Photo No. 2: Overview of Test Pit 1 (TP1). The excavation is approximately 50% completed within this picture.

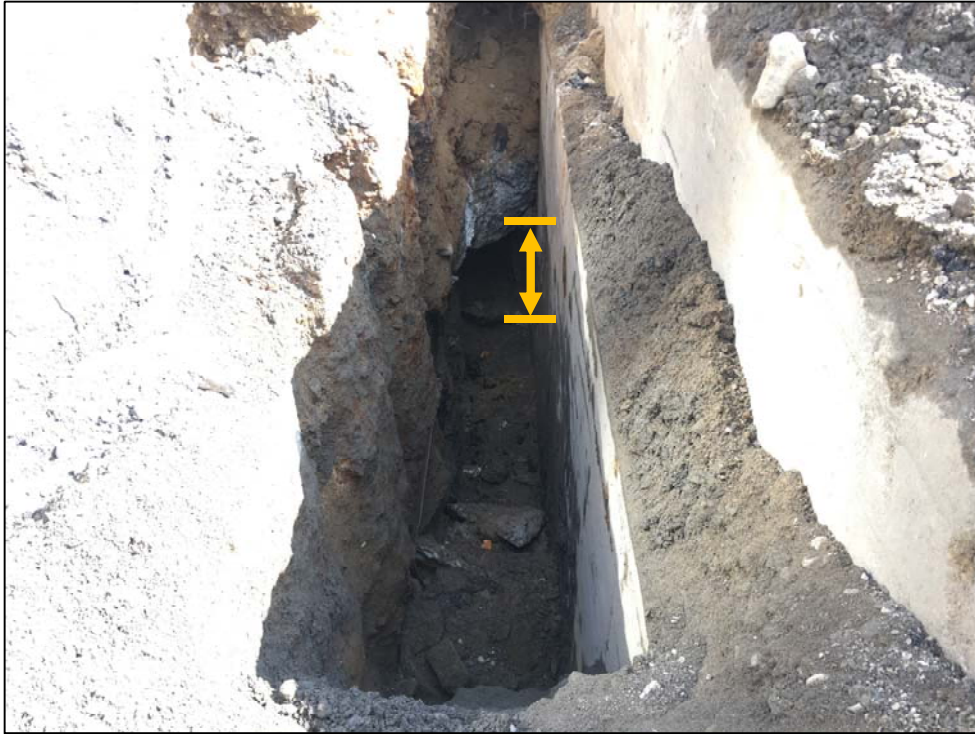
Photo No. 3: Overview of TP1 after the excavation was complete. Note the void below the concrete plug.

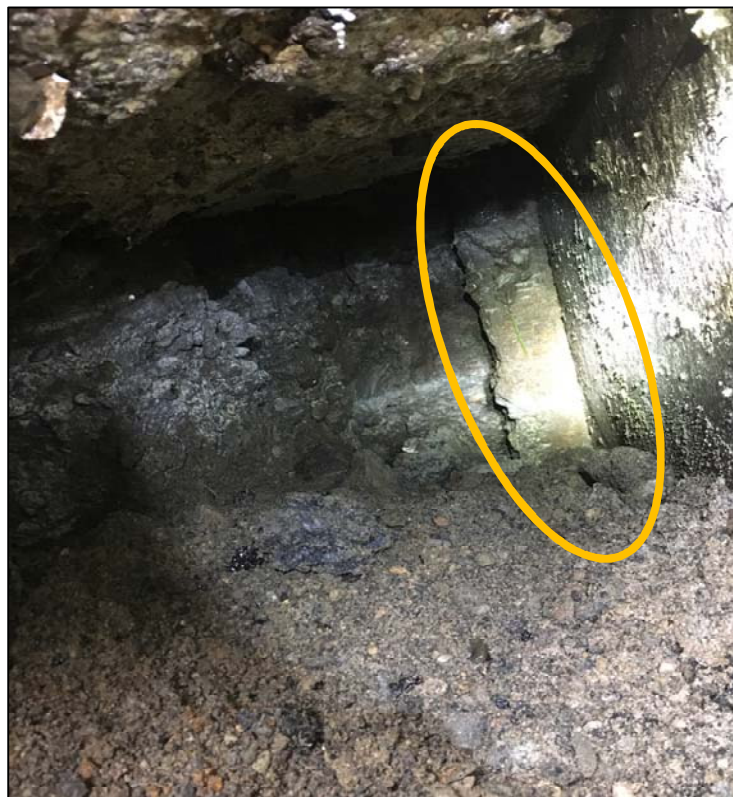
Photo No. 4: View of the void below the concrete plug. A concrete seal appears to be at the intersection of the SSP and the concrete culvert wall.

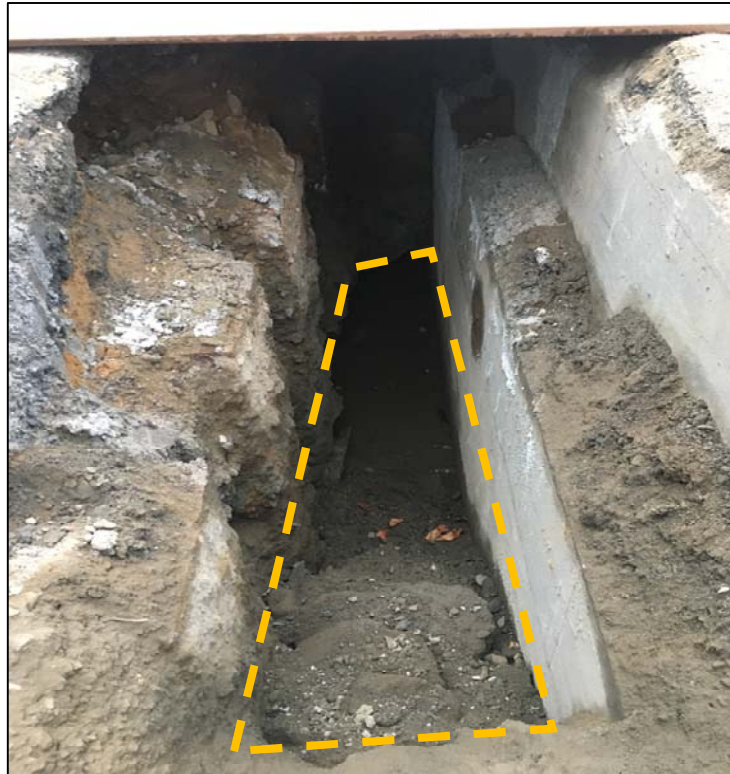
Photo No. 5: 3-foot thick concrete plug placed between the concrete wall and the steel sheet pile wall before backfilling.

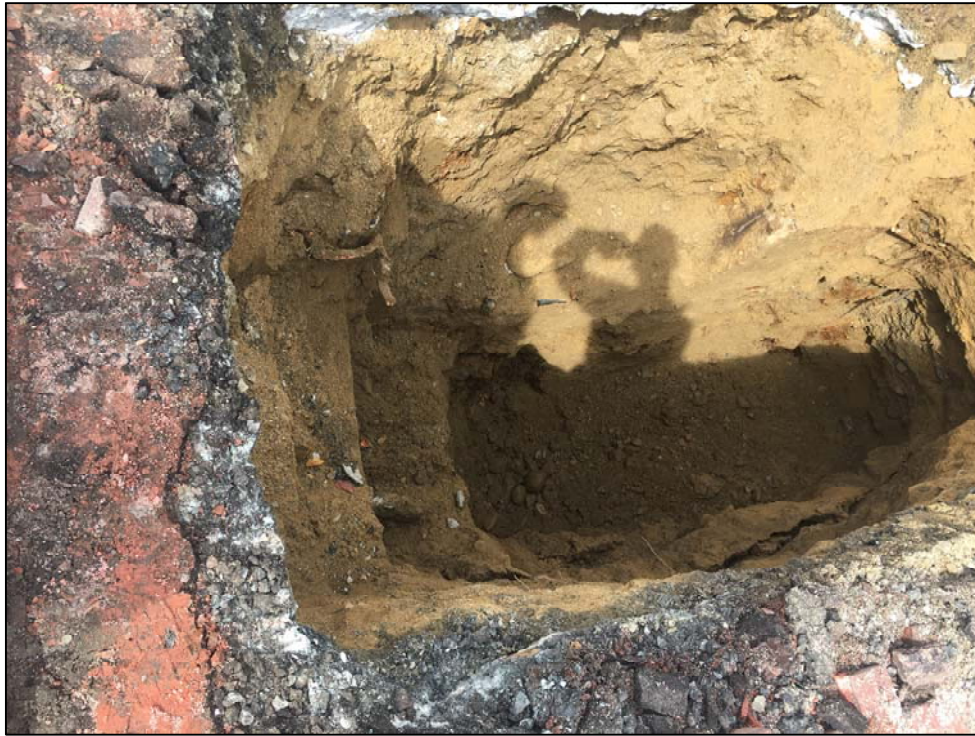
Photo No. 7: Overview of TP2, note the soil appears to be dry intact.

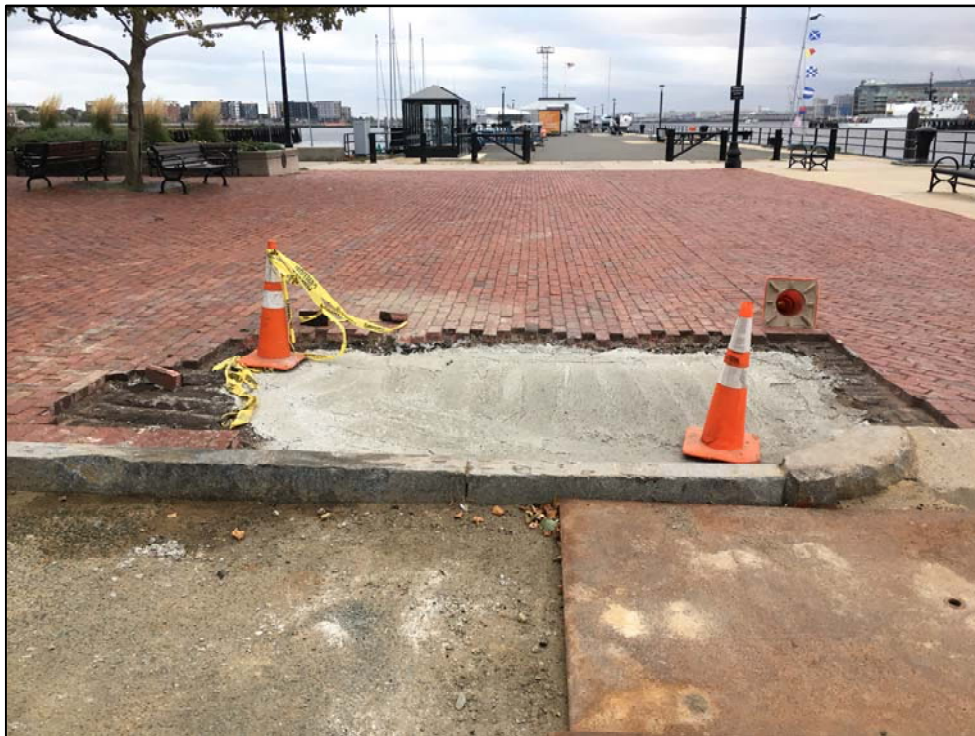
Photo No. 8: Overview of TP2 after it was backfilled. A concrete overlay was placed at the top of the test pit.

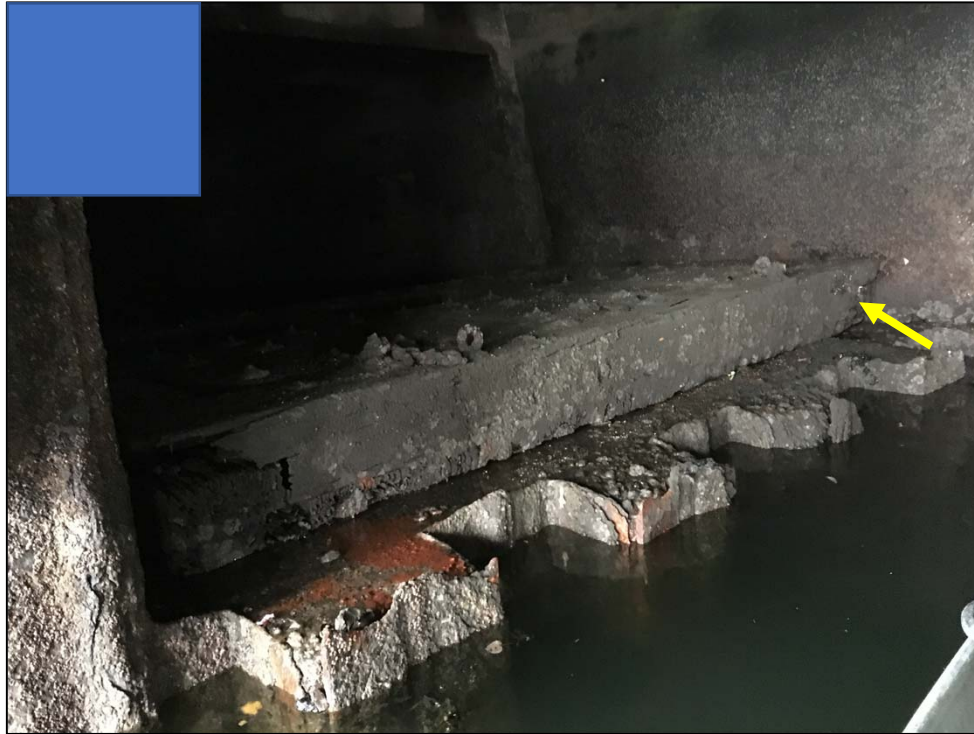
Photo No. 9: View of the discharge end of the culvert. The tide gate is laying at the bottom of the culvert and detached from its hinges.

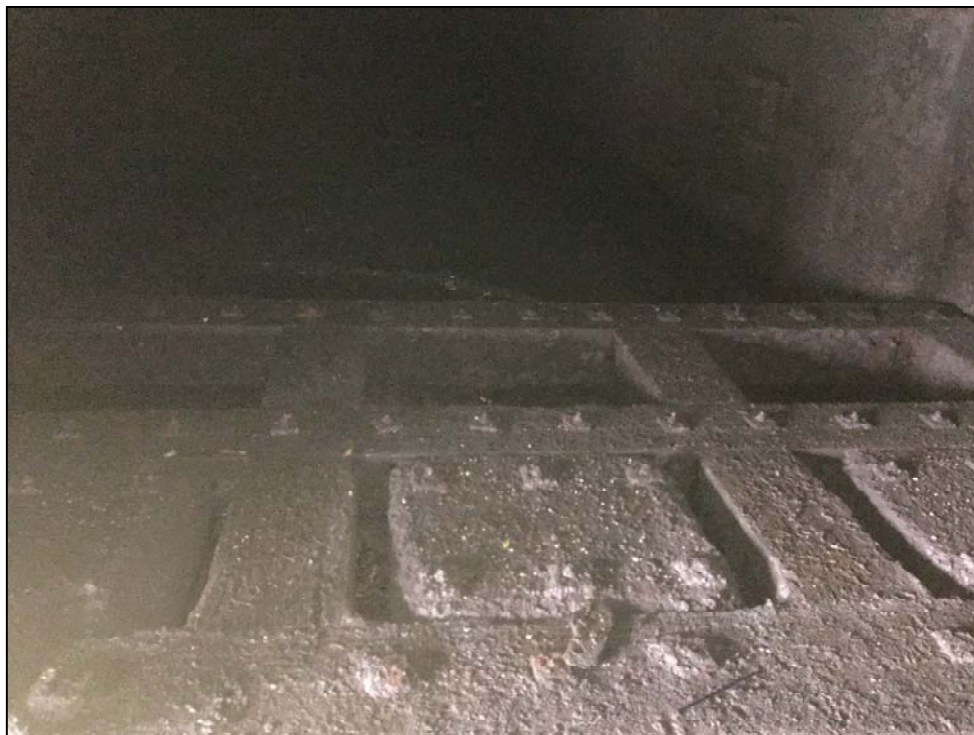
Photo No. 10: Overview of the tide gate on the floor of the culvert. Note the gate is no longer operational.

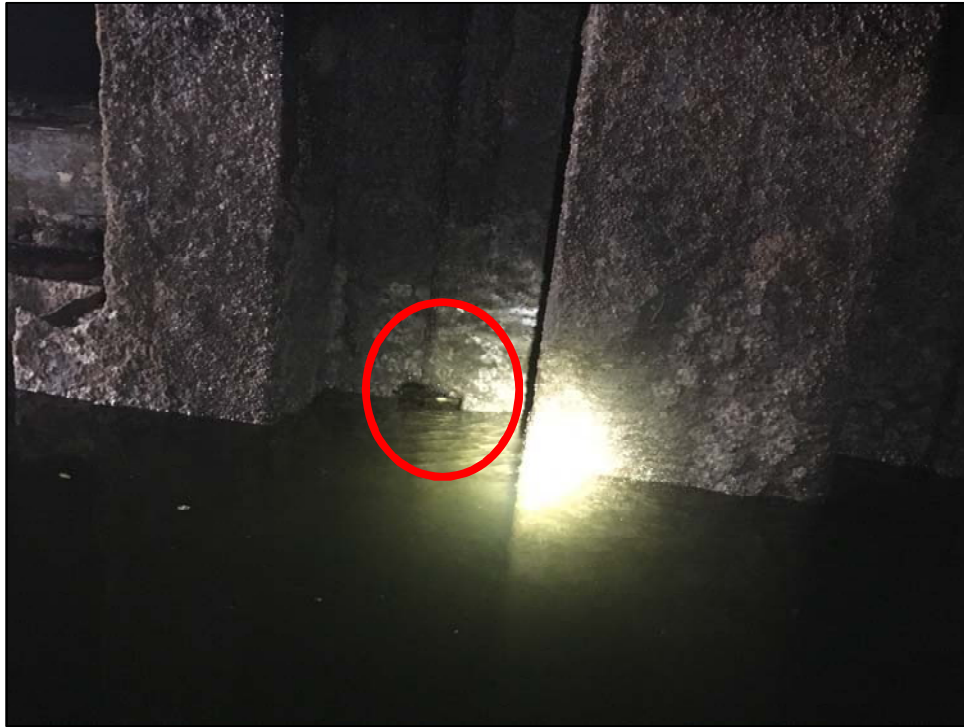
- A boat inspection was performed of the visible portions of the bulkhead adjacent to the culvert opening and along the west side of the culvert.
- To the east of the culvert opening, an electrical duct bank that penetrated the sheet pile was abandoned and was patched with steel plates. The patches appear to be in good condition with no observed leaks or significant deterioration.
- An approximate 5-inch diameter hole was observed nearly 1-foot above the low water line approximately 4 feet east of the culvert opening in the bulkhead.
 - The hole appeared to be cut in the piles, with clean, square edges.
 - A void was noted behind the wall and was probed with a measuring tape to approximately 8 feet.
- No significant deterioration was observed in the section of sheet pile on west side of culvert.

Photo No. 11: Location of a 5" diameter hole east of the culvert opening.

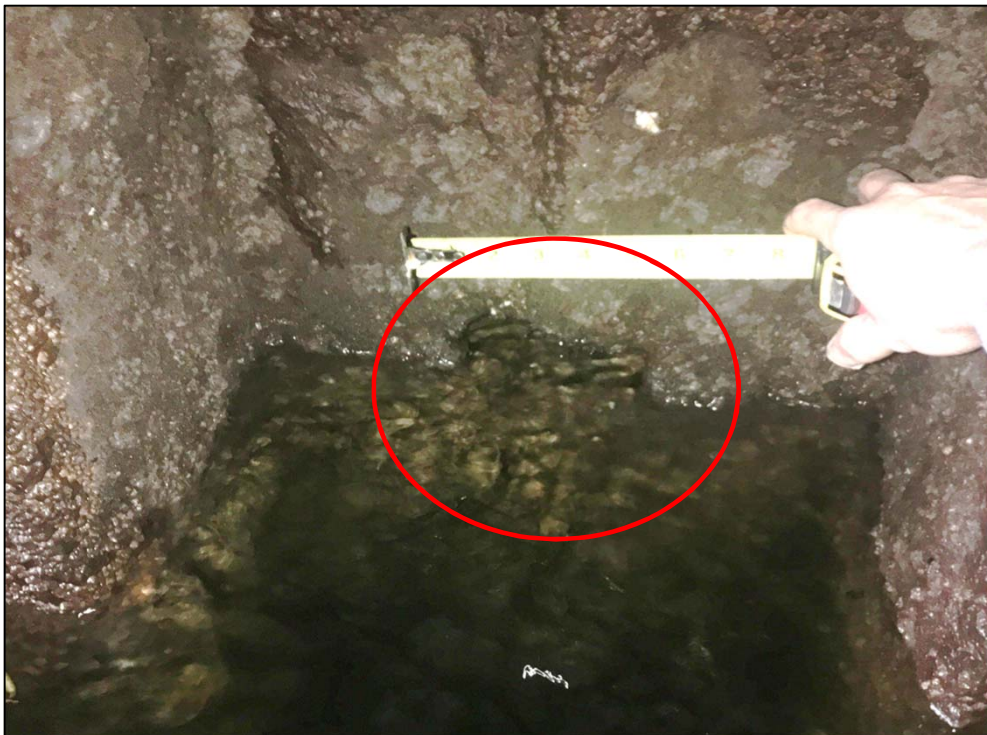
Photo No. 12: Detailed photograph of the 5-inch diameter hole.

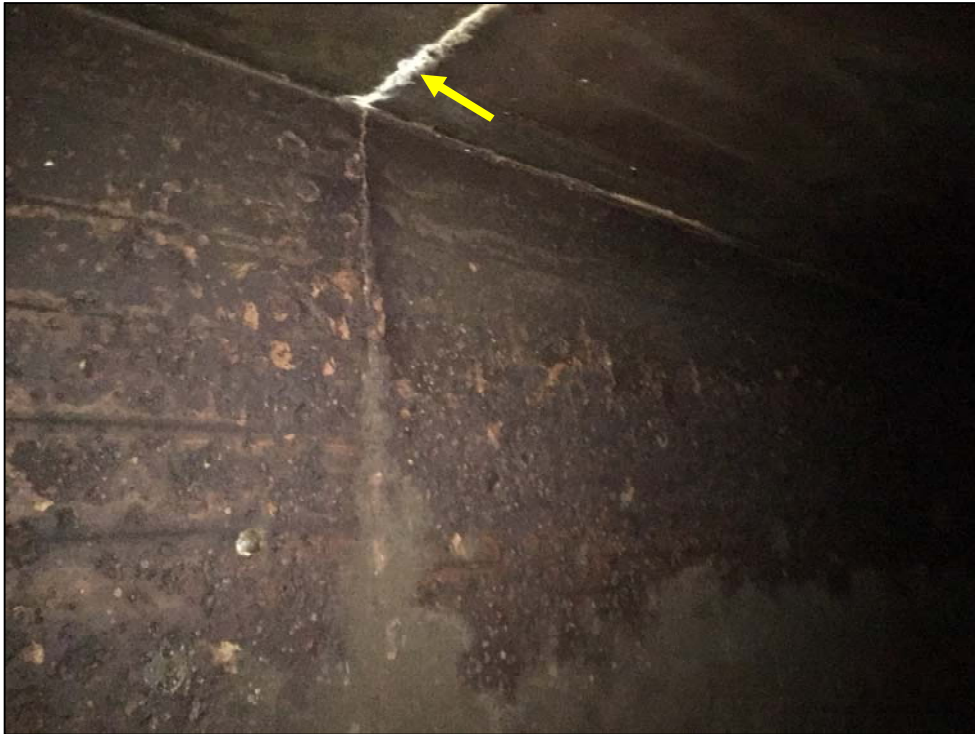
- No significant deterioration was observed throughout the concrete culvert. Cracking was typical along the concrete joints with minor efflorescence noted at several locations.

Photo No. 13: Typical wall and ceiling joint intersection. Note efflorescence along roof joint.

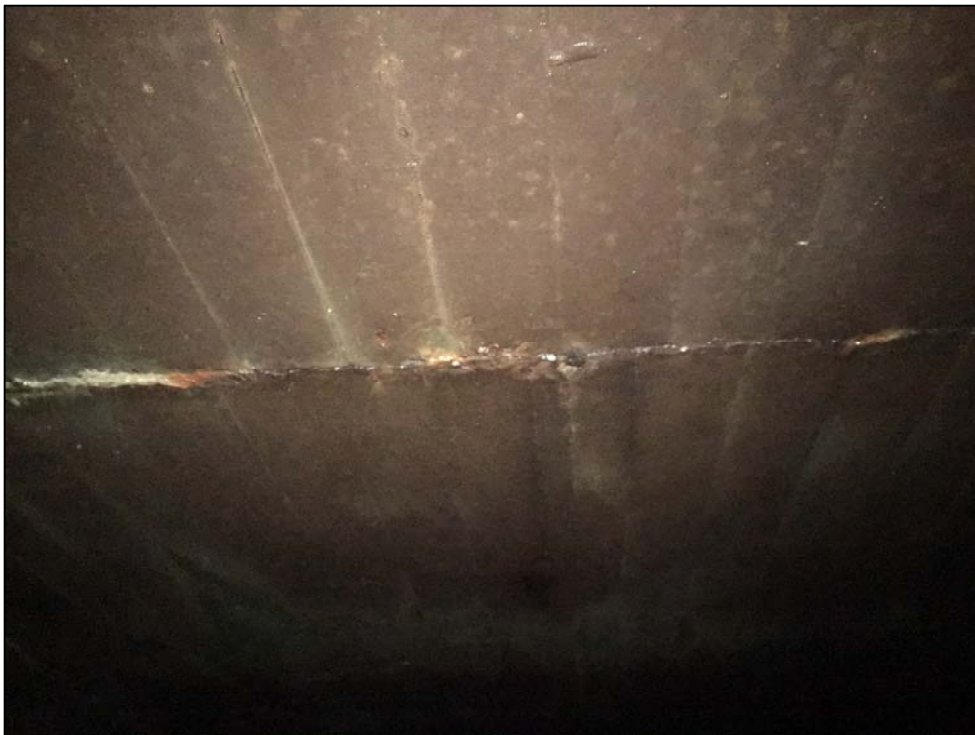
Photo No. 14: Overview of typical culvert ceiling joint.

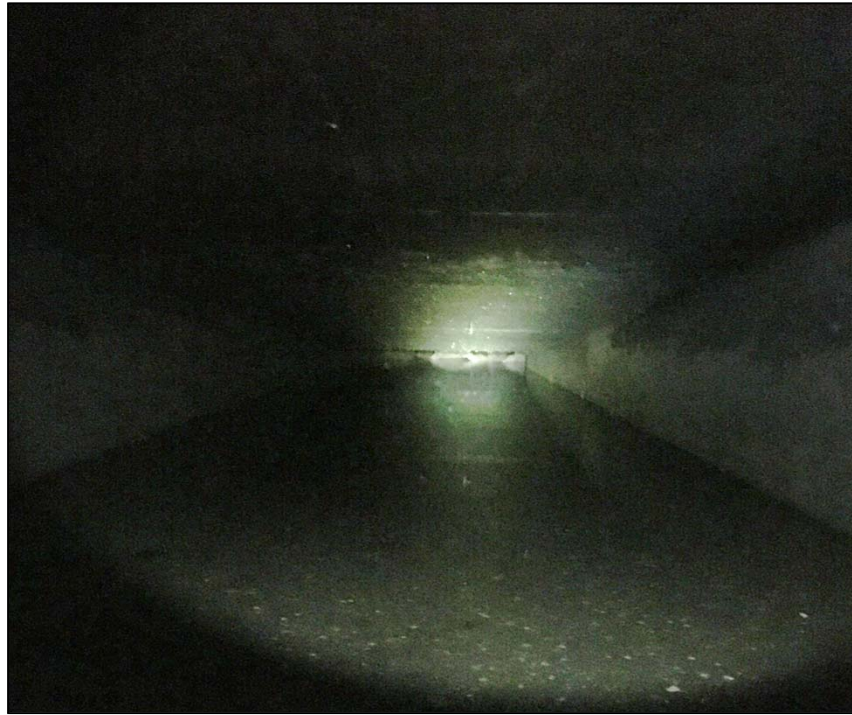
Photo No. 15: Overview of the inside of the culvert looking towards the pump house and the 45-degree bend.

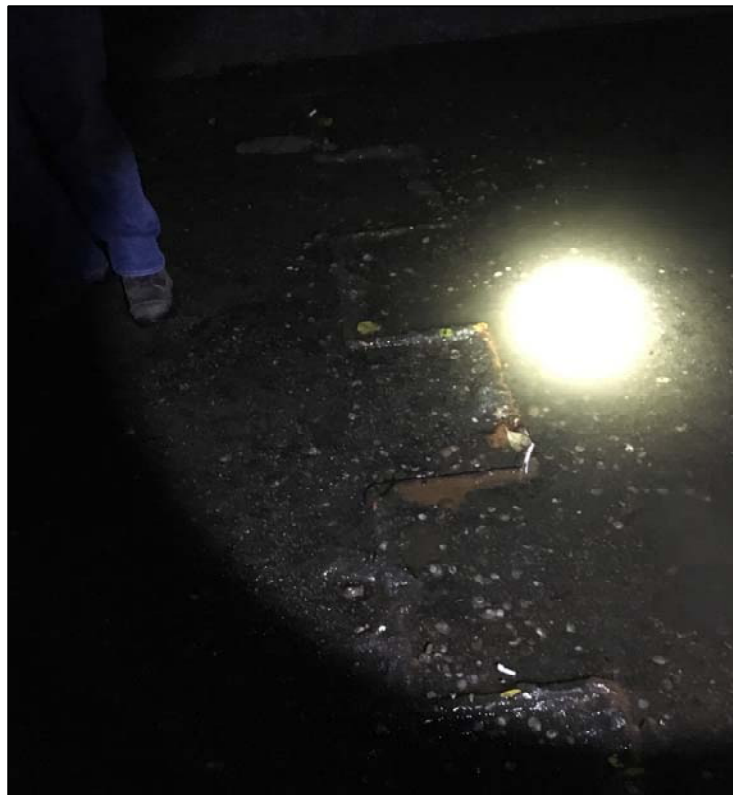
- A steel sheet pile wall, perpendicular to the culvert alignment was exposed at the bottom of the culvert. It appears that the sheet piles were cut to for the installation of the culvert and the floor was cast around the SSP. Based on available drawings, it is believed to be the steel sheet pile observed in TP2,

Photo No. 16: Sheet pile wall protruding through the floor of the culvert, approximately 50 feet from the discharge end of the culvert.

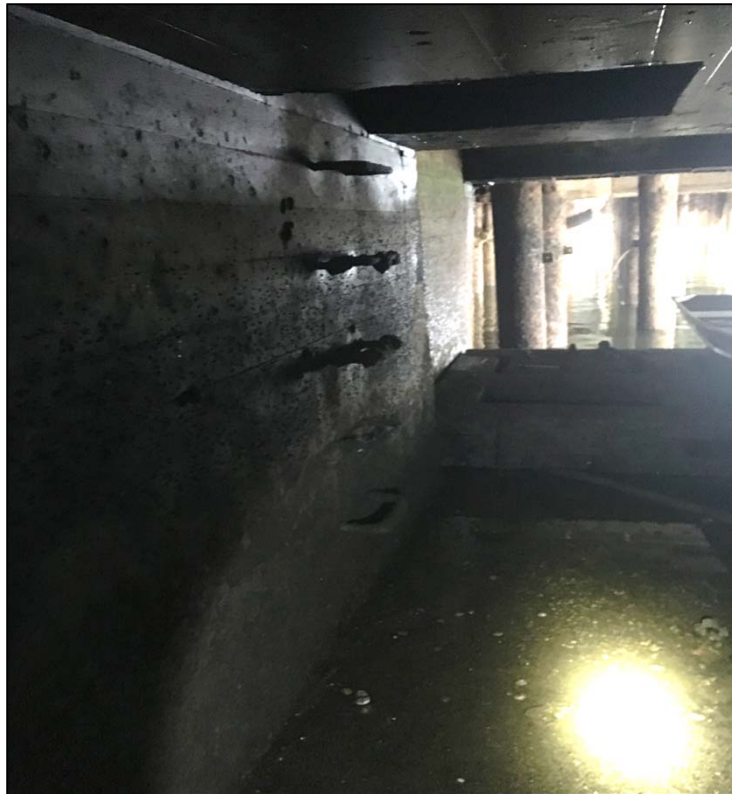
Photo No. 17: Culvert access ladder approximately 15 feet from the discharge end of the culvert.

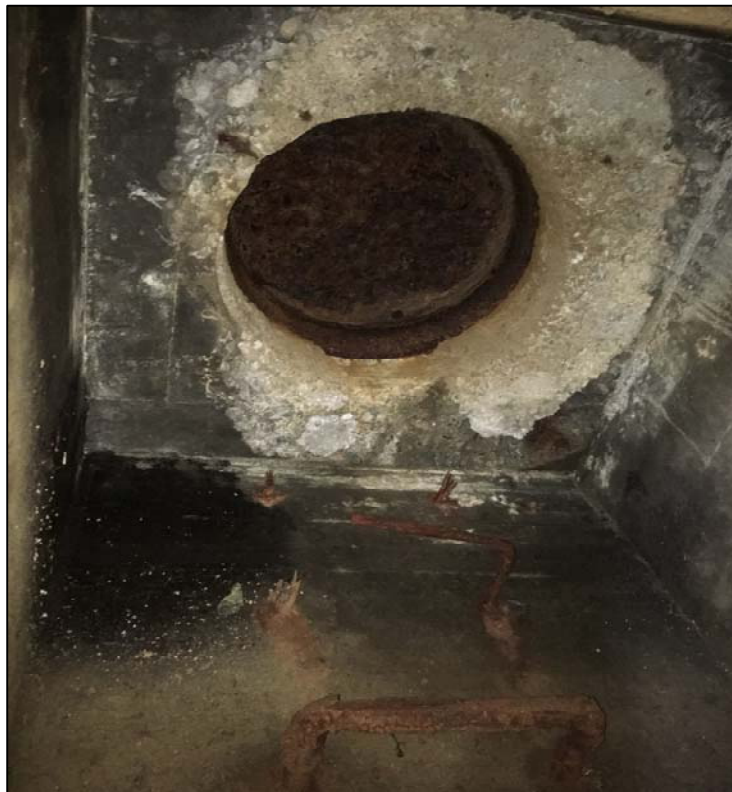
Photo No. 18: Access to culvert hatch opening. Access is not visible from the topside and appears to be abandoned.

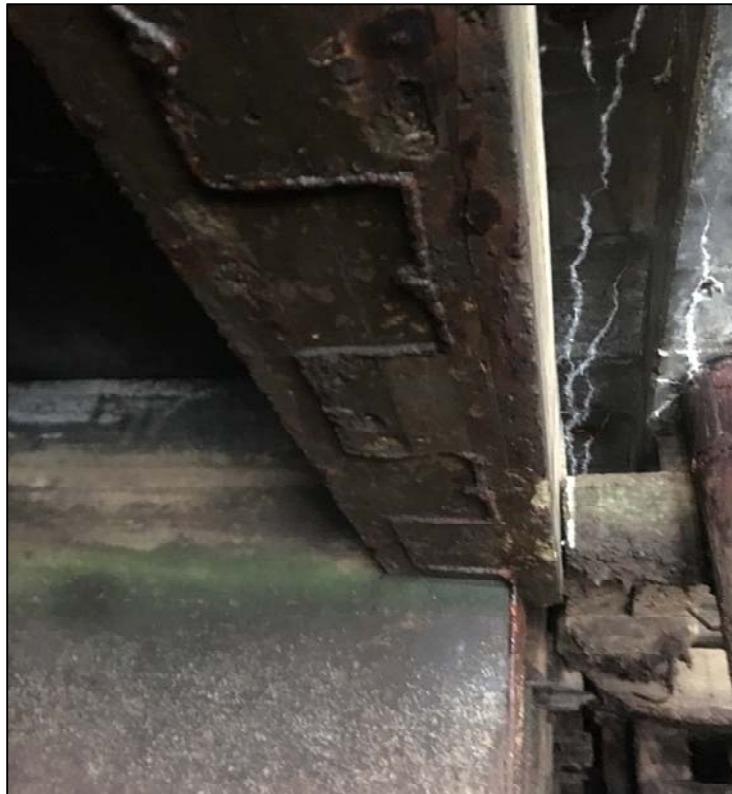
Photo No. 19: Discharge end of the culvert ceiling. Note the culvert appears to protrude through a sheet pile wall.

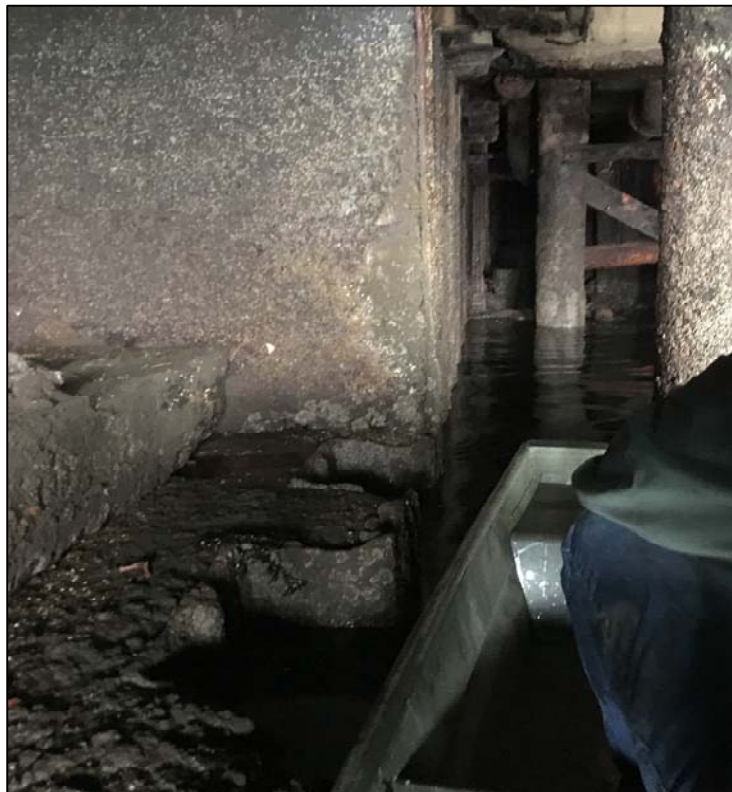
Photo No. 20: Floor of the discharge end of the culvert. Note the sheet pile wall along the underside of the culvert.

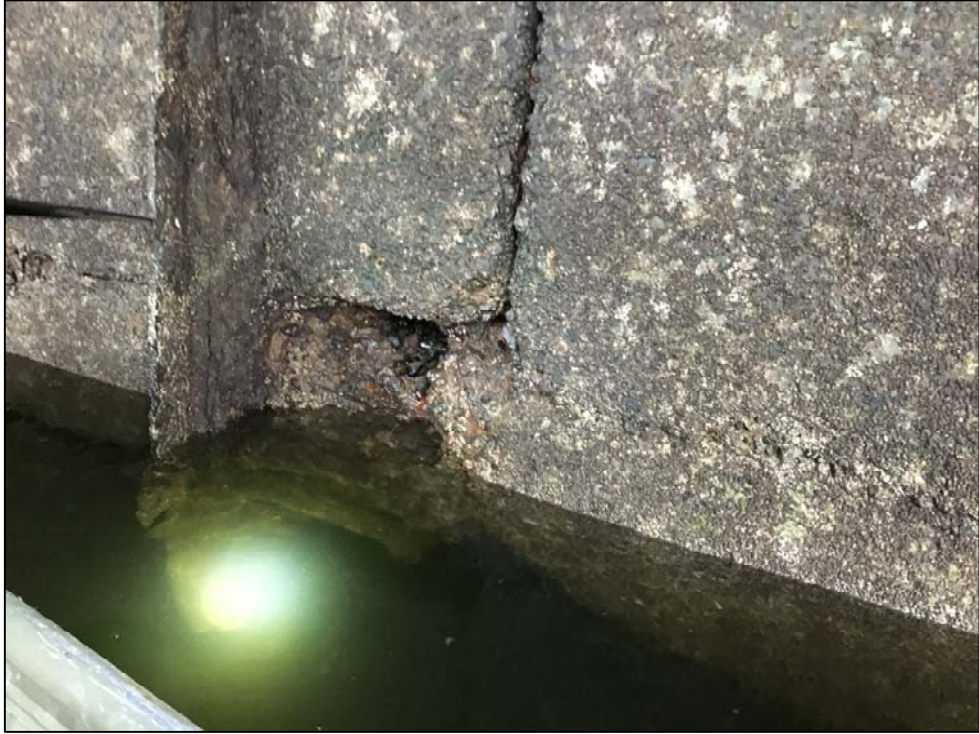
Photo No. 21: View of the cut sheet pile wall from the outside of the culvert, approximately 50 feet from the discharge end.

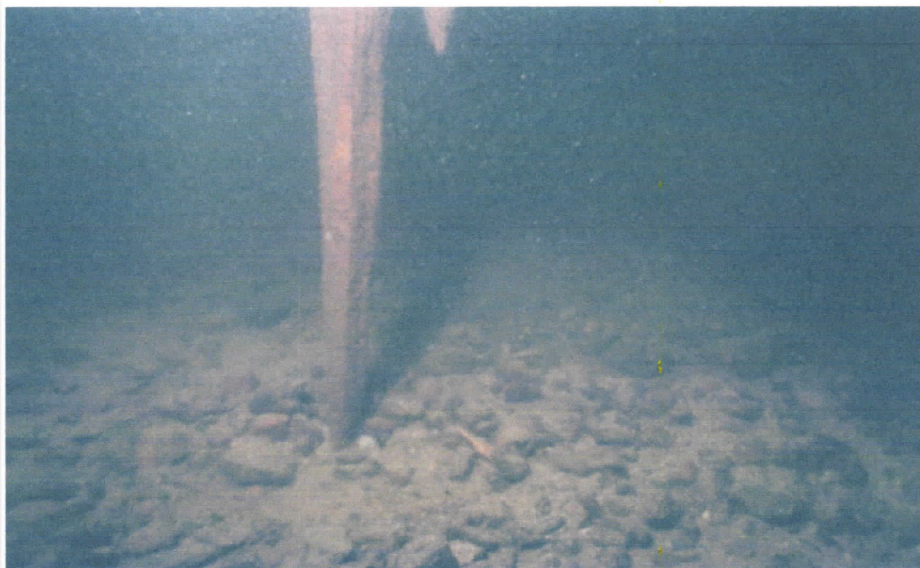
- A majority of the piles are rotted from the bottom of the culvert to approximately 2’ below the structure.
 - The piles that remain in contact with the bottom of culvert are critically deteriorated with significant section loss, deep striations and delamination, and holes from marine borer attack.

Photo #1 showing remains of bearing pile under the culvert

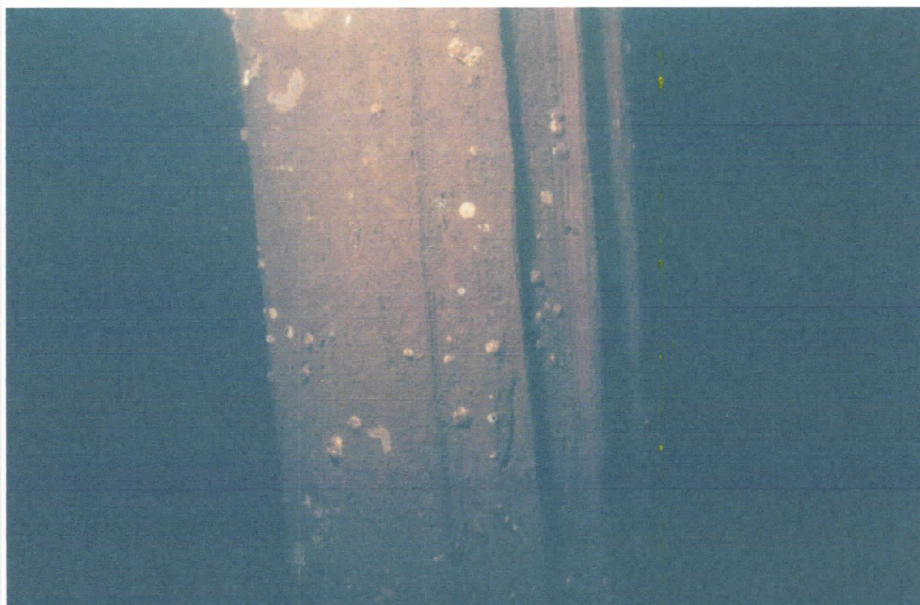
Photo #2 showing intact pile with deep striations

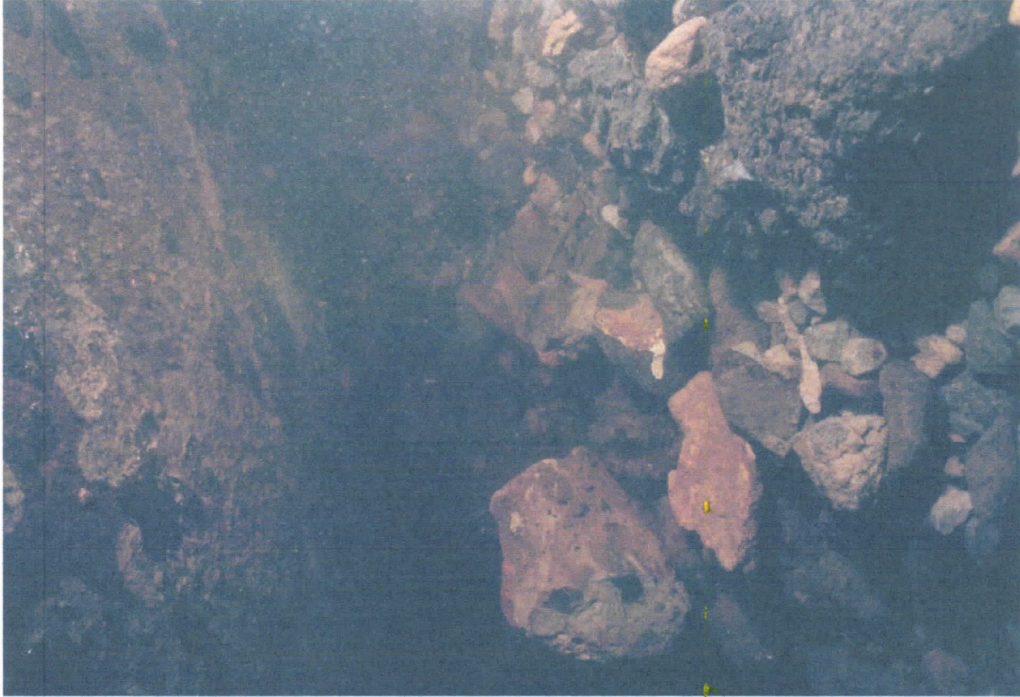
- The diver observed the area beneath the test pit, indicating that it appeared to be a deteriorated “wall” or mass plug. The “wall” consisted of stone and cobbles, brick, concrete, and other deleterious material.

Photo #3 showing typical rubble fill between the sheet pile wall and the culvert wall
