Existing Conditions:

7 ACORN STREET
BEACON HILL
BOSTON MA

BEACON HILL ARCHITECTURAL
COMMISSION APPLICATION

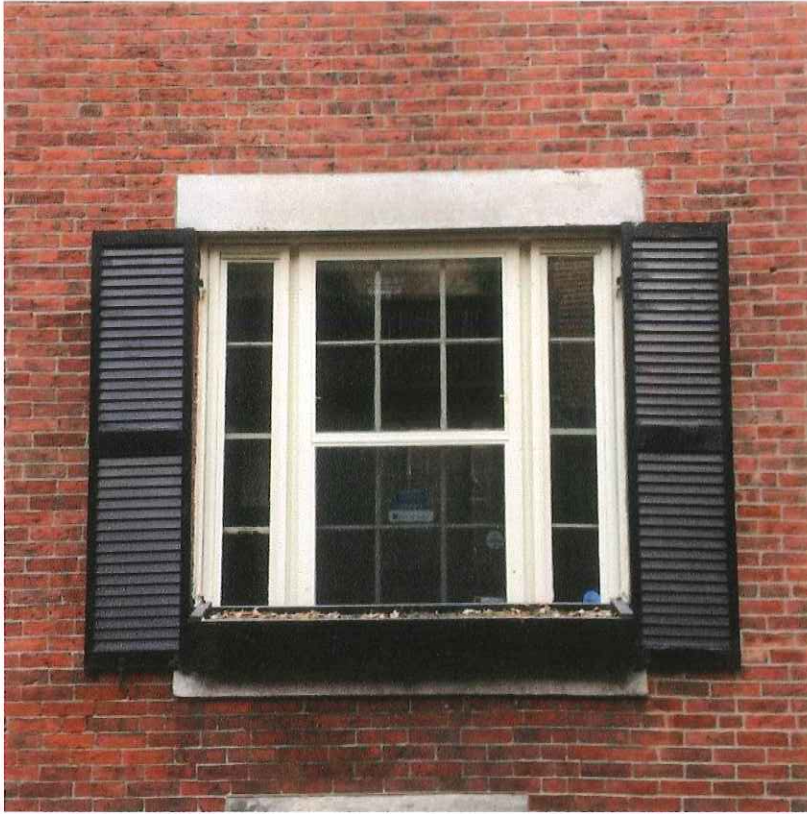
Typical window from exterior

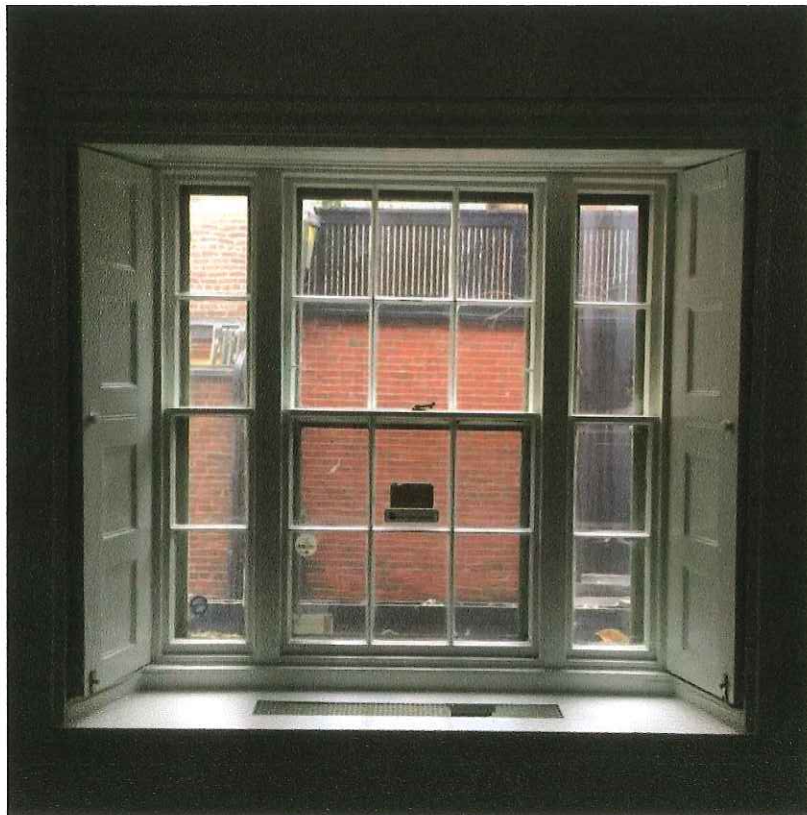
Typical window from interior

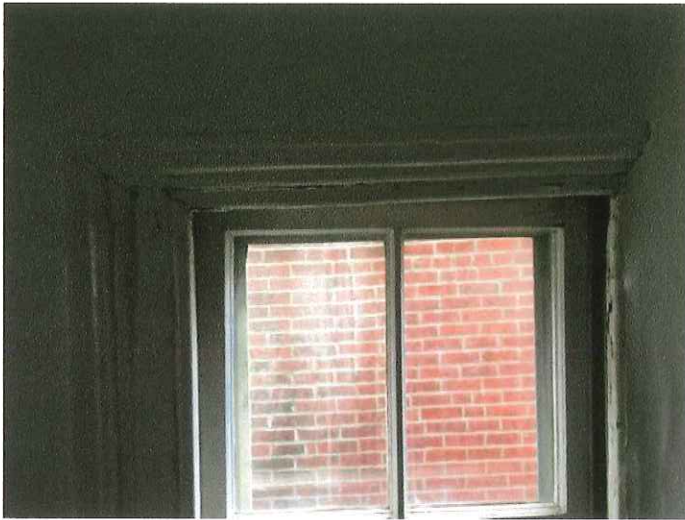
Existing frames are out of square,
making windows inoperable and
difficult to repair

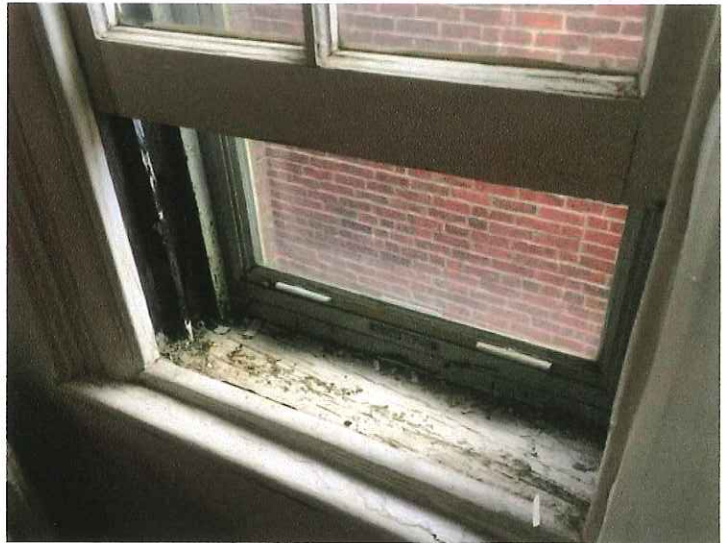
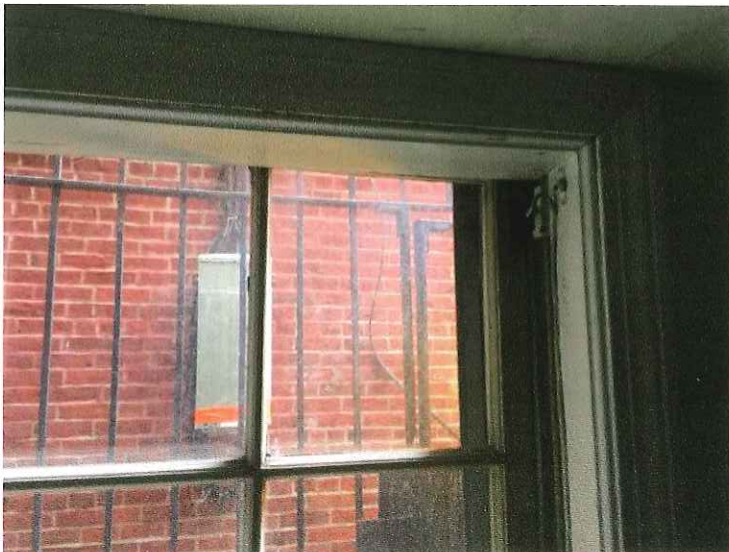
Rotting sills and deteriorated jambs.
Lead paint peeling and flaking

Existing frames are out of square,
making windows inoperable and
difficult to repair

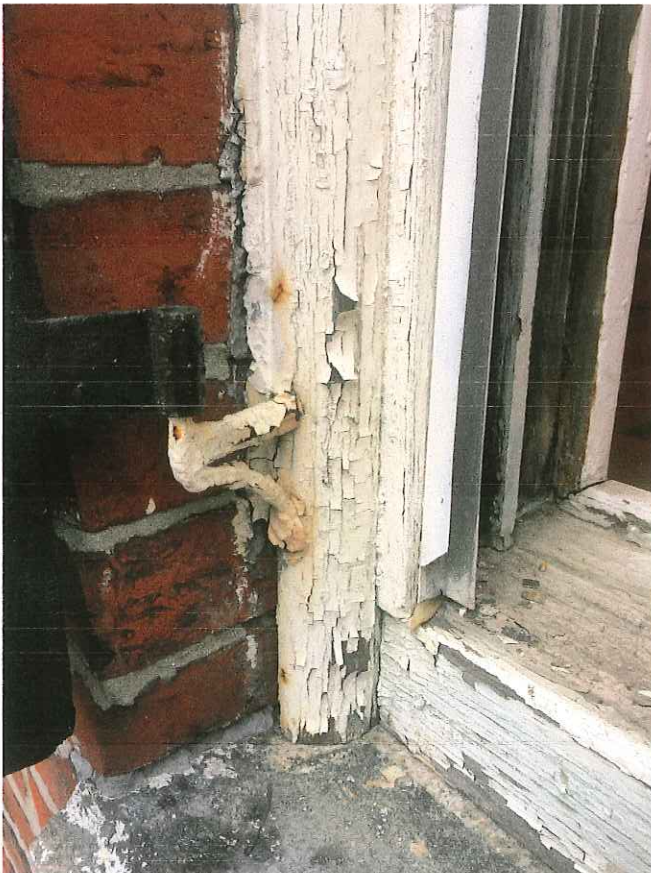
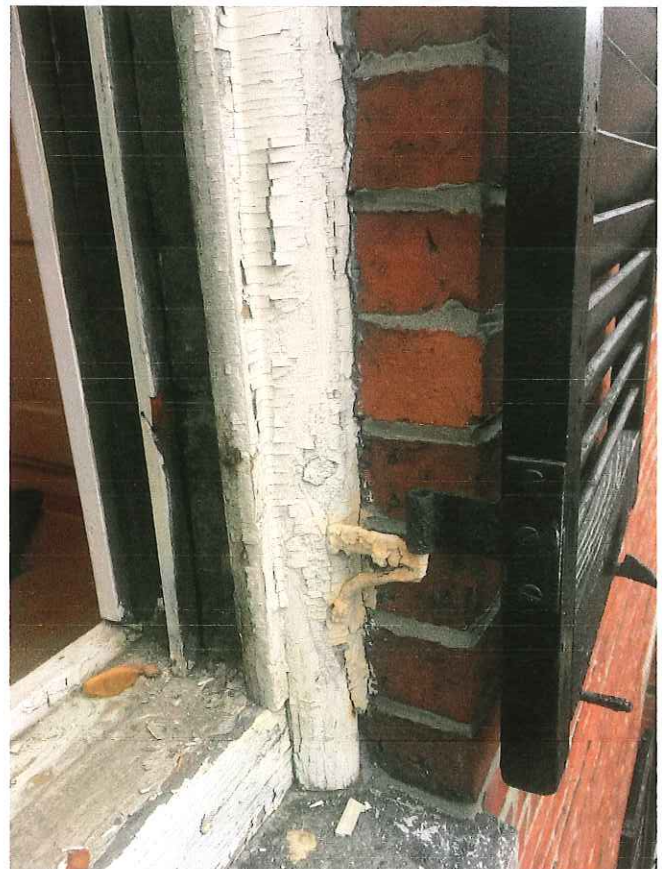
Brick Moulding Profiles

While every effort will be made to reuse the existing wood brick molds, it is likely that they will need to be replaced when the old windows come out. If this is the case, we intend to match the existing brick mold in kind with the same profile. Here is a photo of the existing brick mold and our best guess at the profile. Once we are able to cut out a piece and clean off layers of paint, we will match exactly:

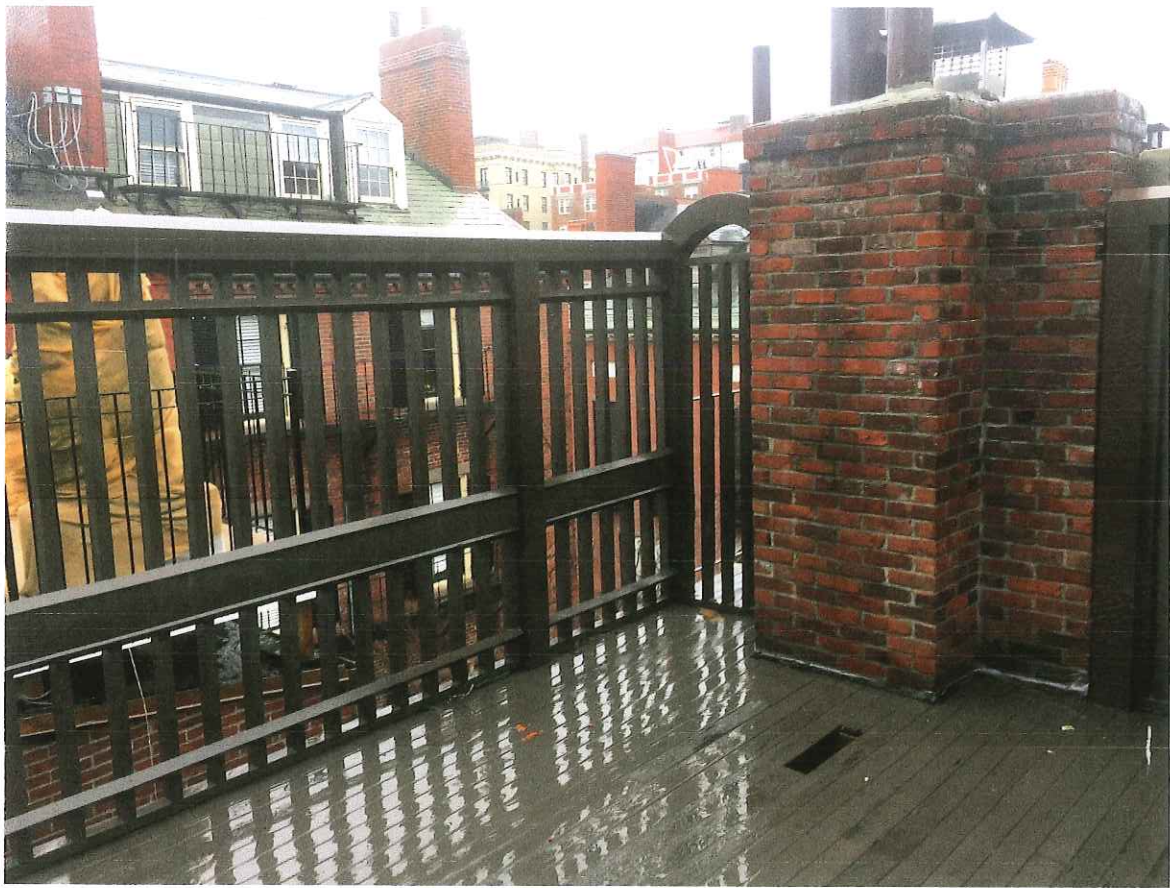
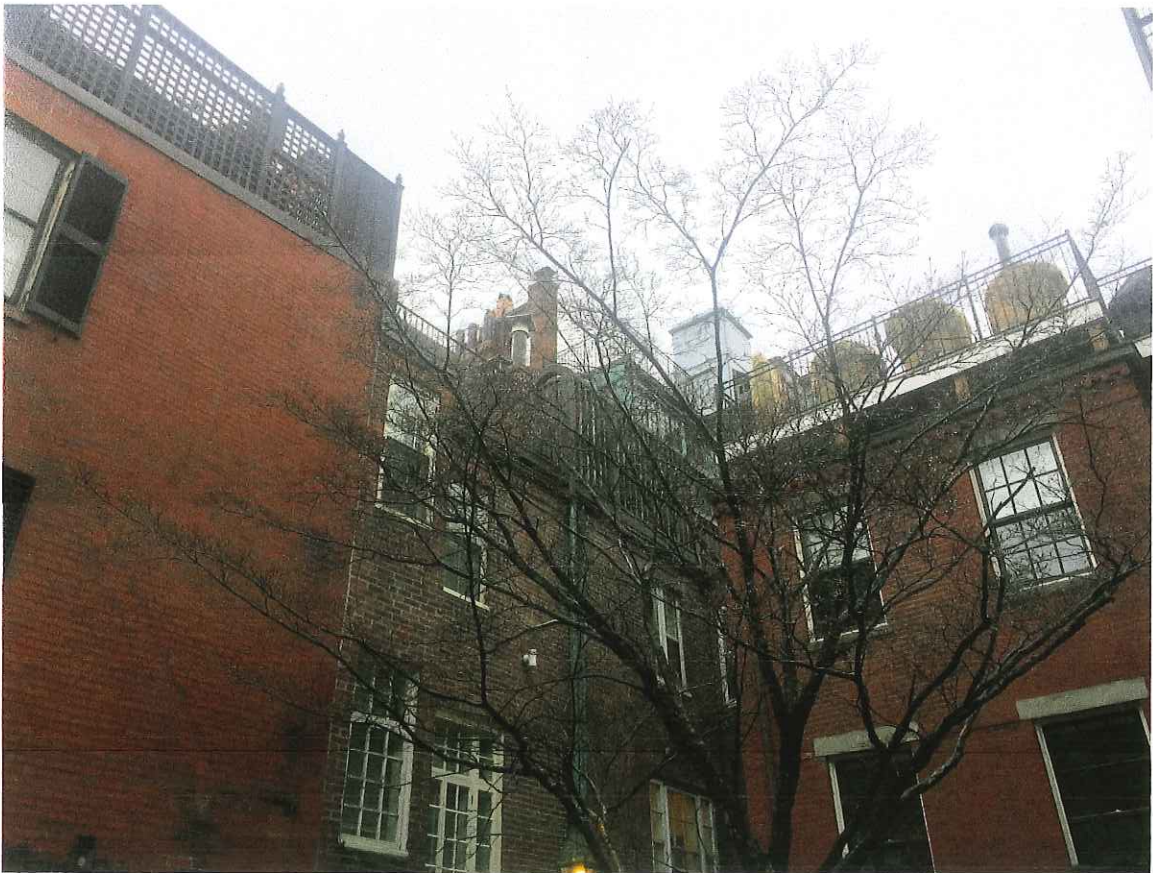
- *From the submitted photographs, it appears that the existing roof deck is made of wood with wood railings. It is recommended that the proposed replacement roof deck have metal railings with a dark finish that have a smaller profile to help reduce the visibility.*

We will replace the wood railing with a metal railing painted black to match the profile and color of the adjoining roof deck (see previous photo)

We would be happy to pull the roof deck in 1' from both roof edges to break up the massing. See attached plan and profile/section

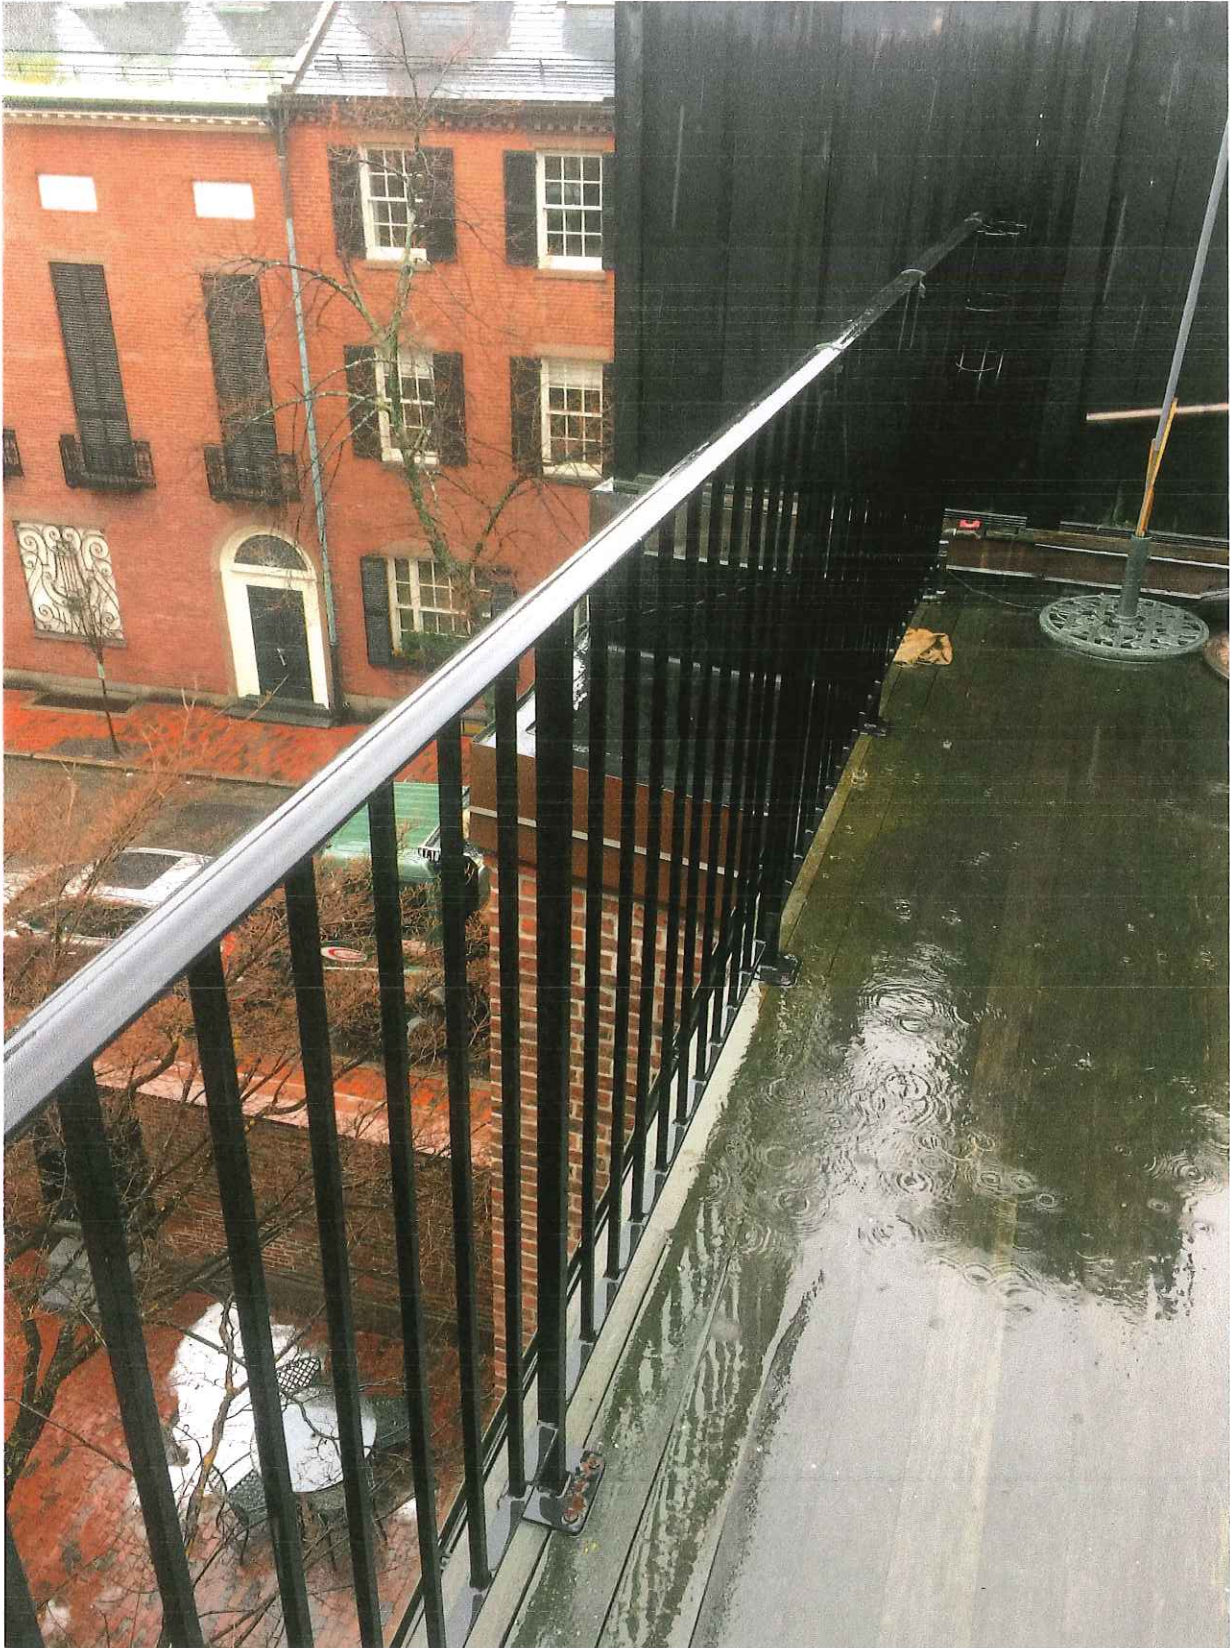
Neighbor's adjoining roof deck. New railing to match this railing style and color

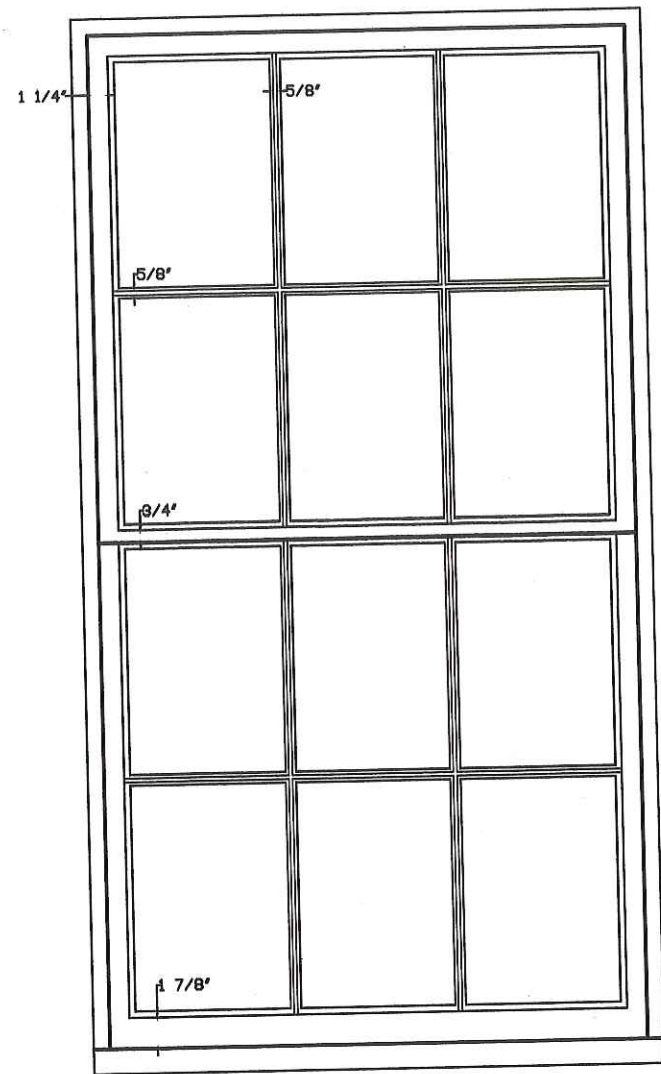
TYPICAL EXISTING DOUBLE HUNG
ELEVATION & SECTION
SCALE: 1" = 1'-0"

Existing Conditions of Typical Window
