Improvements to
**JAMAICA
POND
PATHWAYS
AND ENTRIES**

JAMAICA POND PATHWAYS SCOPE OF WORK

PHASE 1 ANALYSIS AND RECOMMENDATIONS

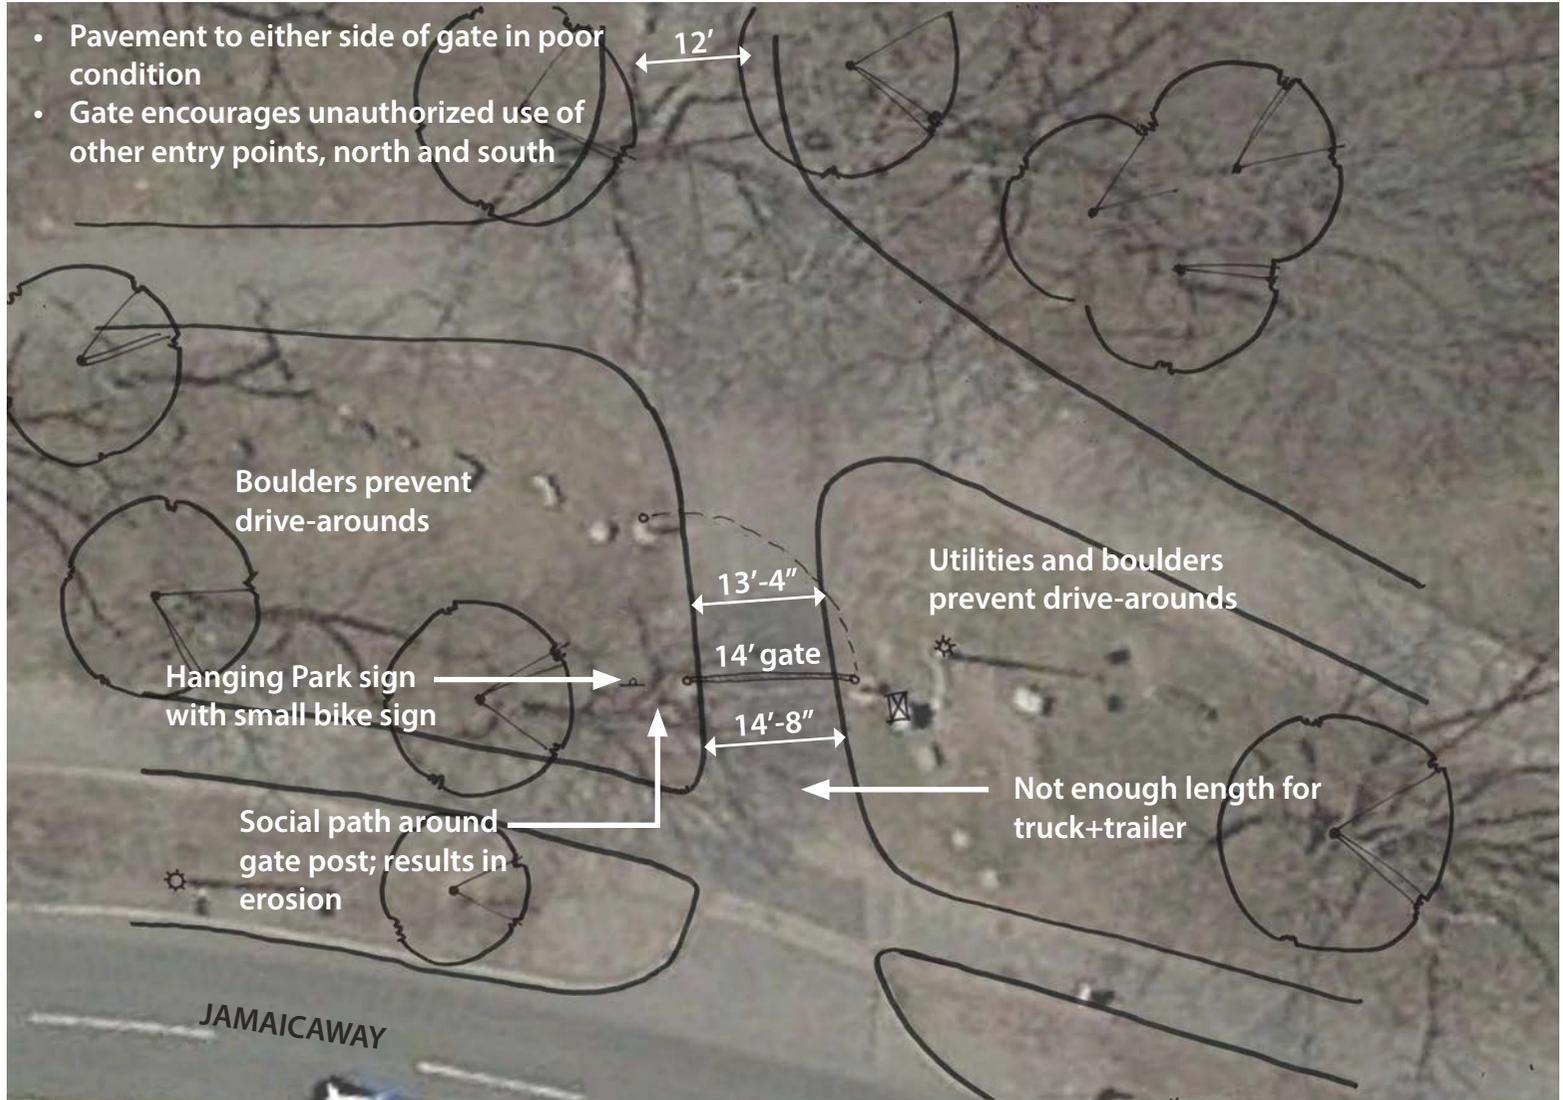
PINEBANK DRIVE - EXISTING

- Pavement to either side of gate in poor condition
- Gate encourages unauthorized use of other entry points, north and south

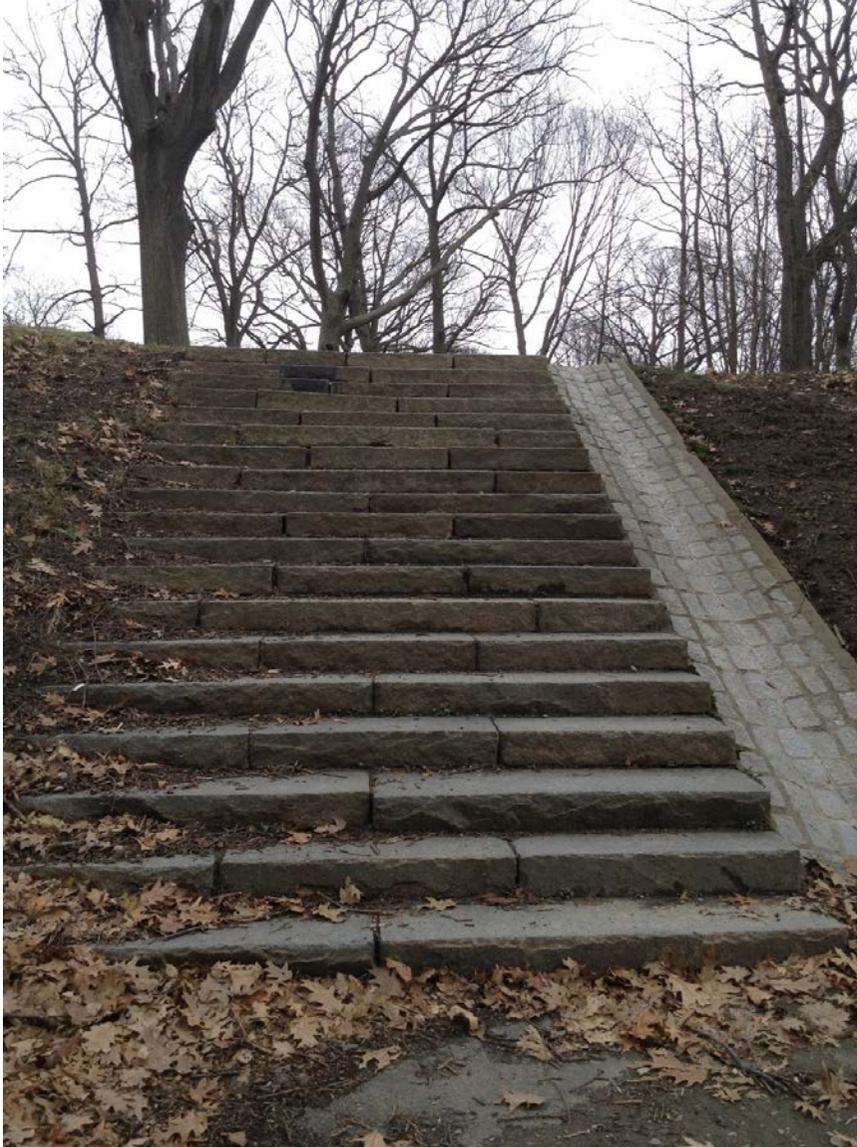
STAIRCASES - POND STAIRS

- Stone dust pathway at top of stair is eroding onto stairs
- Treads have settled/shifted over time
- Uneven stair treads have encouraged social trails to form on the southern slope
- Armored swale is unsightly and not original to the site

- Reset existing granite treads
- Manage stormwater above stairs to limit erosion on the sides
- Plant vegetation on the edges to reduce the creation of social trails
- Consider adding handrail(s)

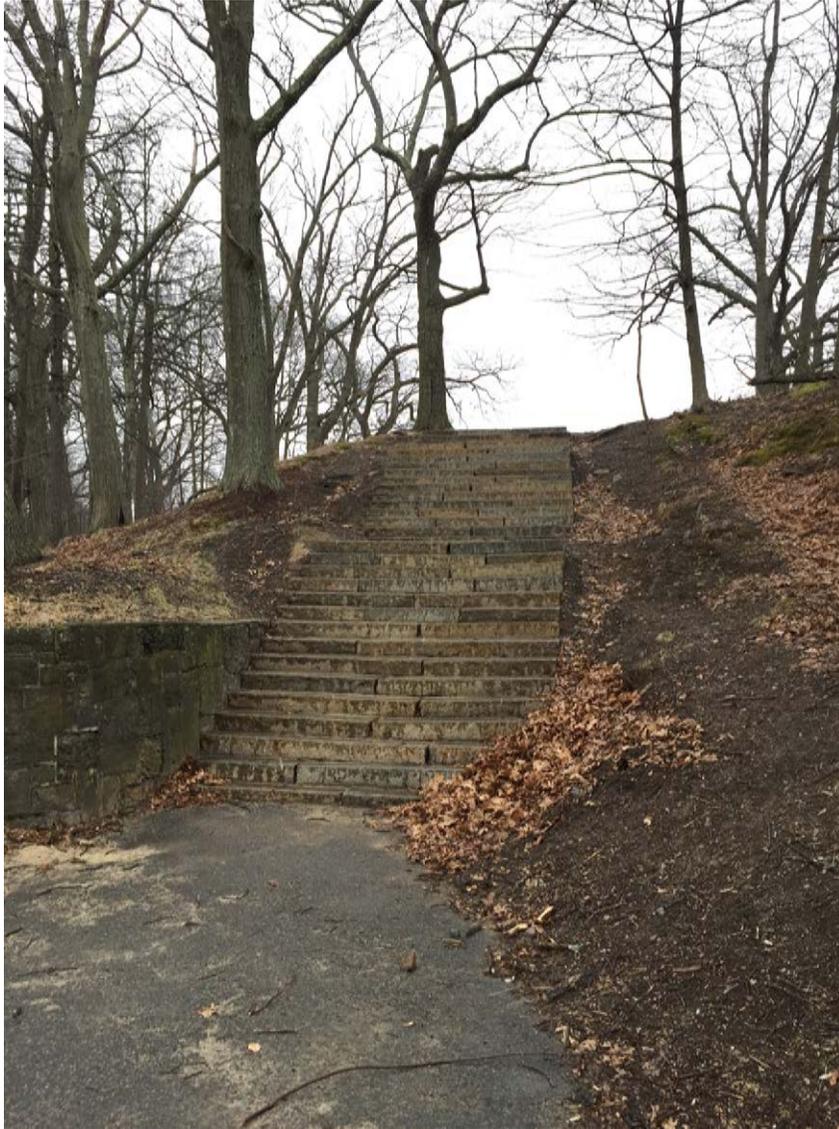
STAIRCASES - PERKINS & CHESTNUT STAIRS

- Pathway at top of stair well above ADA allowed gradient
- Treads have settled/shifted over time
- Riser/tread relationship is relatively steep
- Uneven stair treads have encouraged social trails to form on the edges
- Stormwater flows down the sides of the stairs

- Reset existing granite treads
- Study rise/tread relationship
- Plant vegetation on the edges to reduce the creation of social trails
- Consider adding treads to the top of existing stairs to ease steep slope
- Consider adding handrail(s)

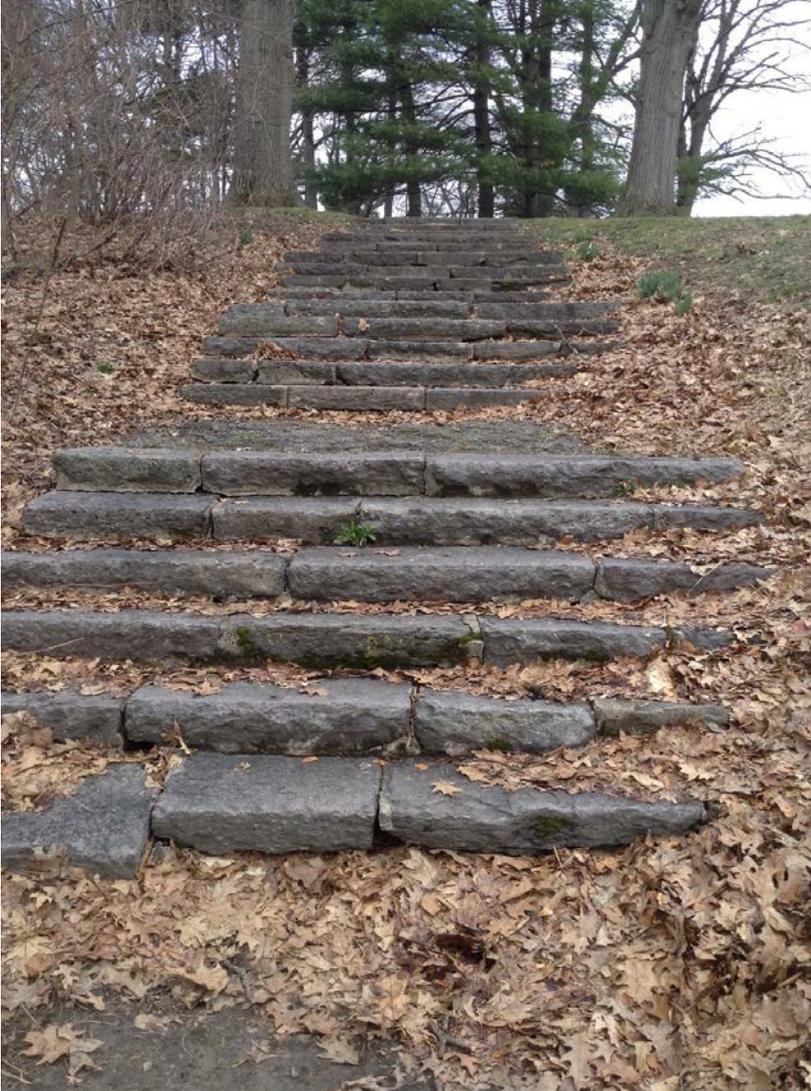
STAIRCASES - PUDDINGSTONE STAIRS

- Stairs do not connect to an established path
- Treads have settled/shifted over time

- Replace bituminous concrete landings
- Reset granite treads
- Maintain stairs as a historic remnant

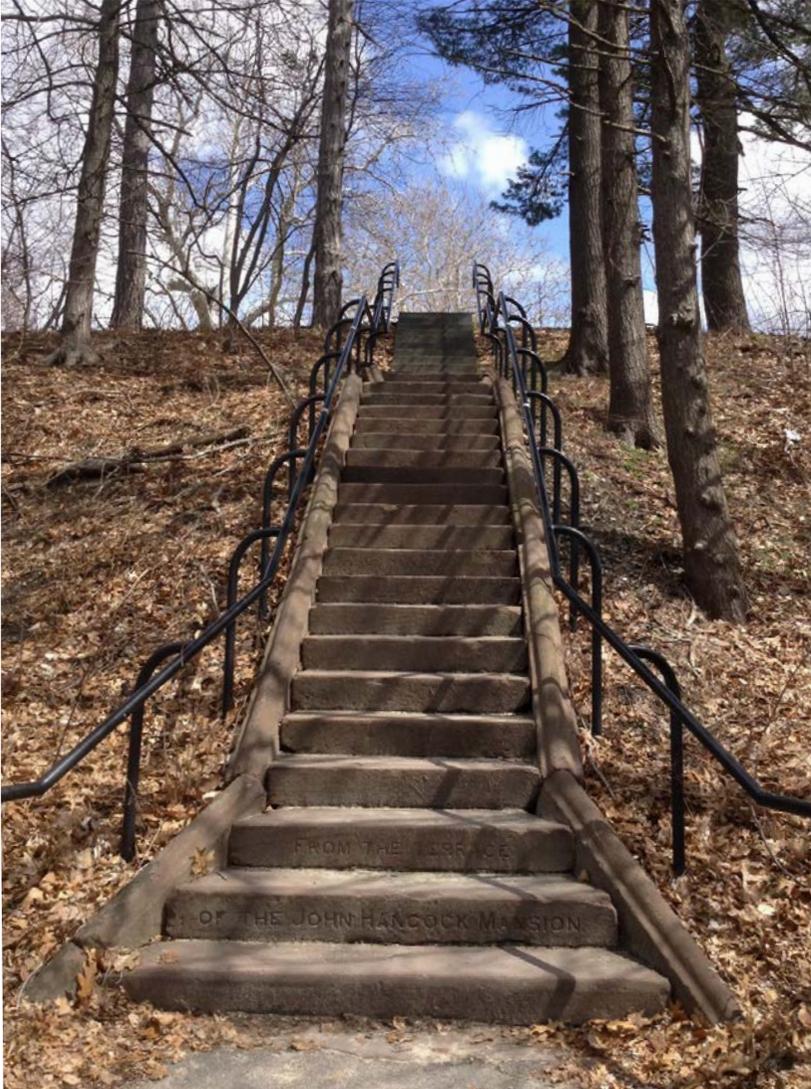
STAIRCASES - HANCOCK STAIRS

- Select stair treads rock

- Shim unstable treads

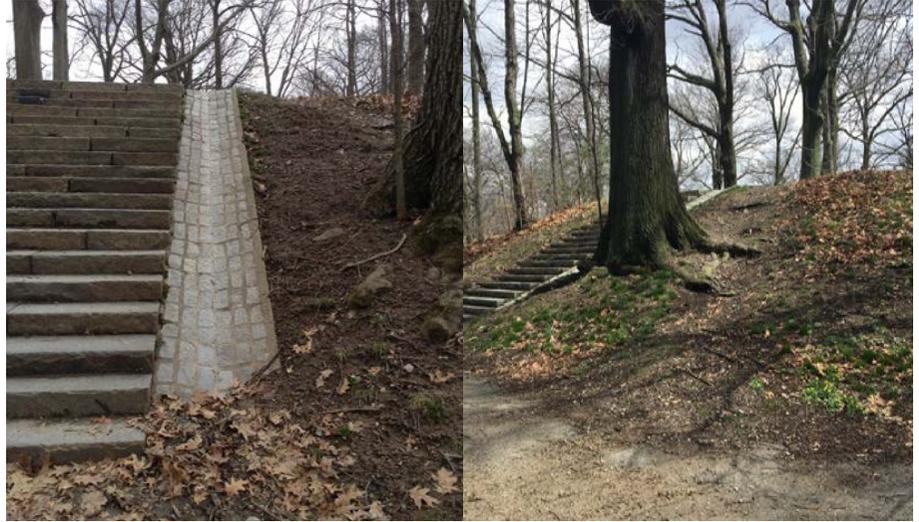
Stairs near pond with erosion alongside sluice and social trail stripped of vegetation

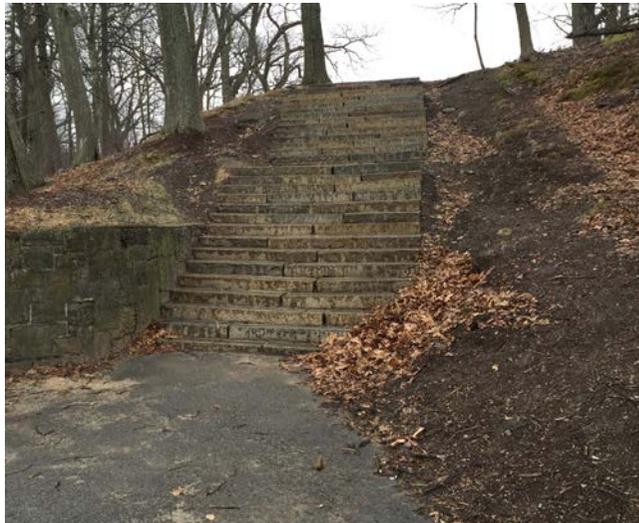
Perkins and Chestnut Street stairs with erosion and social trail stripped of vegetation
