253 SUMMER ST

DOOR AND ENTRANCE AREA REPAIRS

LANDMARKS SUBMISSION 3.21.17

- 253 SUMMER DOOR REPAIR AND RECLADDING, FLOOR PAVING AND HANDRAIL REPLACEMENT

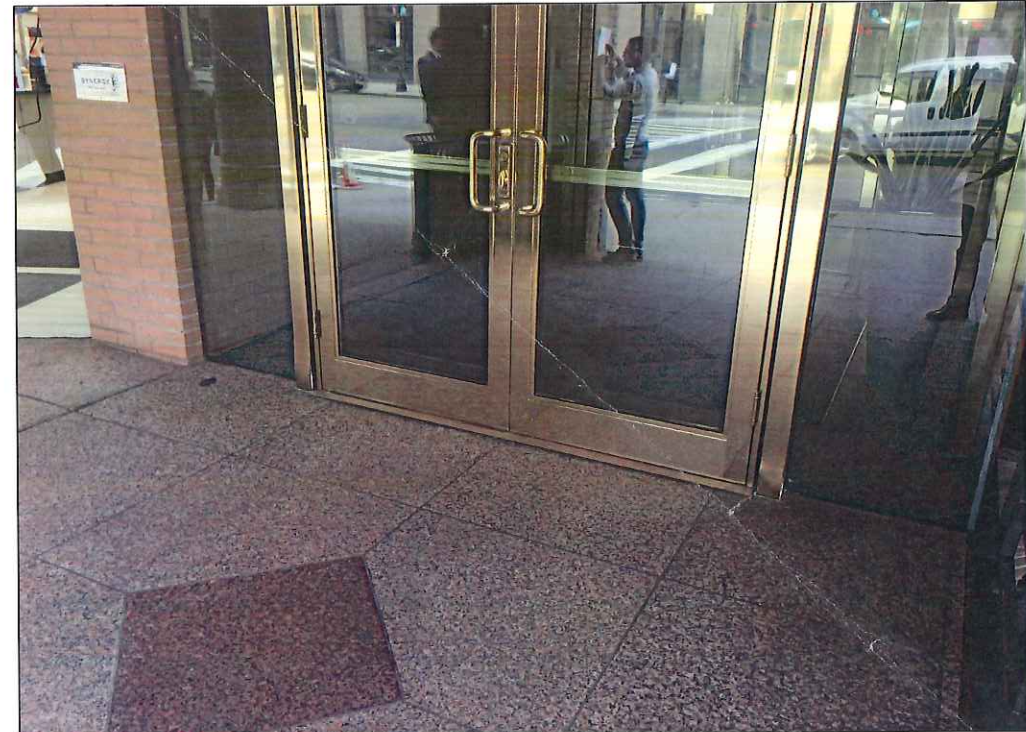
threshold condition @ entry door

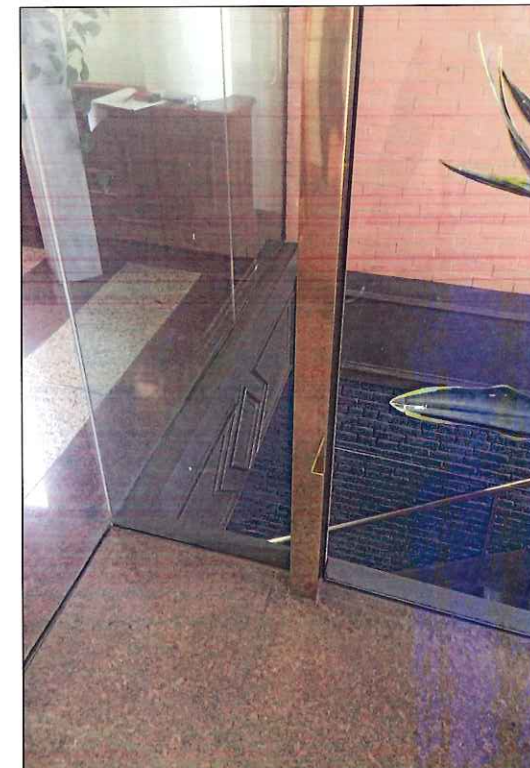
threshold condition @ interior vestibule

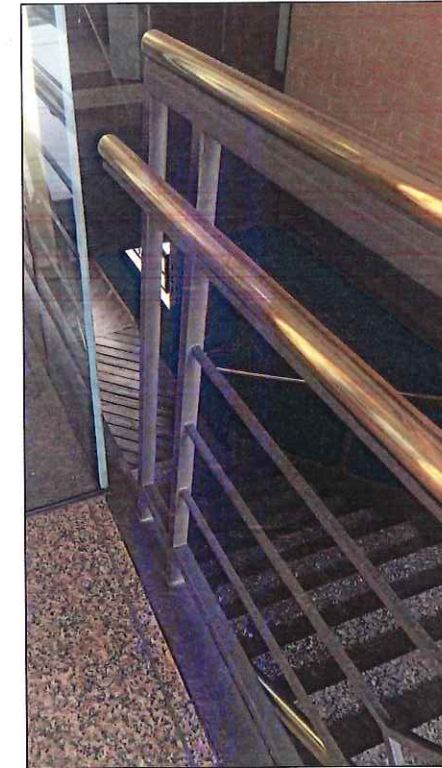
existing guardrail / handrail configuration

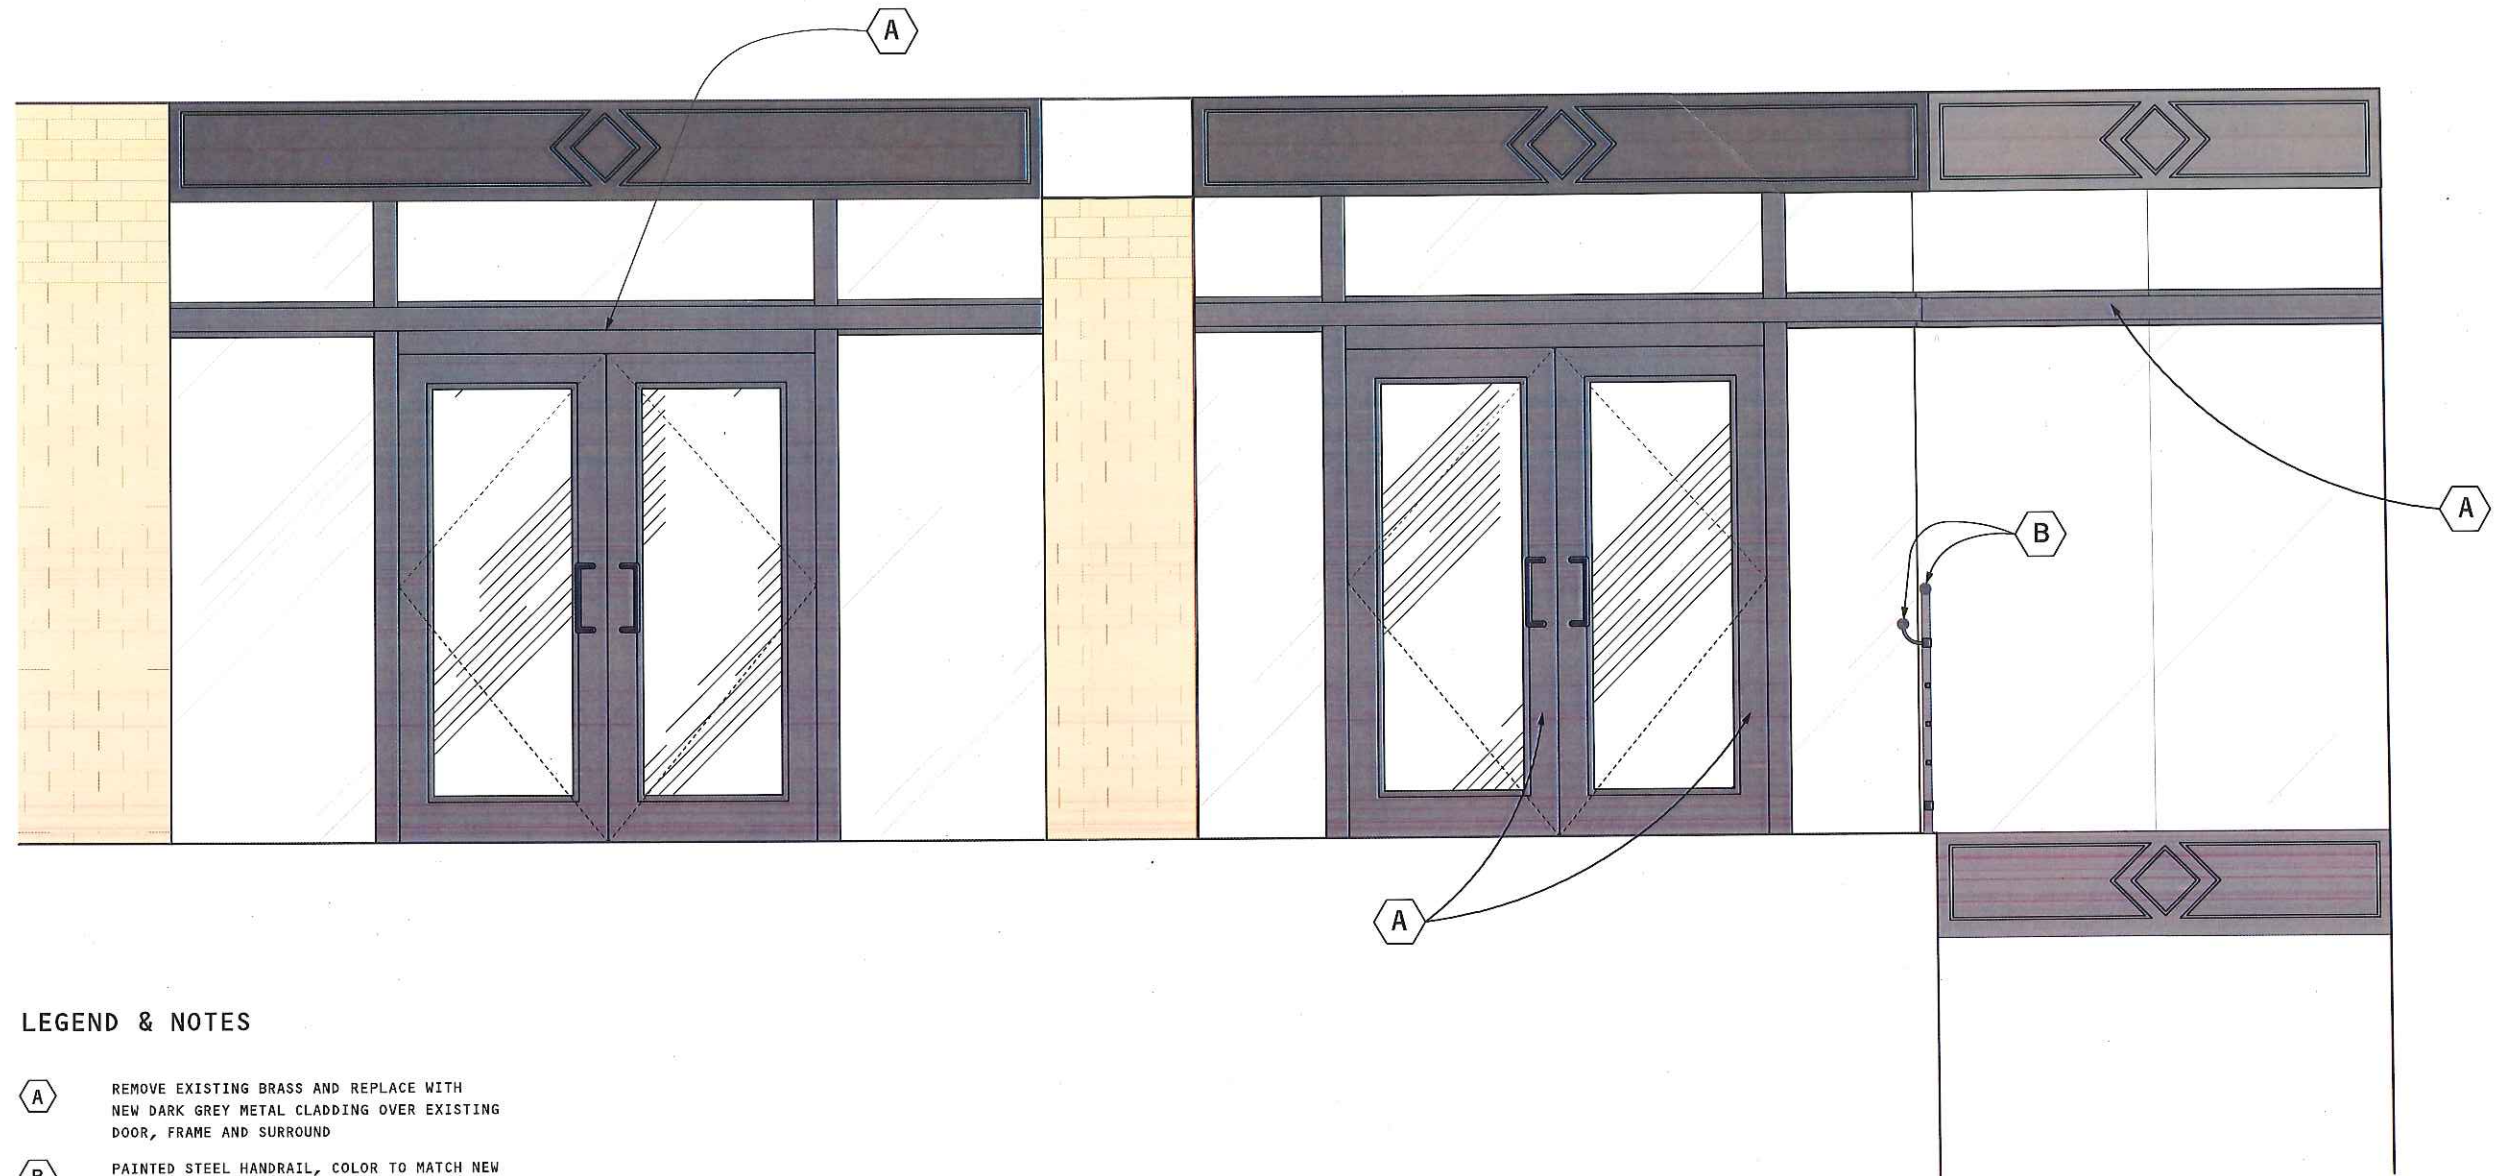
- A** REMOVE EXISTING BRASS AND REPLACE WITH NEW DARK GREY METAL CLADDING OVER EXISTING DOOR, FRAME AND SURROUND
- B** PAINTED STEEL HANDRAIL, COLOR TO MATCH NEW METAL CLADDING

NO ADDITIONAL WORK IS PROPOSED BEYOND RECLADDING EXISTING SURFACES AND CHANGING BRASS HANDRAIL
