TUDOR BUILDING
UNIT 8/9 SOUTH

34.5 BEACON STREET
Boston, Massachusetts

21 December 2017

***REVISED** DESCRIPTION OF PROPOSED WORK:**

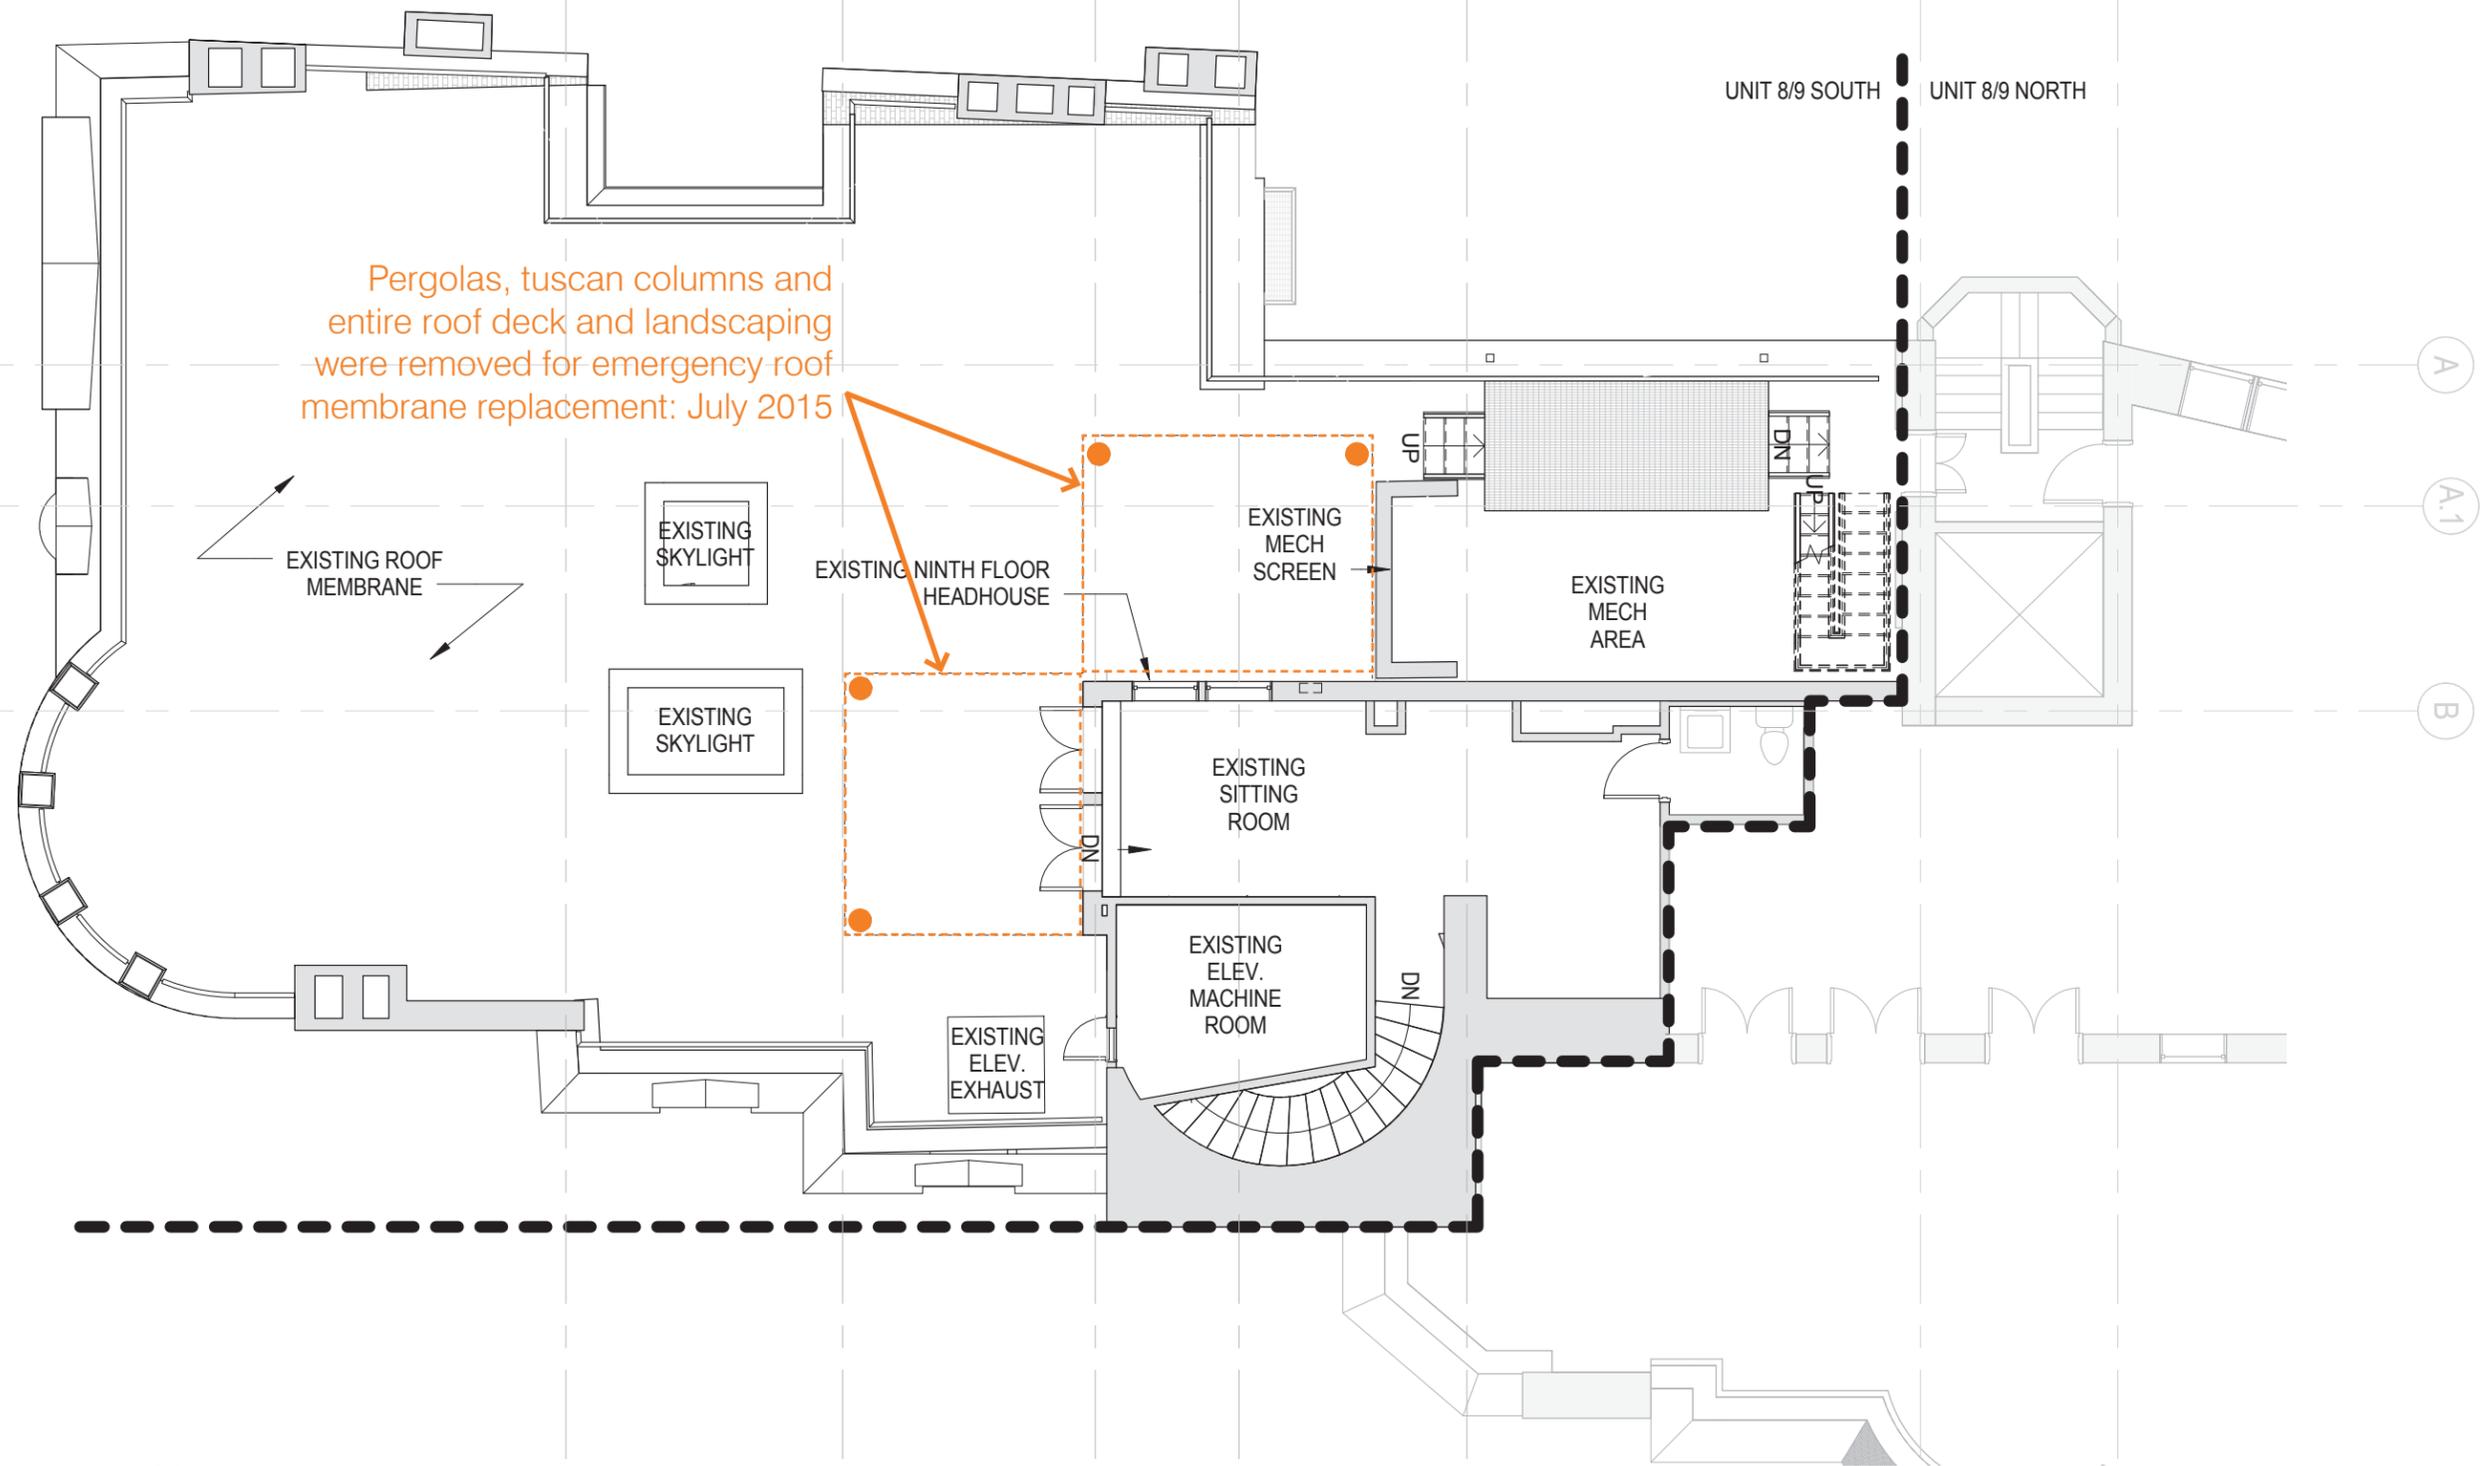
EXISTING NINTH FLOOR PLAN
CURRENT

Pergolas, tuscan columns and entire roof deck and landscaping were removed for emergency roof membrane replacement: July 2015

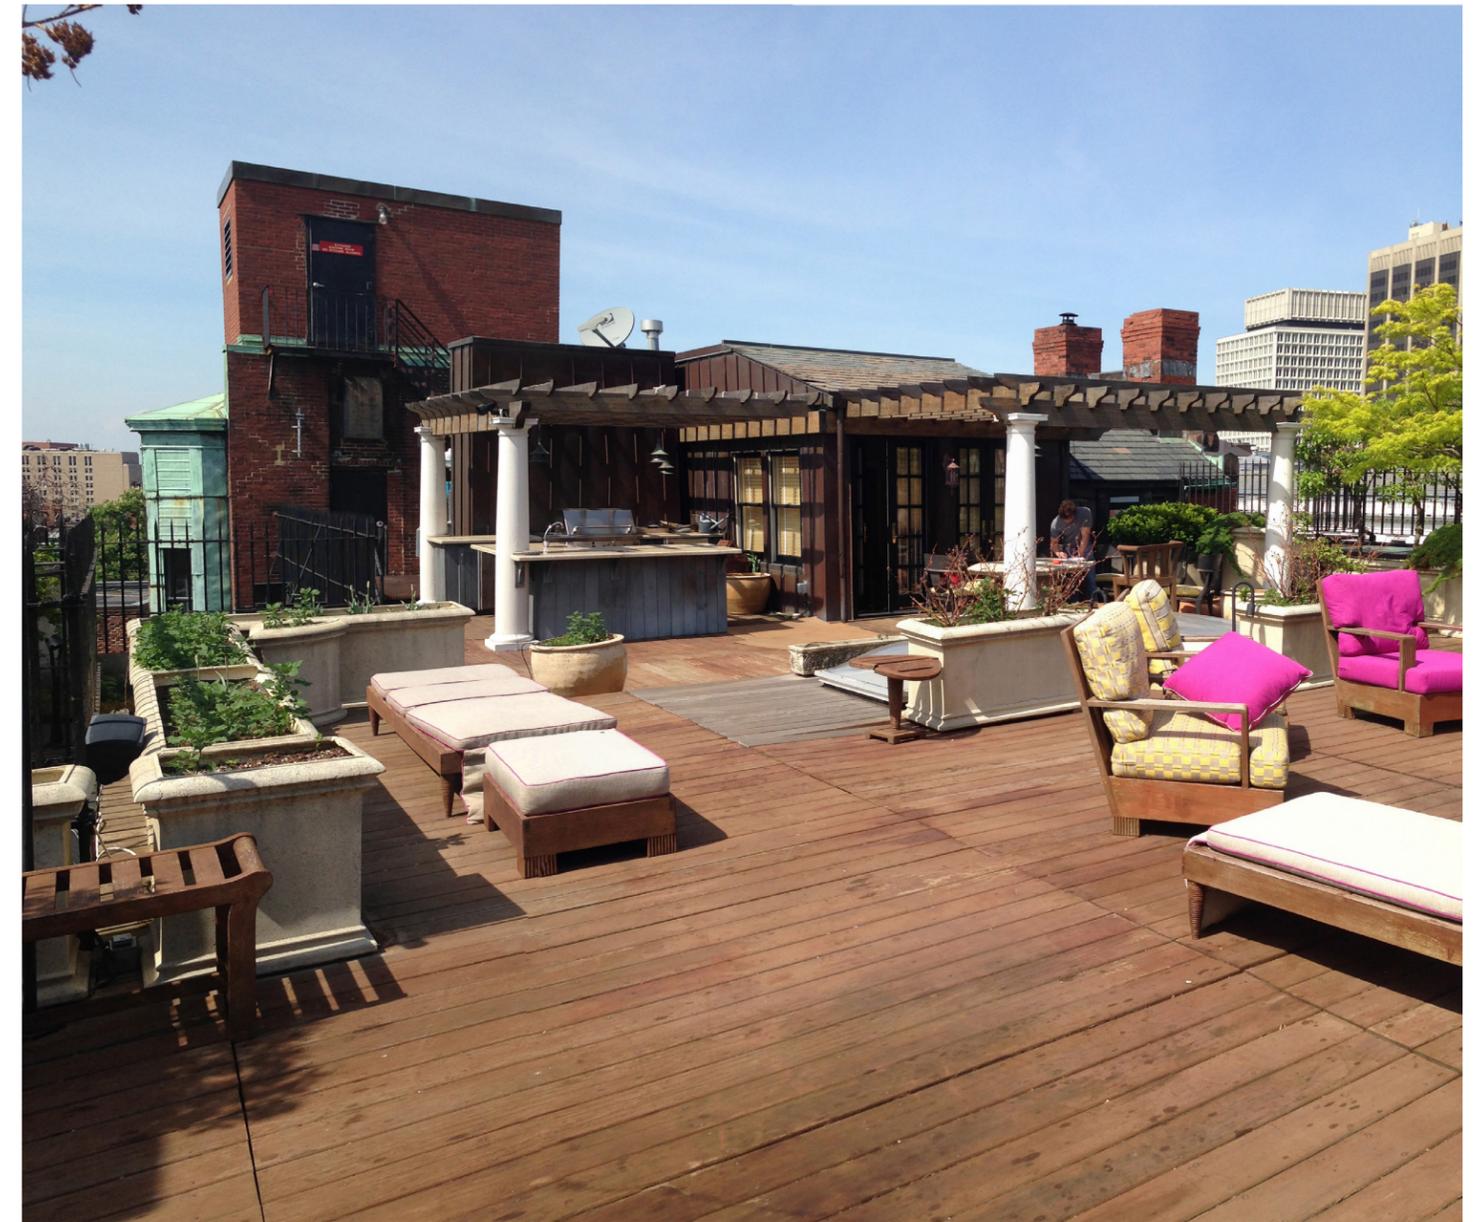
ORIGINAL PERGOLA + COLUMNS

ORIGINAL EXTENDS BEYOND EXISTING COPPER ACOUSTICAL SCREEN

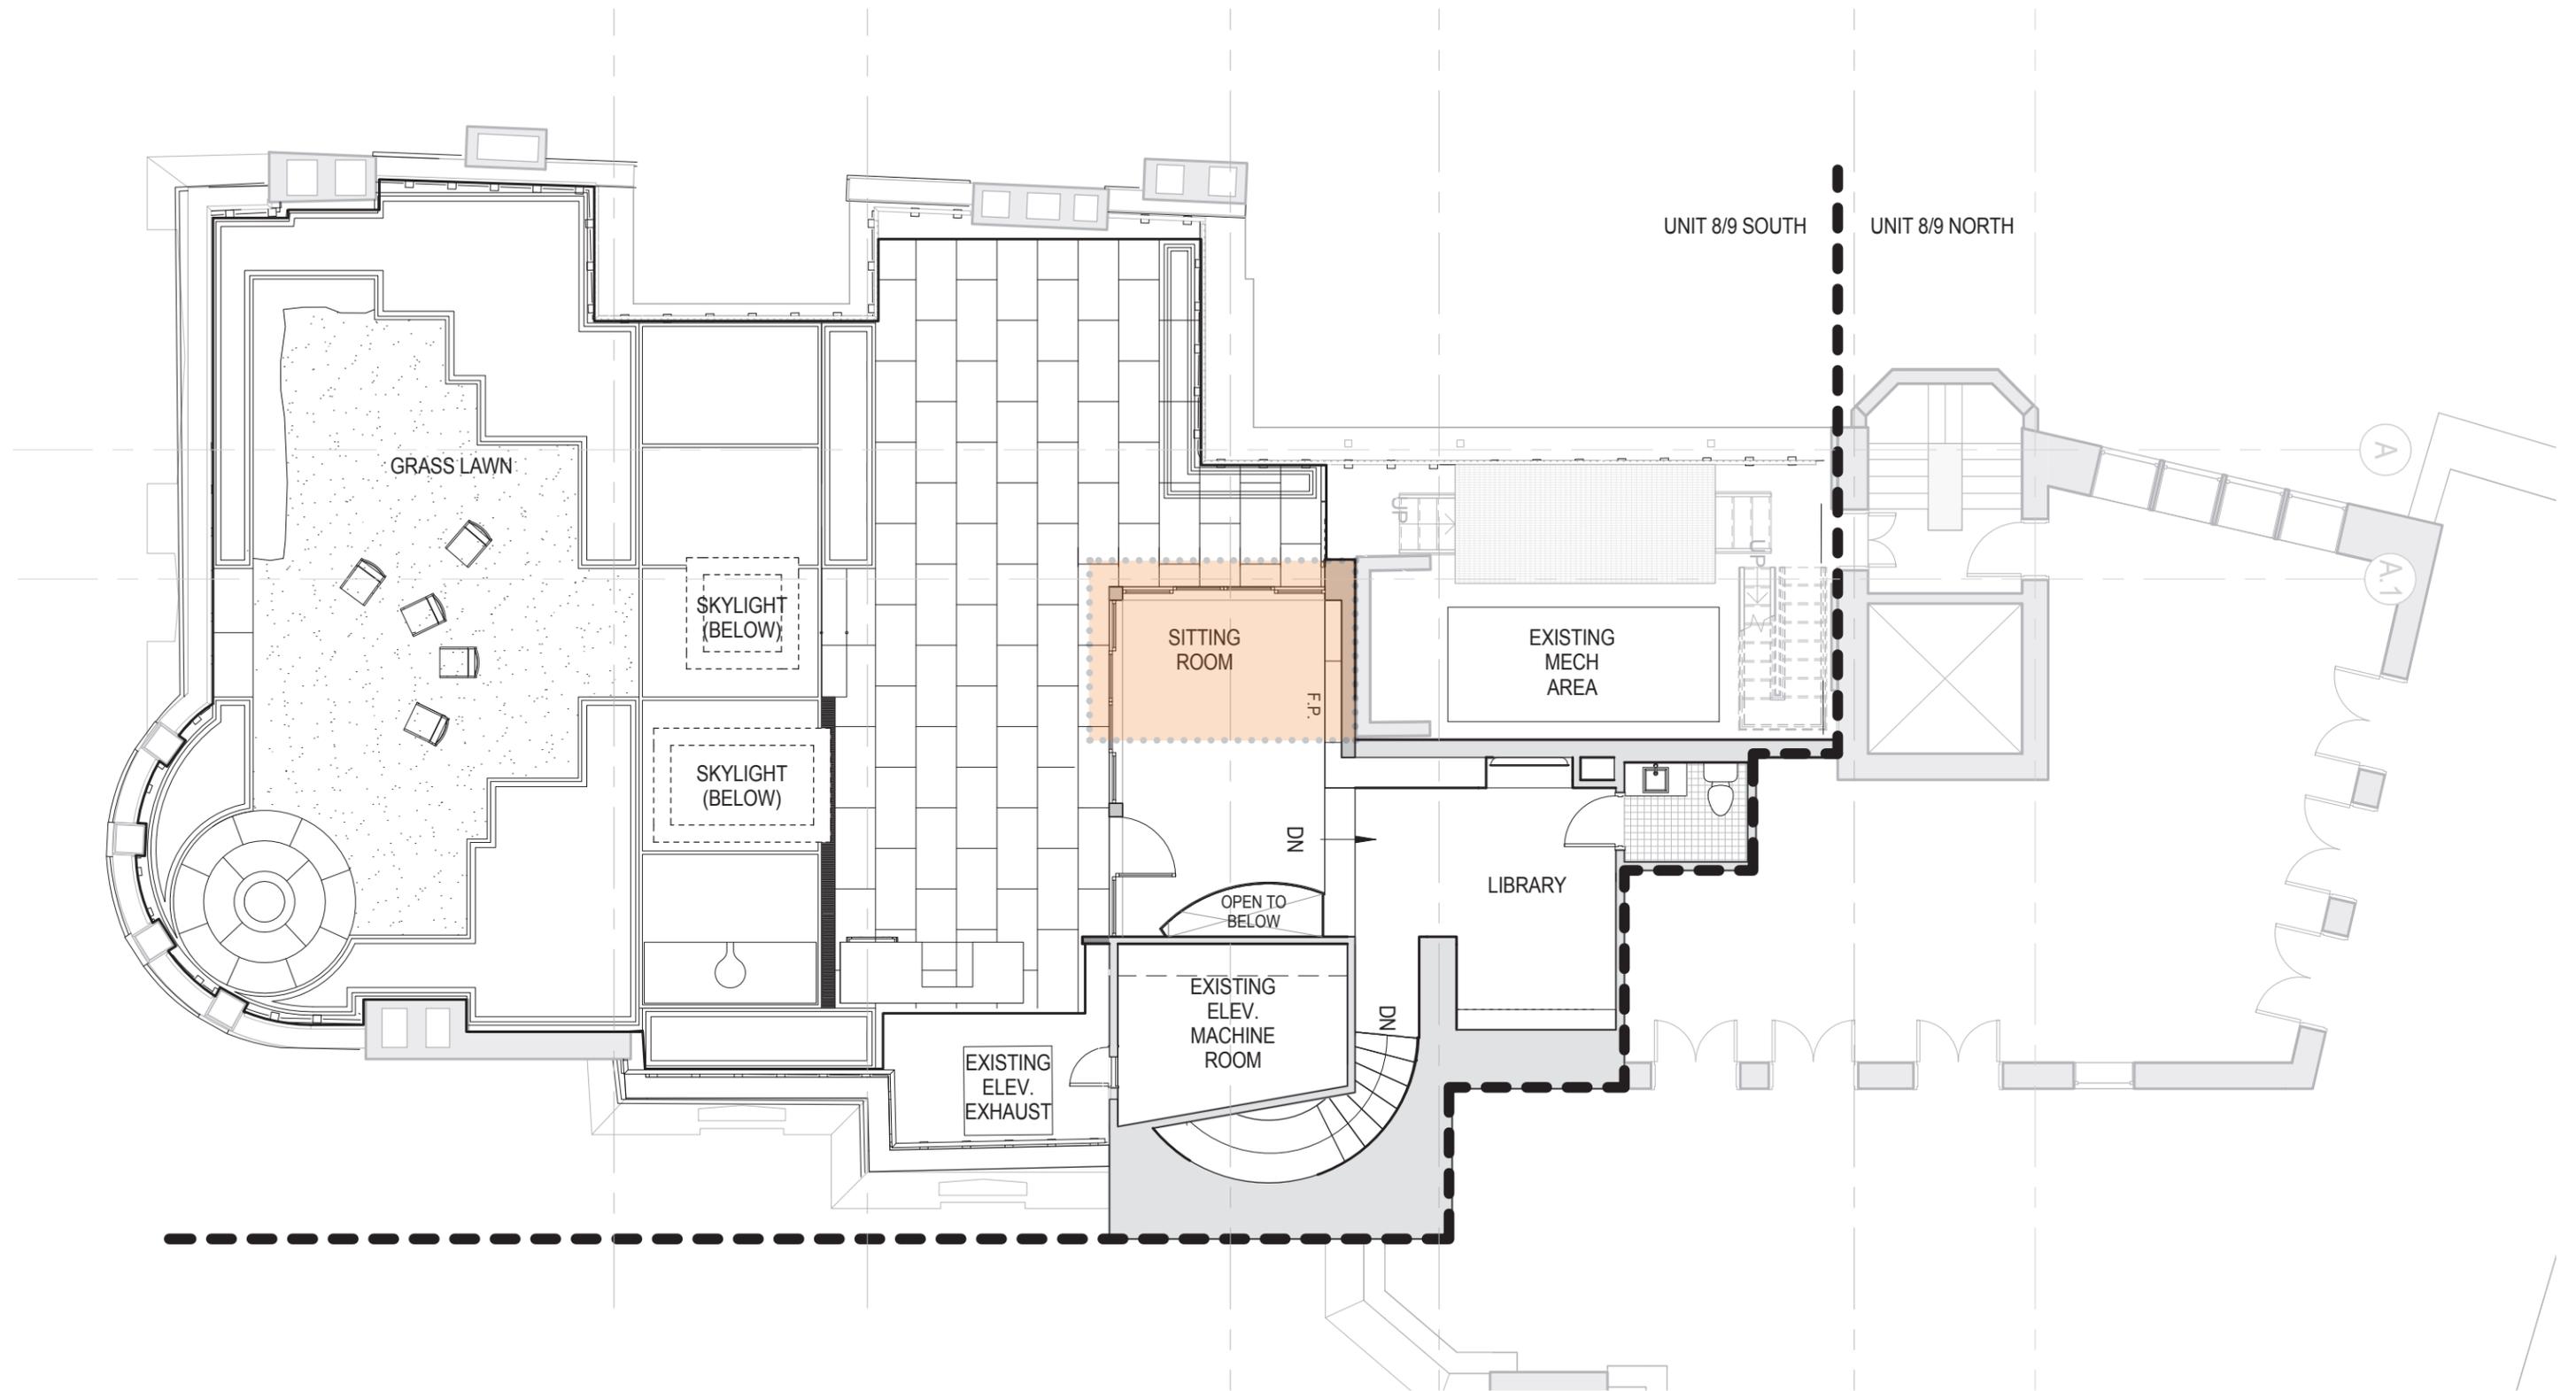
PROPOSED NINTH FLOOR PLAN | REVISED

NEW ADDITION TO UNIT 8/9 SOUTH

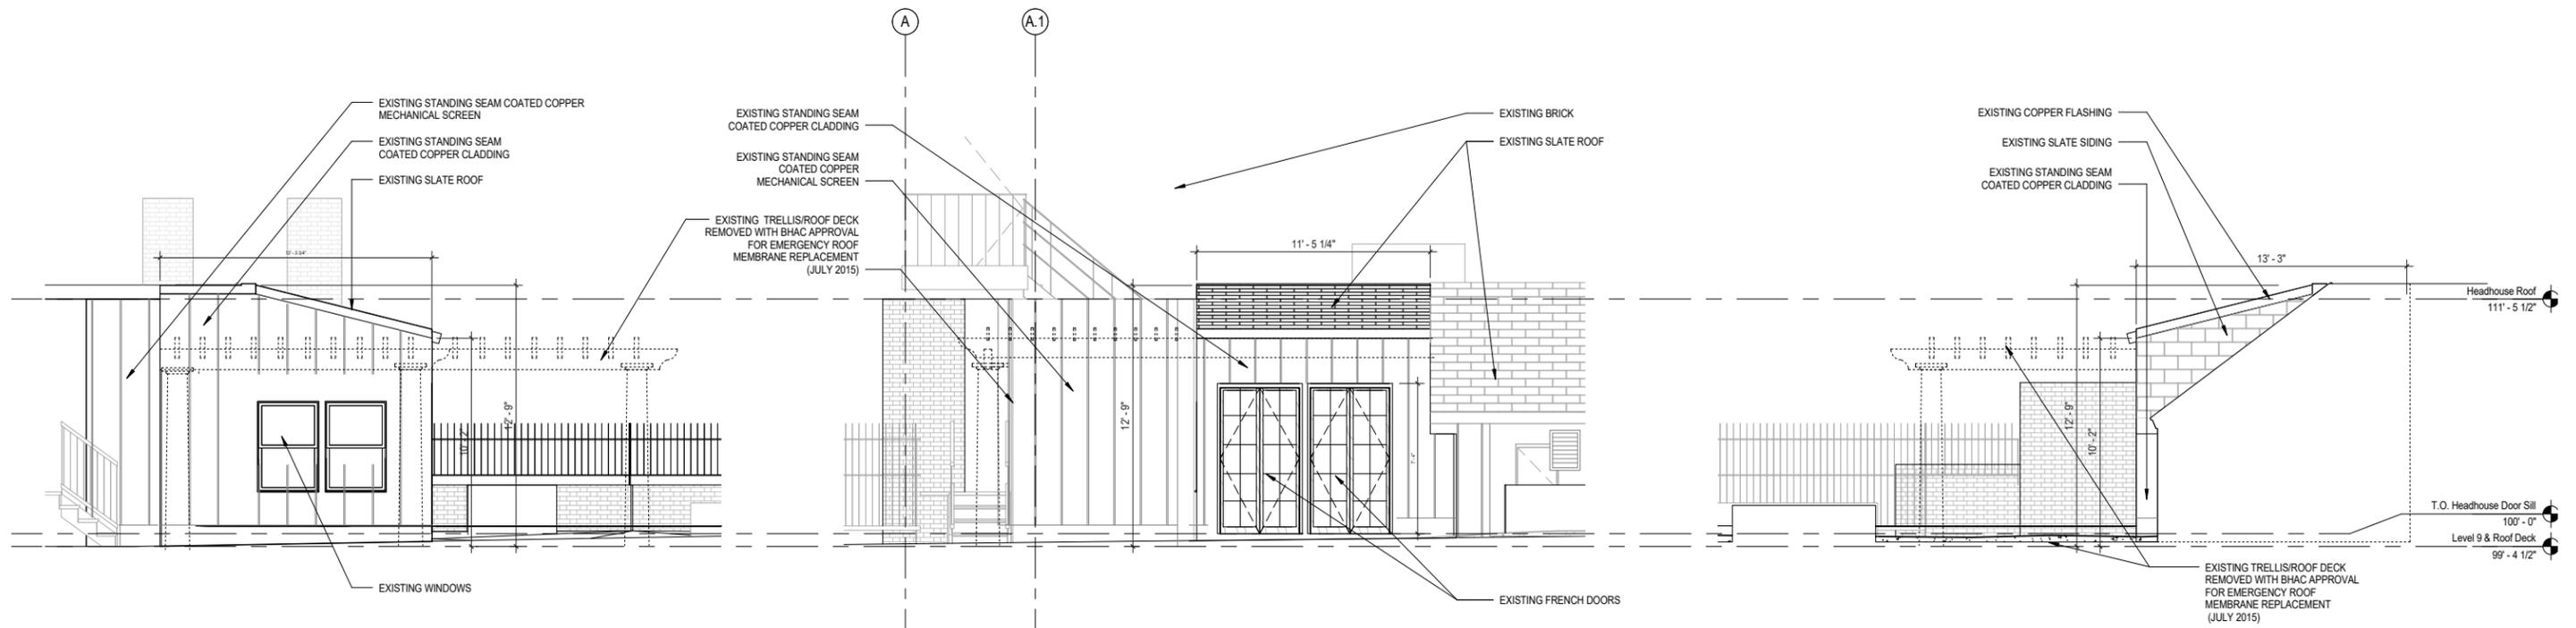
3 NINTH FLOOR HEADHOUSE - EXISTING WEST ELEVATION
1/4" = 1'-0"

2 NINTH FLOOR HEADHOUSE - EXISTING SOUTH ELEVATION
1/4" = 1'-0"

1 NINTH FLOOR HEADHOUSE - EXISTING EAST ELEVATION
1/4" = 1'-0"

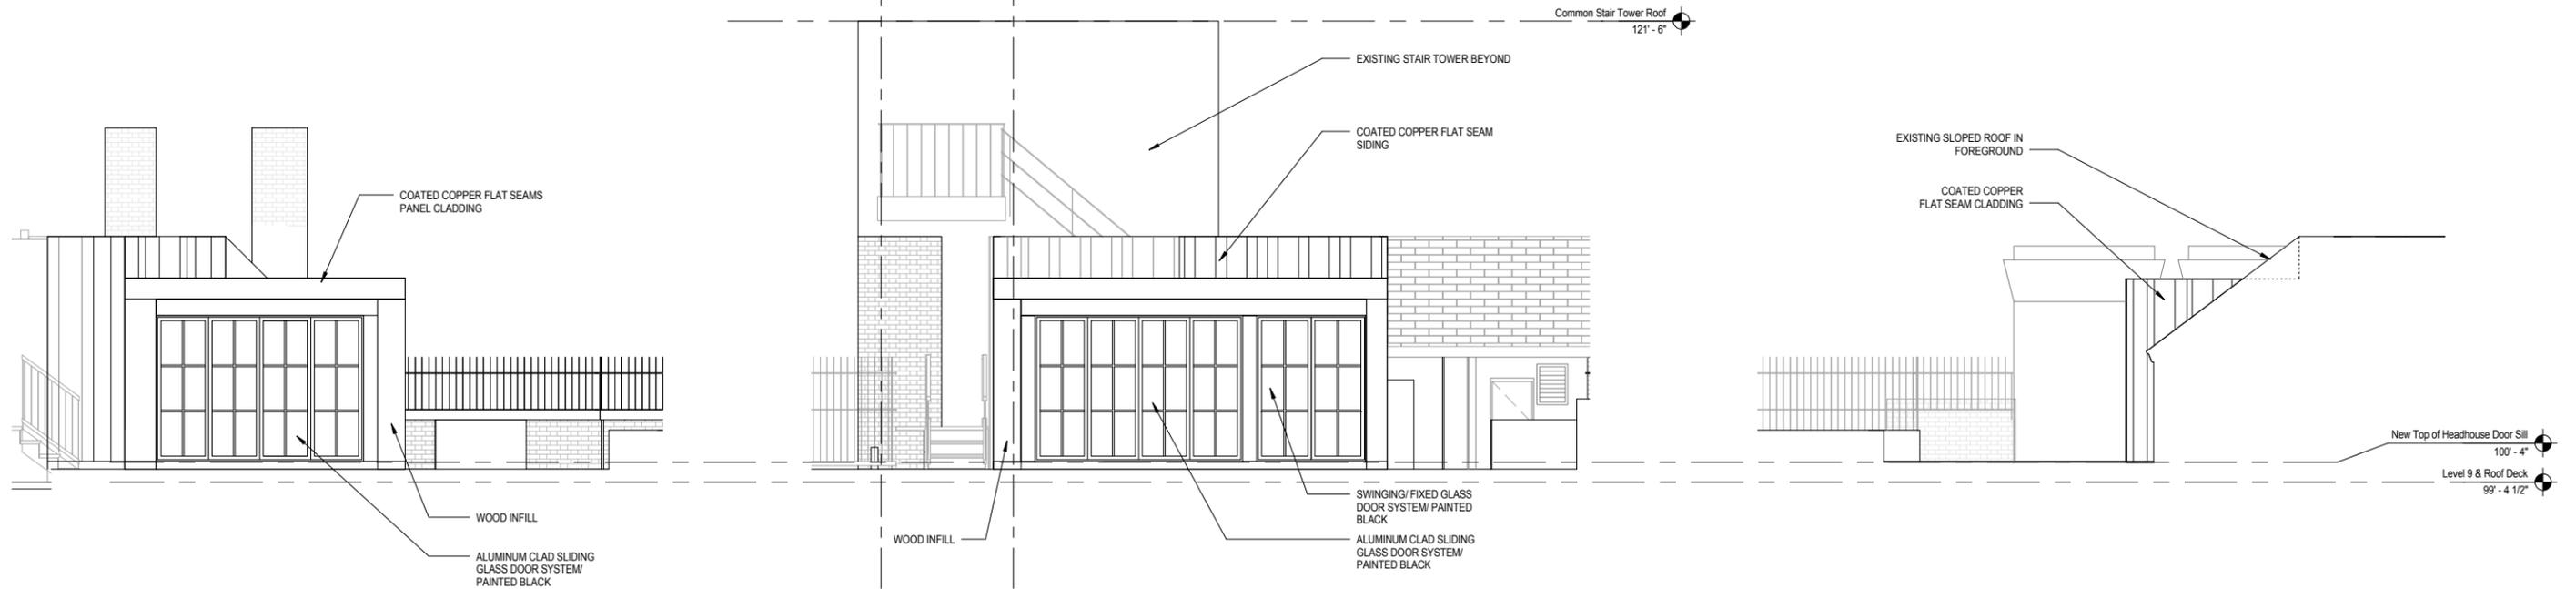
EXISTING + PROPOSED HEADHOUSE ELEVATIONS | REVISED

6 NINTH FLOOR HEADHOUSE ADDITION - PROPOSED WEST ELEVATION
1/4" = 1'-0"

5 NINTH FLOOR HEADHOUSE ADDITION - PROPOSED SOUTH ELEVATION
1/4" = 1'-0"

4 NINTH FLOOR HEADHOUSE ADDITION - PROPOSED EAST ELEVATION
1/4" = 1'-0"

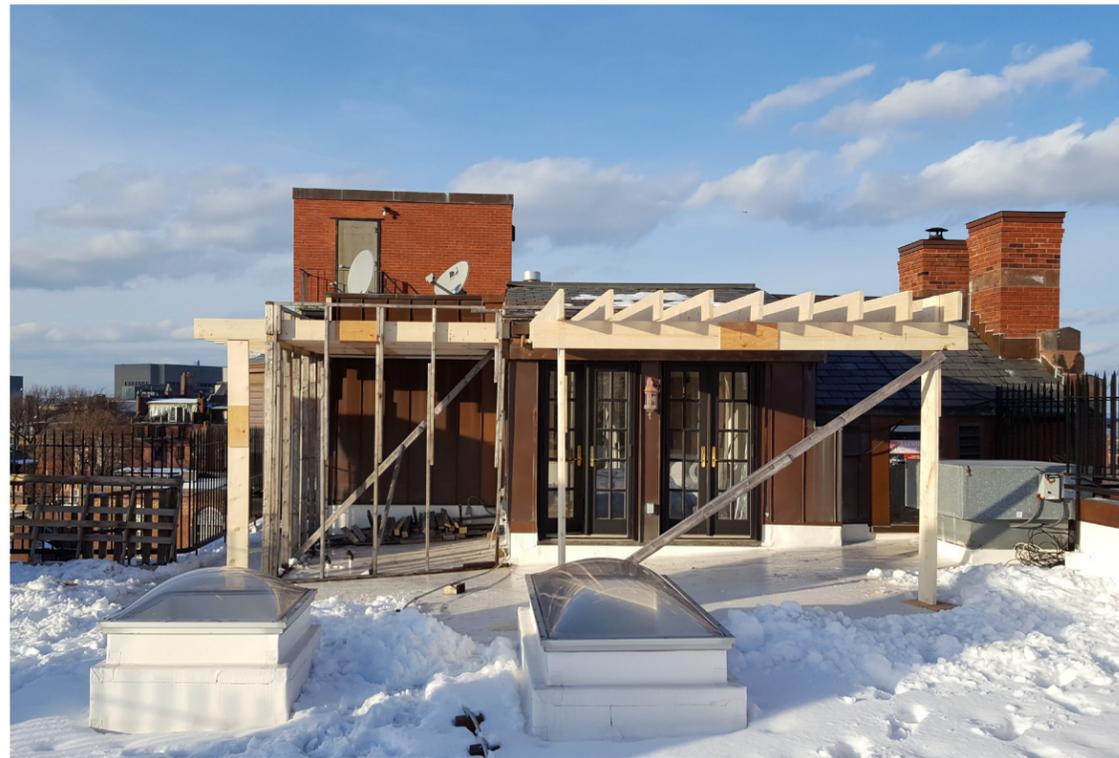
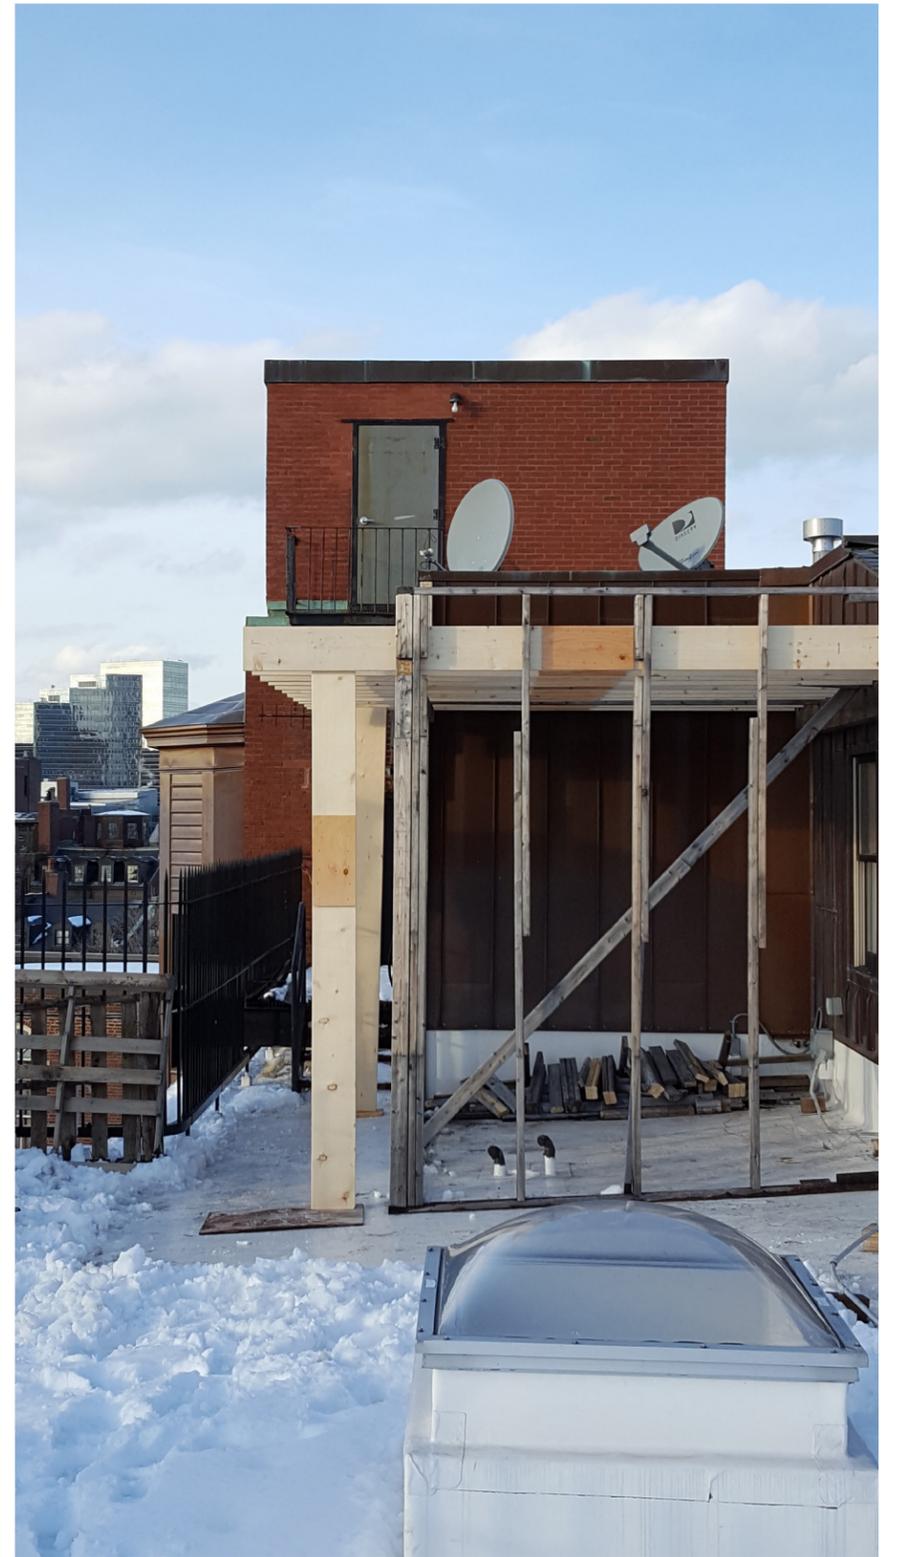
VIEWS OF ORIGINAL PERGOLA + PROPOSED HEADHOUSE MOCK-UPS

PROPOSED SMALLER THAN ORIGINAL PERGOLA

NEW WOOD = MOCK-UP OF ORIGINAL PERGOLA | WEATHERED WOOD = EXTENT OF PROPOSED HEADHOUSE

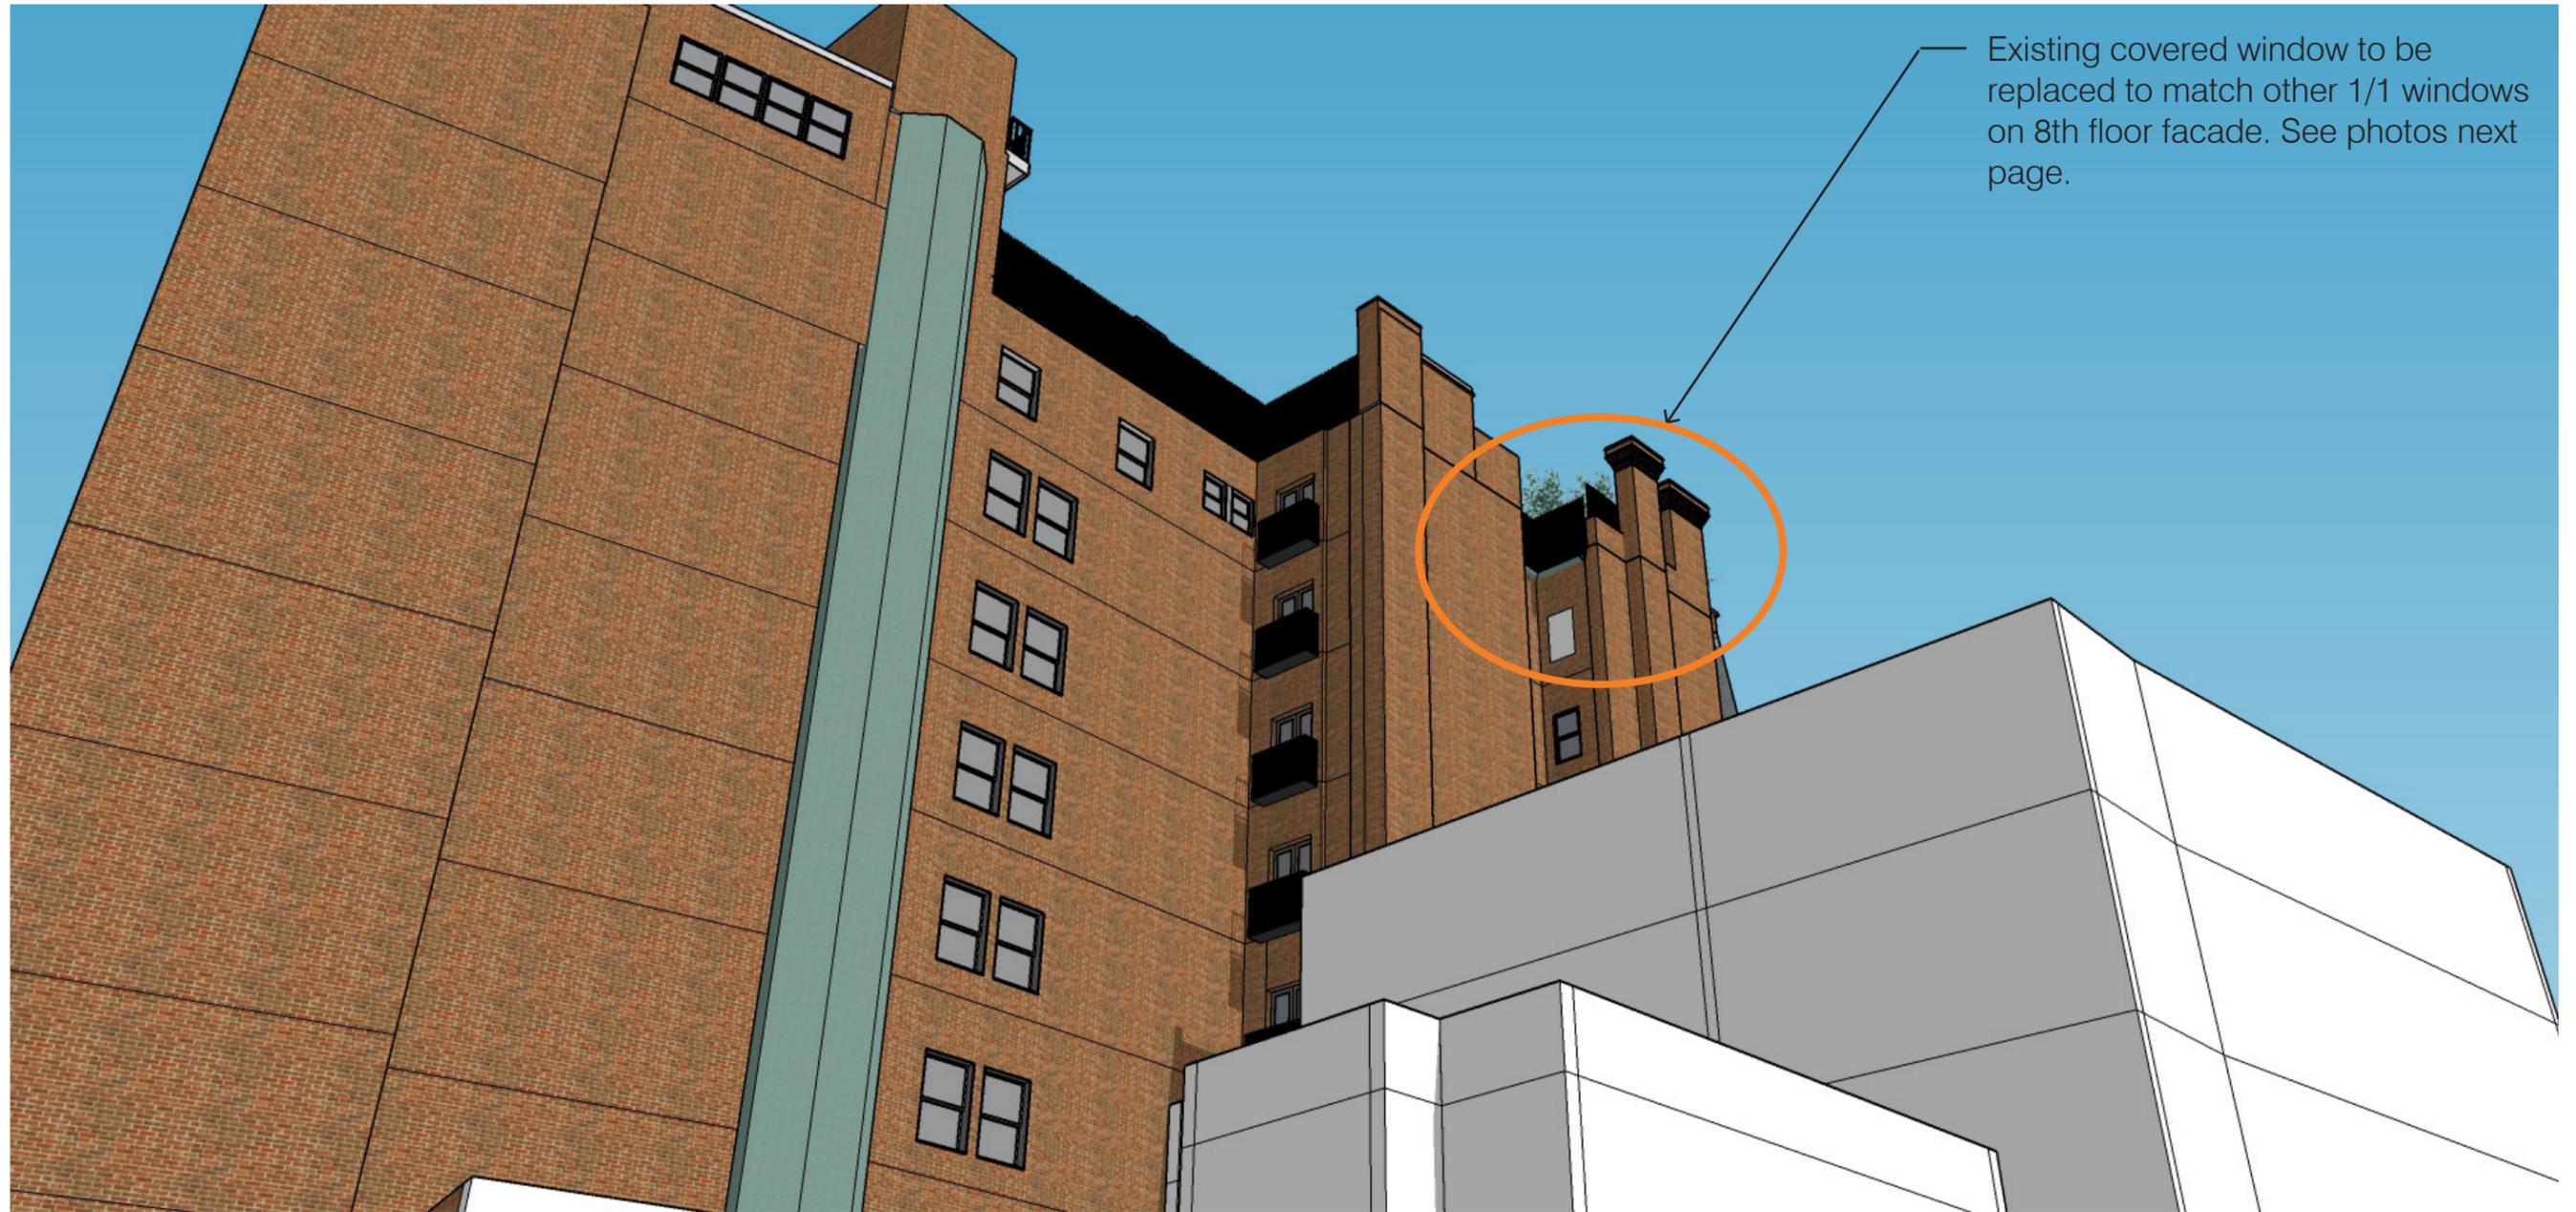
8TH FLOOR | EXISTING COVERED WINDOW TO BE REPLACED

Existing covered window to be replaced to match other 1/1 windows on 8th floor facade. See photos next page.

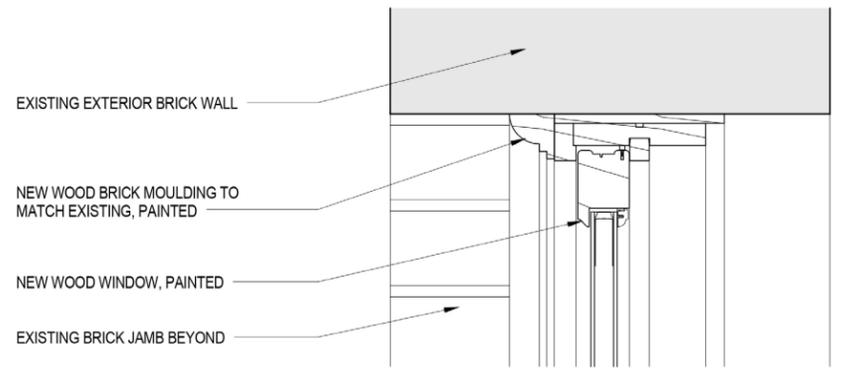
1 WINDOW HEAD
3" = 1'-0"

2 WINDOW JAMB
3" = 1'-0"

3 WINDOW SILL
3" = 1'-0"

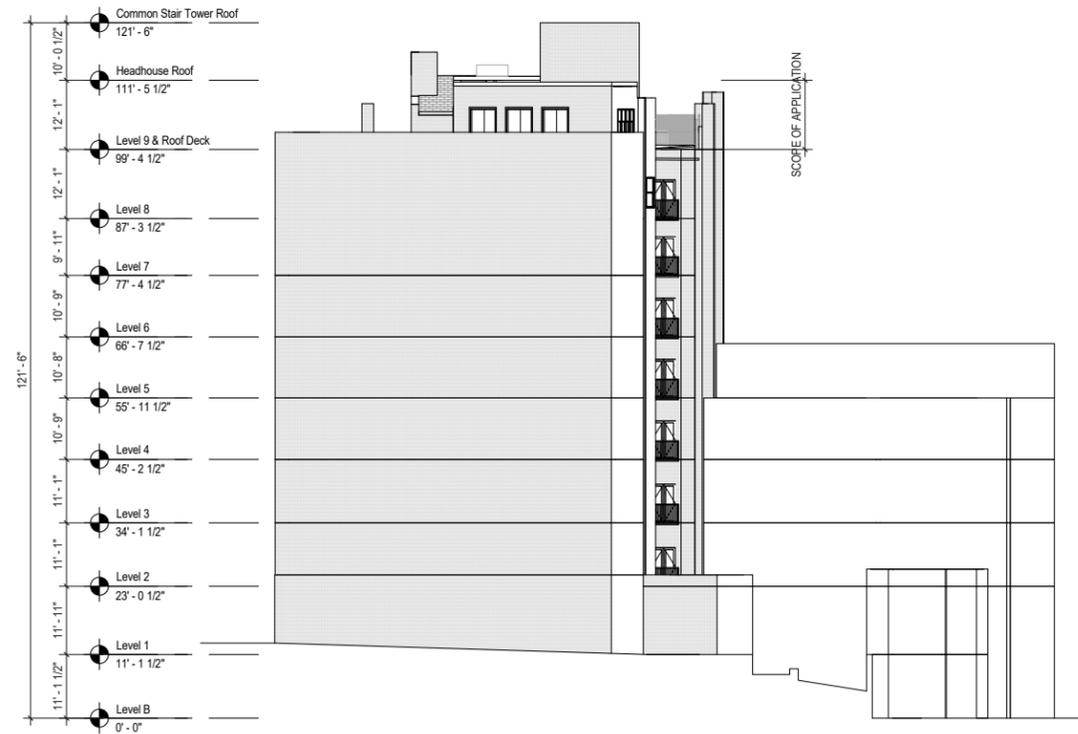
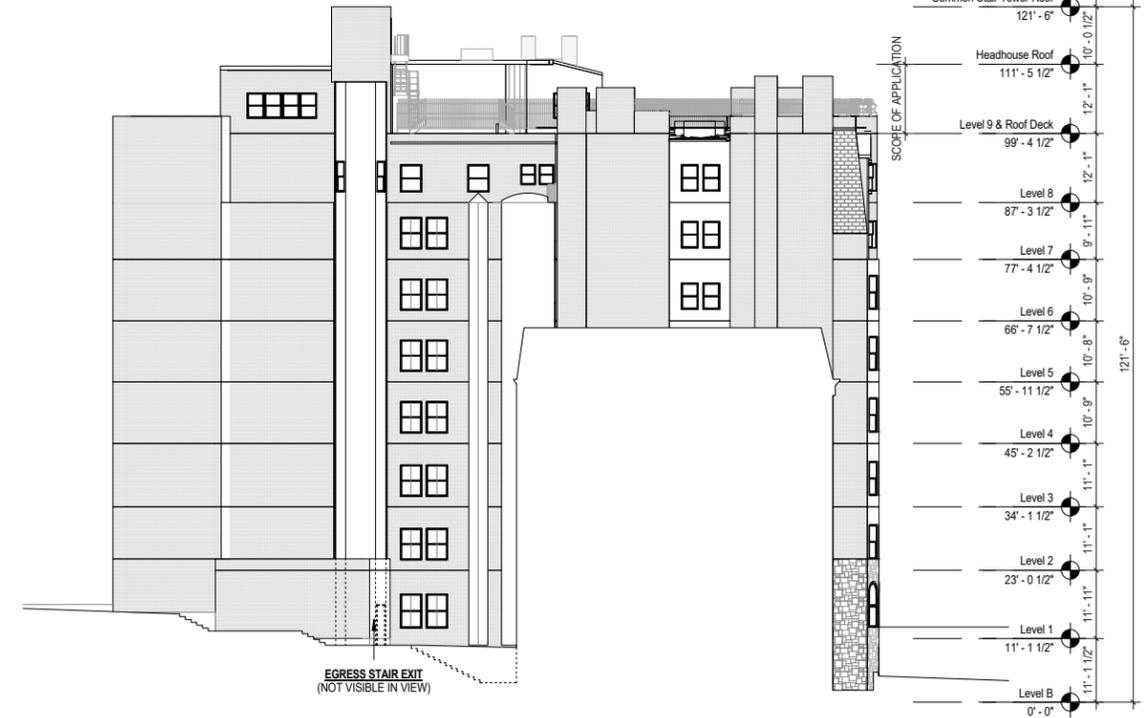
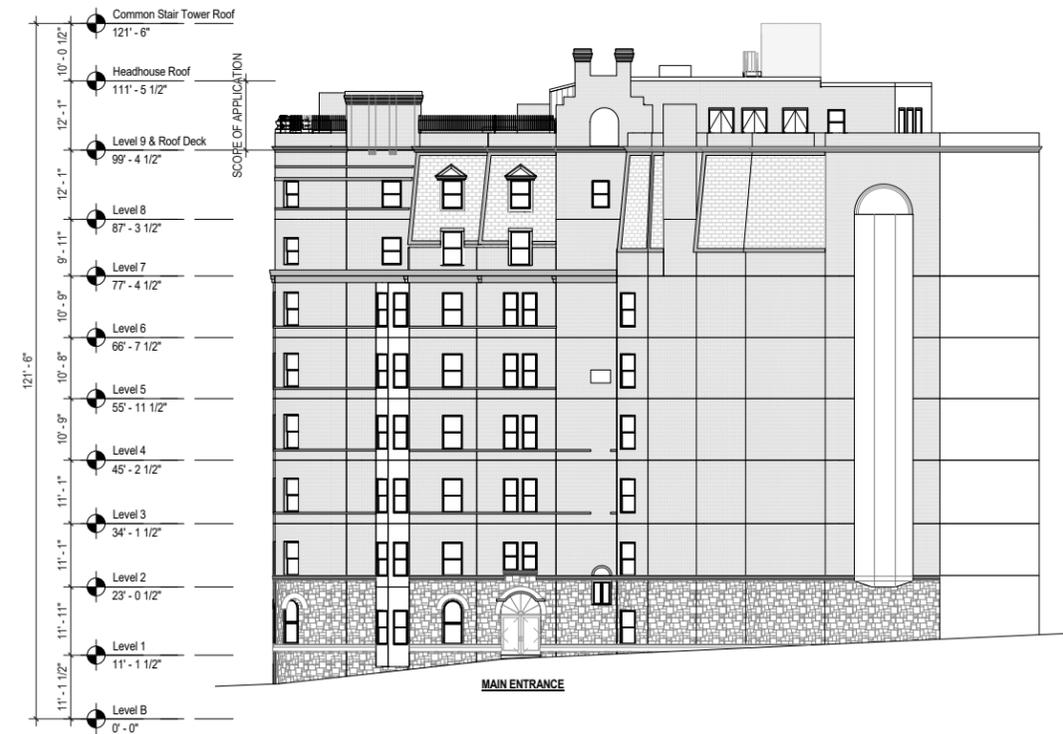
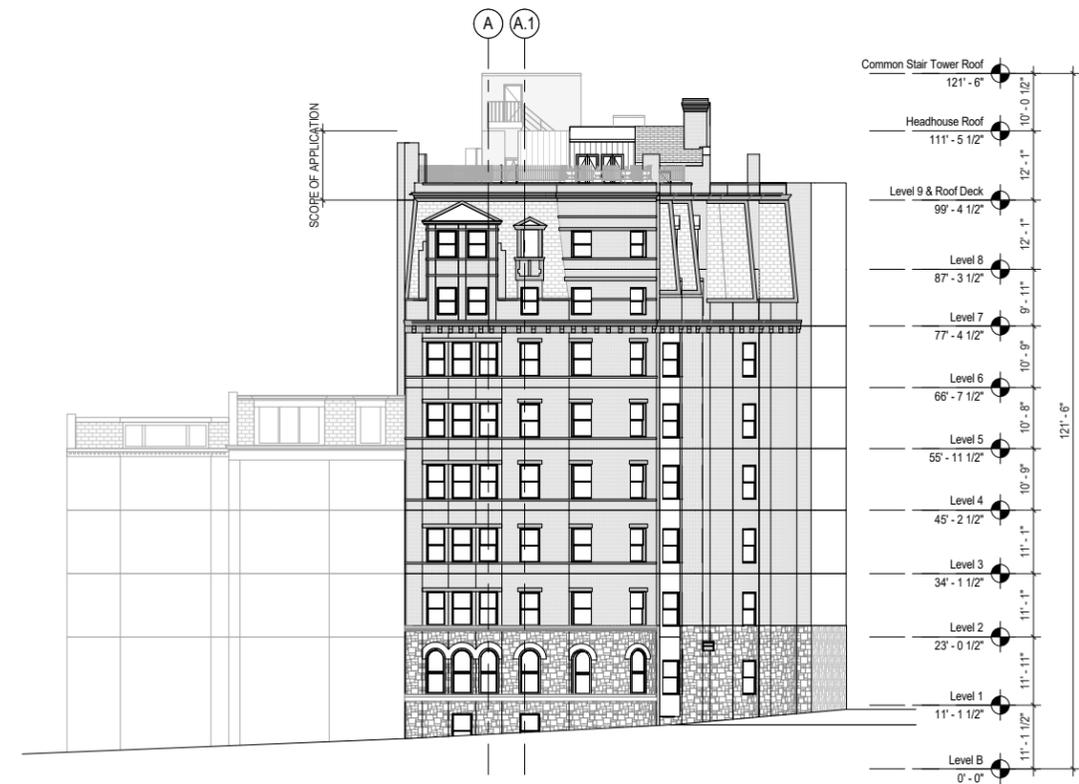
EXISTING BUILDING ELEVATIONS
DRAWING DOES NOT INCLUDE ORIGINAL PERGOLAS
