TUDOR BUILDING
UNIT 8/9 SOUTH

34.5 BEACON STREET
Boston, Massachusetts

21 December 2017

***REVISED** DESCRIPTION OF PROPOSED WORK:**

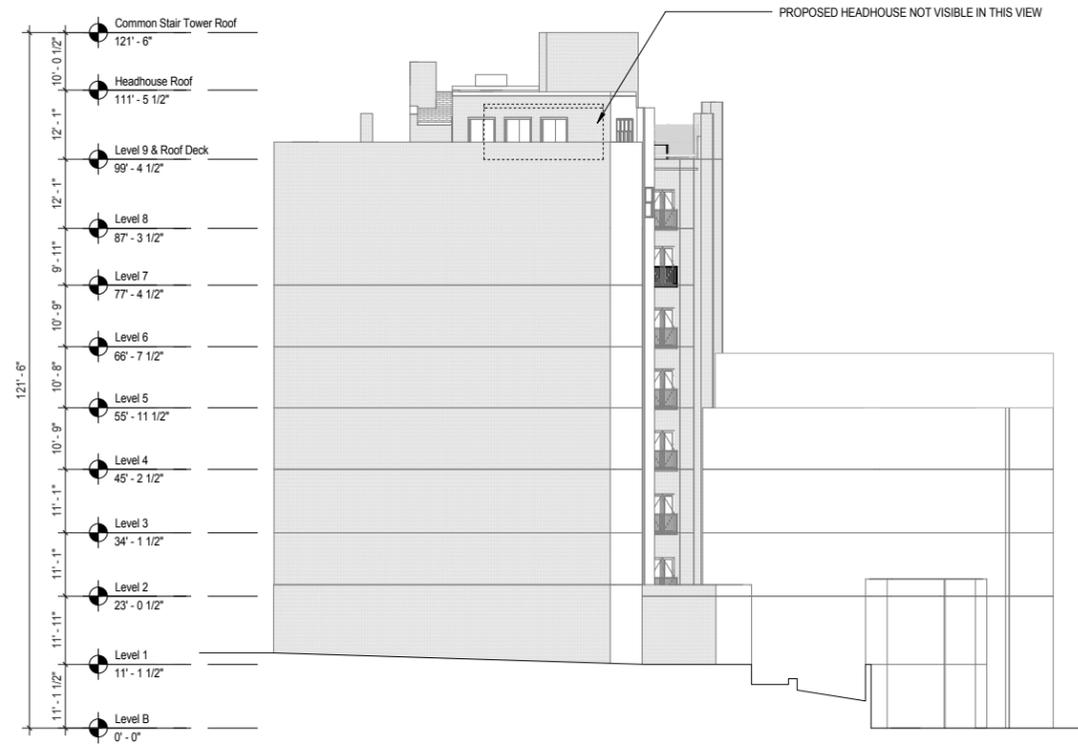
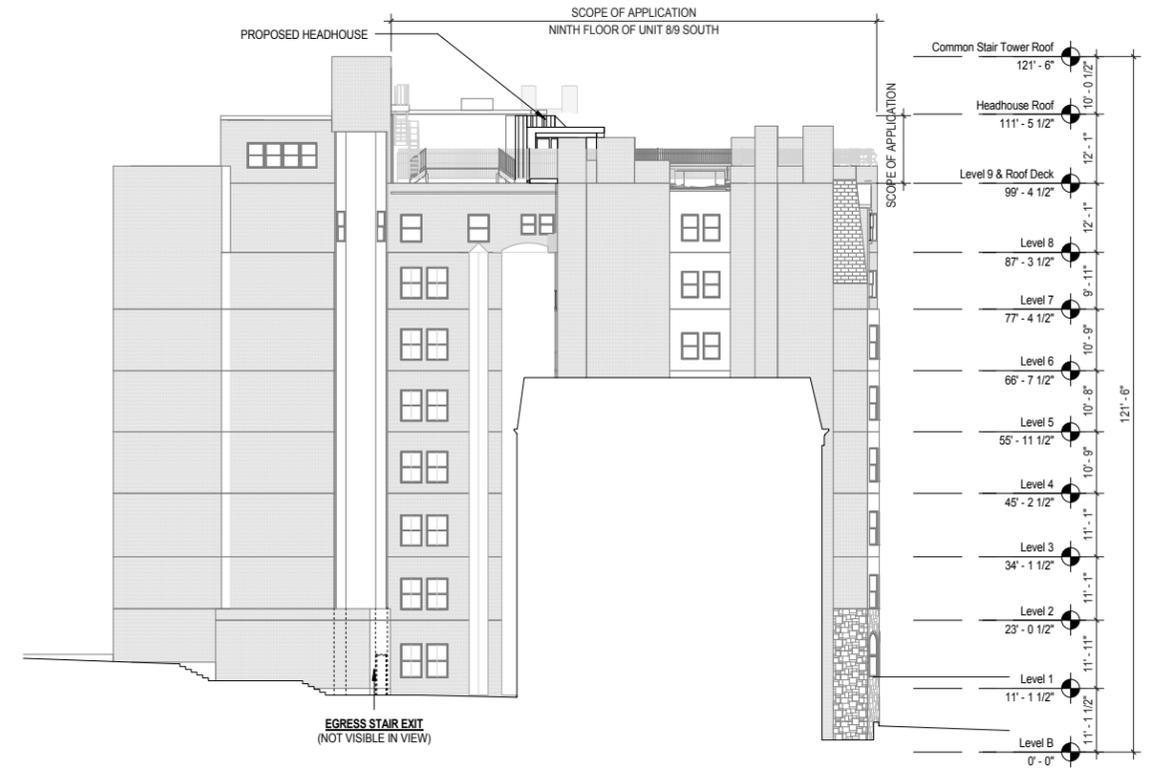
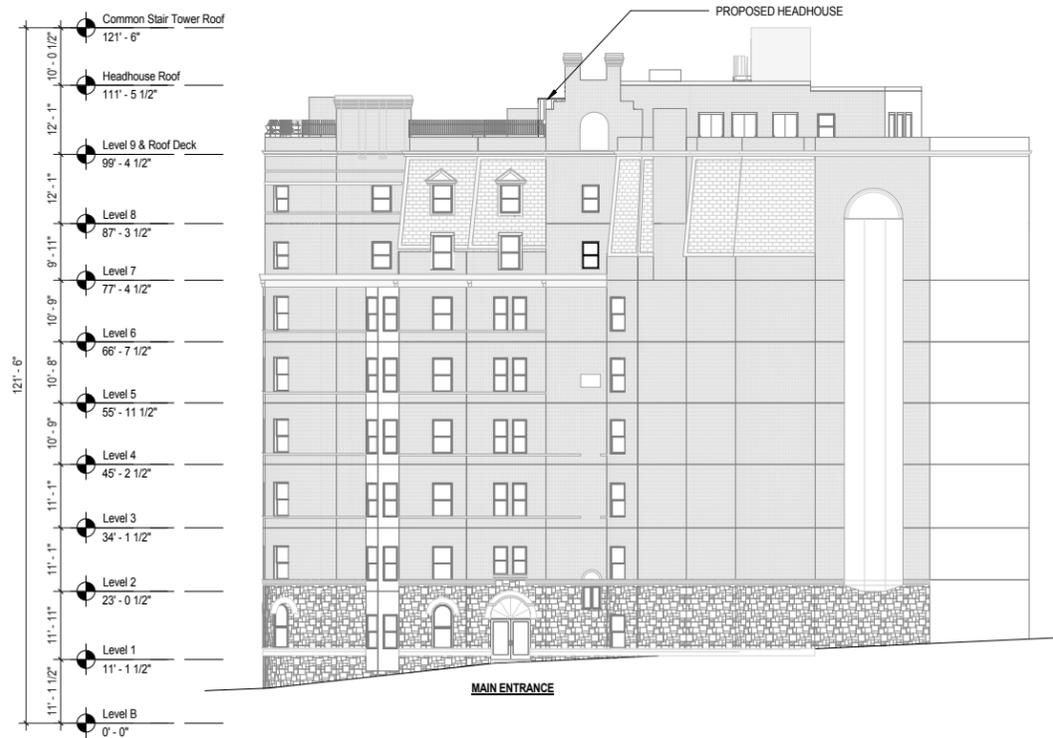
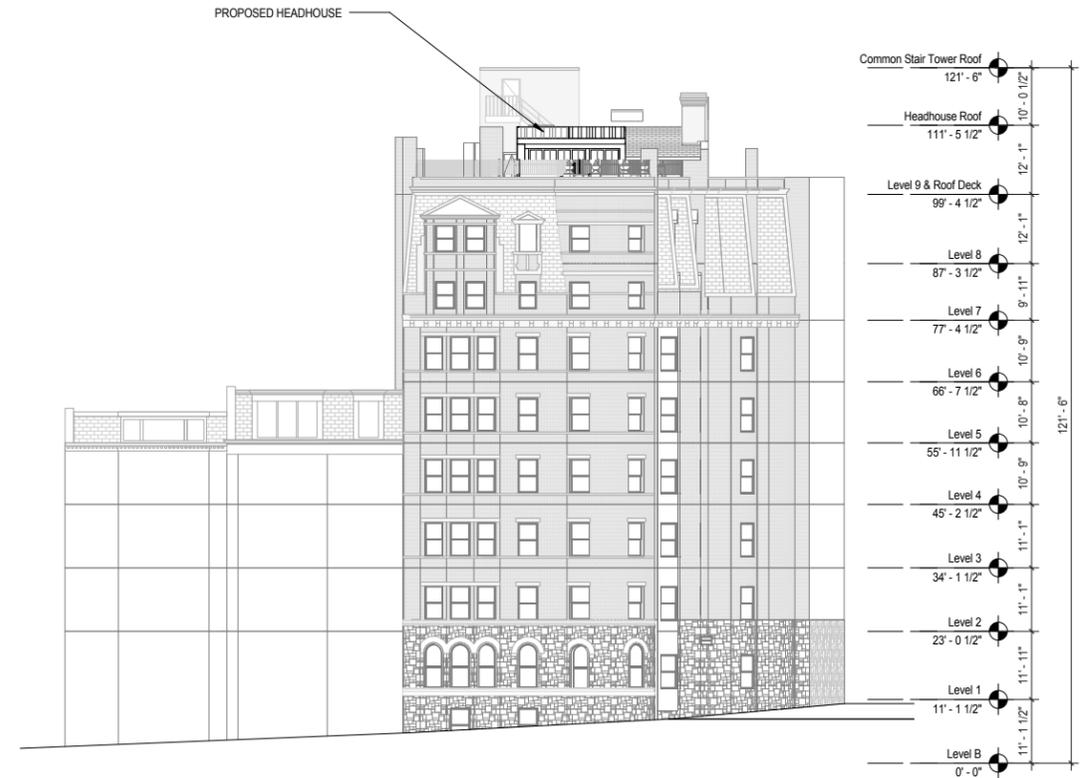
PROPOSED BUILDING ELEVATIONS
WITH HEADHOUSE EXPANSION
