# HISTORIC BURYING GROUNDS INITIATIVE NEWSLETTER

## Preserving Boston's 16 Historic Burying Grounds

BOSTON PARKS & RECREATION DEPARTMENT

SUMMER 2019

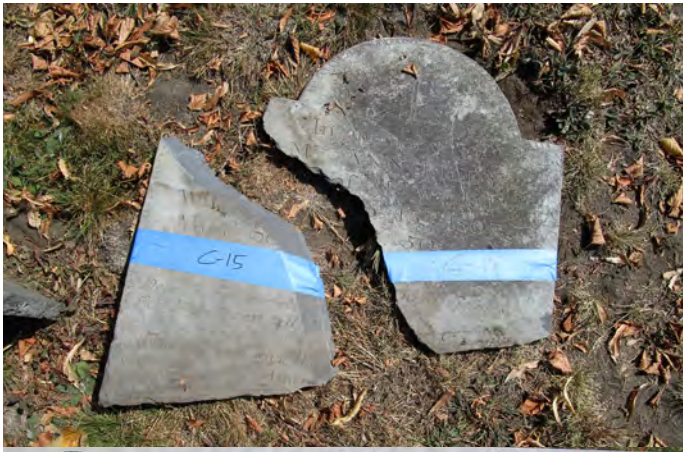
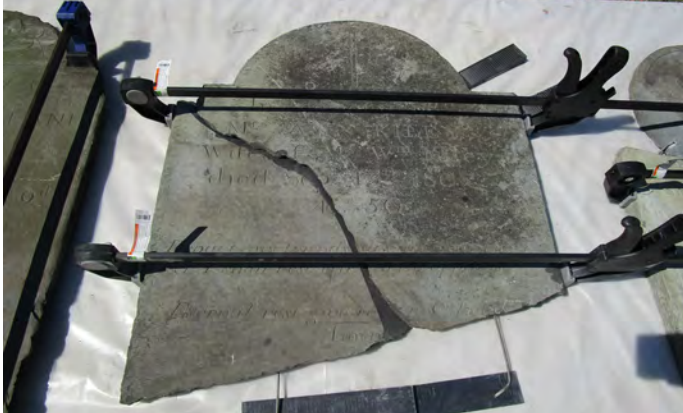
Above: The gravestone of Mrs. Ann Kiley before being conserved.  
Below: The two parts are glued together with an epoxy adhesive and clamped together while the epoxy cures.

Since the gravestones are outside and constantly exposed to damaging weather and temperature variations, gravestone conservation is not a single-event undertaking, but rather a continuous project. There are over 12,000 grave markers in Boston's historic burying grounds and a headstone which does not require the attention of a conservator during one project, can require conservation later on. The ground is always shifting and over the years upright headstones can start to tilt and can fall over and break. A particular weak point of headstones is the point where the stone enters the ground. Many headstones have broken at this point and are either lying on the ground or have been reset into the ground with the epitaph halfway covered. If a broken stone is set into the ground this way it makes it impossible to read the full epitaph. The carved portions underground also create an easier entry path for moisture to get into the stone. Gravestones

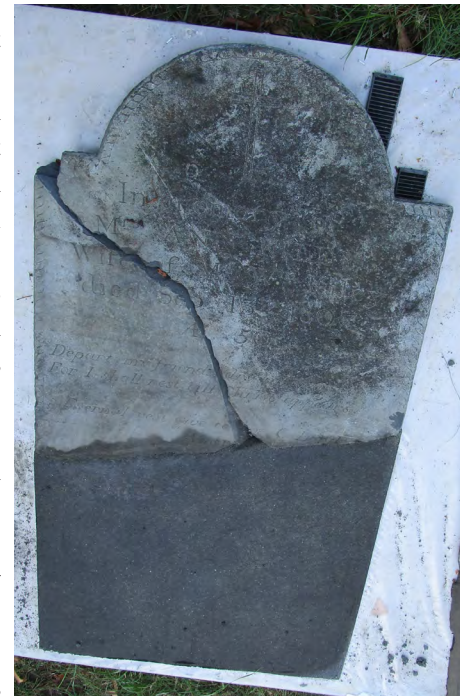
The missing bottom piece of the headstone is replaced with tinted concrete in order to reset it at the correct height in the ground.

ground, leaning against other objects, or tilting and in danger of falling down. During a walk-through of the site with a stone conservator, we identified all the headstones which met our criteria. One additional headstone whose carved face was about to fall off was also included in the project. The conservator submitted a detailed proposal for the conservation and resetting of all of the stones selected for this project. The appropriate repair for a headstone in this situation is to attach a new subterranean part

to the headstone, either of stone or concrete. If the stone is thick enough, stainless steel pins are inserted in the headstone part to attach the original headstone and the new part together. After the subterranean part has been attached, the headstone can be reset properly into the ground. Sometimes parts of the broken stone cannot be found, leaving an incomplete epitaph. We judged that it was better to keep stones with an incomplete epitaph standing up in the site, rather than to store them in the fragments collection, hoping the missing pieces will be found someday.

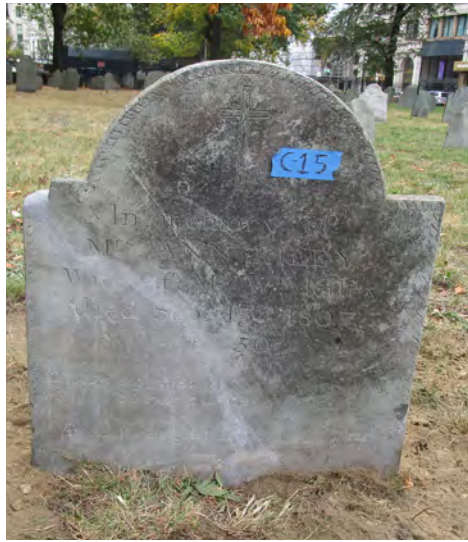
This headstone was returned to its spot in Central Burying Ground.

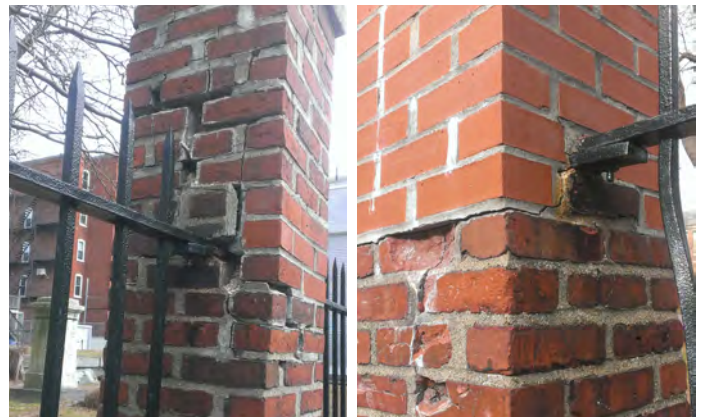
These close-up shots of two different columns illustrate some of the problems. The left column shows extensive cracking and mortar loss. The right column shows more cracking and two types of bricks.

the project. Without the original plans, we could only guess at how the tomb was built. We believed that the tombs had a rear wall integrated into the tomb structure and that a secondary brick wall was built at a later date to delineate the boundary of the site. The existence of a foundation was also unknown but it was difficult to verify due to the inaccessible location of the tombs. A narrow alley measuring only 2.5-feet-wide separated the tomb from the wall of the neighboring house. We decided to prepare construction plans based on what we be-

The scope of the work included rebuilding of the low brick wall which runs along the western side of both sites and forms the rear wall of the tombs in Hawes Burying Ground, the 12 brick columns in Union Cemetery and one in Hawes Burying Ground, repair and painting of the Union Cemetery fence, and repairs to the transverse tombs. The lack of plans for the original installation of the wall, piers, and tombs complicated this otherwise straight-forward scope of work. During the design phase we were unsure if the brick columns and wall had an underground foundation, since many old walls were built without one. Preliminary investigation indicated the wall had a foundation but the columns did not. The portion of the brick wall that runs behind the tombs in Hawes Burying Ground presented more challenges for

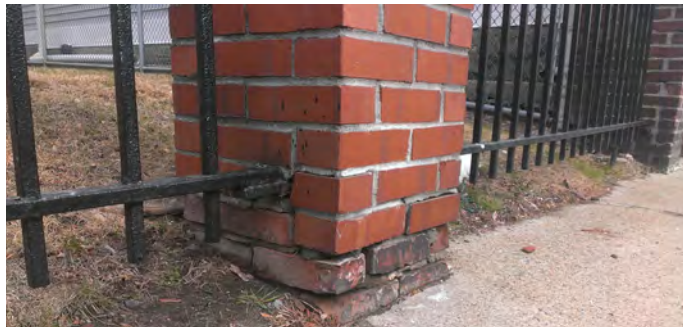
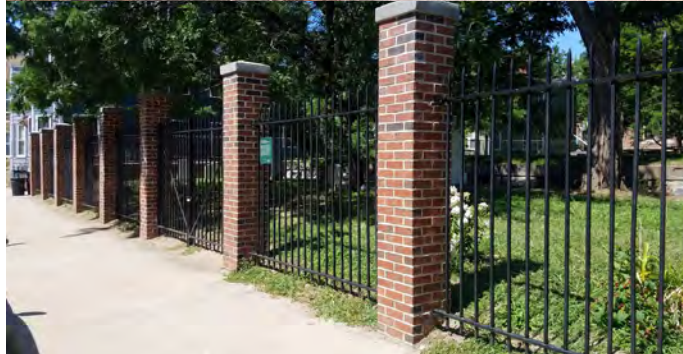
As soon as demolition started we found the answers to our questions. Both the perimeter wall (including behind the tombs) and brick piers had foundations. However the current columns were built on top of the foundations, but not keyed into them. This fact could explain why serious structural problems with the columns have occurred repeatedly over the years, and why the various repairs undertaken always proved ineffective. The contractor used the old foundations but reinforced the whole structures by drilling holes in the foundations to insert reinforcing bar. We also discovered that there

Above: Crumbling bricks at the bottom of the pier contributed to structural instability. Below: The finished product. The same brick was used for all of the piers creating a uniform look.

was not an earlier wall sealing up the back of the tombs on the west perimeter wall. Upon dismantling the brick wall we quickly realized that removing the brick wall would completely open the rear of the tomb and we adjusted our plans accordingly.

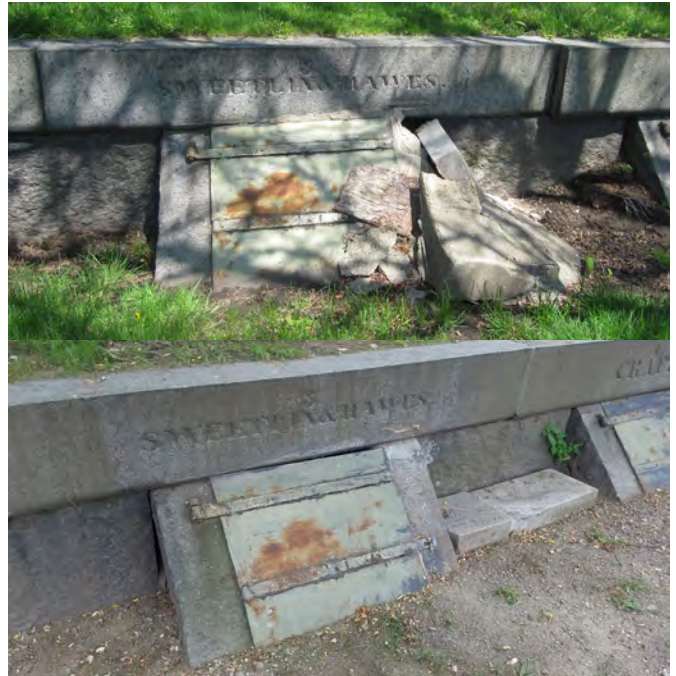
Some work also took place on the transverse tombs that form the boundary between the sites. In one tomb part of the granite entry side wall had fallen into the tombs

years ago. A makeshift repair had been performed to block the opening using available masonry elements and blobs of concrete. Recently the repair started to fall apart and the tomb was no longer securely sealed. Upon inspection, we found the side wall located inside the tomb in an intact state. Our contractor pulled the wall out of the tomb and reset it in its original location. Several of the granite copings that run the length of the tomb had shifted forward in some spots. To correct this

Before and after photos of the repair of the broken tomb doorway.

issue our contractor pinned the copings into the wall below to prevent them from shifting forward again and reset them flush along the wall.

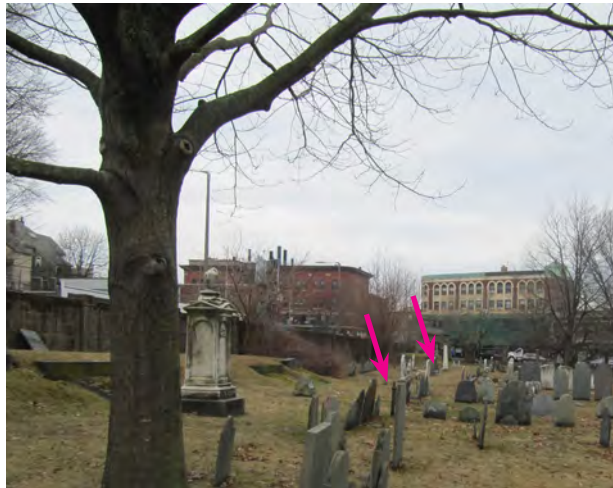
Fast forward to 2017 and there were still many trees in the burying ground but there were also a growing number of stumps and diseased or dangerous trees. A few trees fell over during storms and one tree was hit by lighting. A tree with a crack down its trunk was grow-

Two large trees used to form an allee down this pathway. One died and the other one was damaged in a storm.

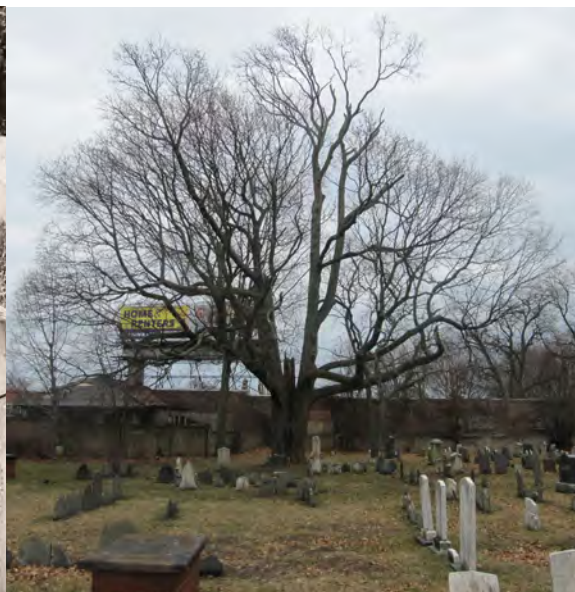
ing near Columbia Road. The biggest, most majestic tree in the burying ground, a Norway maple which was over 100 years old, was showing many signs of ill health. Previous attempts to cable the large tree limbs in order to strengthen the tree had failed. It was apparent the tree was at the end of its lifespan and could pose a danger to people visiting the burying ground. Many trees had grown up against the masonry walls that surround the site or into underground tombs, creating situations for existing or potential destruction of these structures. Vines were growing up and over the site walls, creating entry points for moisture. The signage marking the pathways was in very poor condition with all of the signs severely rusted and most of the signs broken or missing.

The same Norway maple about 110 years later. This glorious maple was witness to the entire 20th century.

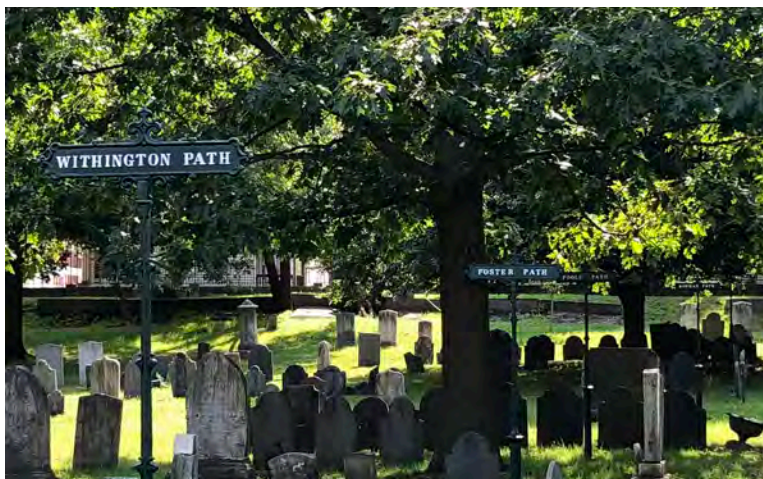
Replicated pathway signs harmonize well with the landscape

The Victorian landscape reflected these trends by selecting exotic plants, showy flowers, and interesting leaf types. The tree and shrub species selected for these improvements are those that were used during this era of garden design. They have splashy flowers and berries of white, pinks, and purples and some also add fragrance to the historic landscape. Approximately 40 trees ranging from saplings to the giant Norway maple were removed because they were dead, dangerous to visitors, deleterious to masonry structures, or invasive. Large trees were pruned to encourage safety, growth, and light. Vines were removed from the walls. All of this removal made room for the planting of 28 trees and 126 shrubs. The types of trees planted are: horse chestnut, red horse chestnut, apple serviceberry, cornelian cherry, redbud, tuliptree, Japanese pagoda tree, American elm, and Japanese cedar. The types of shrubs planted are: beautyberry, gray dogwood, slender deutzia, and lilac. A cloud of fragrant lilacs will perfume the main entry gate in spring. New pathway signs were also cast to replace the old broken ones.
