GARCELON'S PARK STABLES

NEIGHBORHOOD CONTEXT

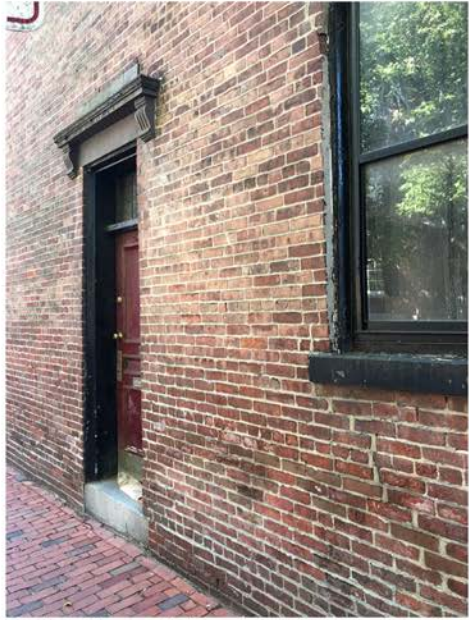
180712-IMG_8802.jpg

*Historic Primary Entrance at 57 Brimmer Street;
Tall 12" High Granite Stoop Up from Sidewalk*

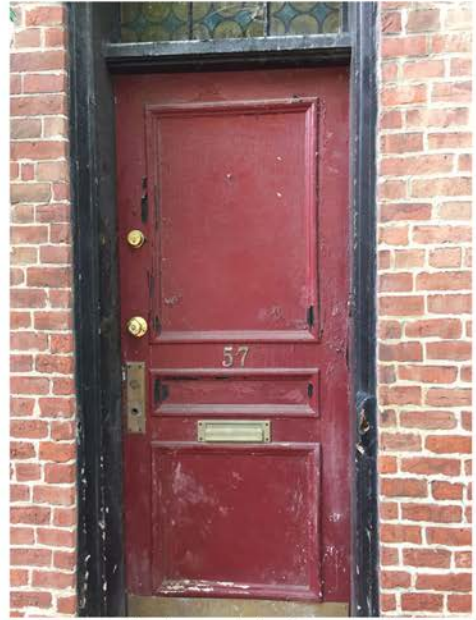
170608-IMG_6535.JPG

*Contemporary Hardware to be Removed; Door to be
Patched, Painted & Fixed in Place; Will not be
Used as an Entrance or Exit for the School*

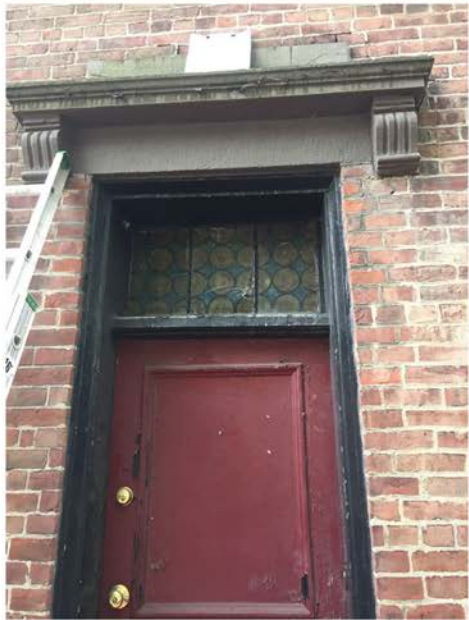
170608-IMG_6536.JPG

*Hooded Stone Lintel and Glass Transom Panel;
Door & Transom Frames to be Retained & Painted*

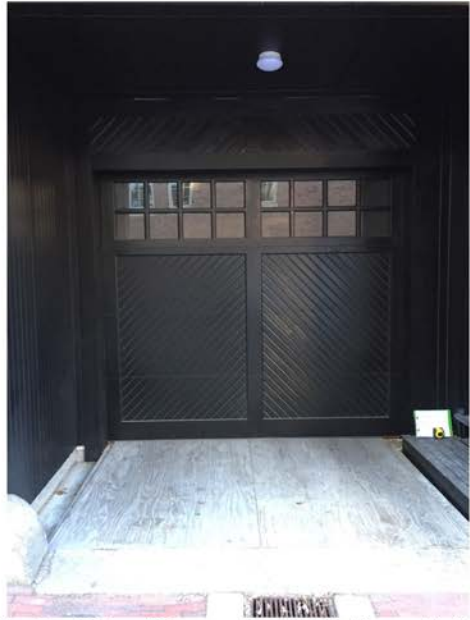
161209_IMG_5752.jpg

*Chestnut Street Garage Door with Upper Lights;
Plywood Floor Infill to be Removed for Brick Pavers;
No Other Changes to Door & Surround*

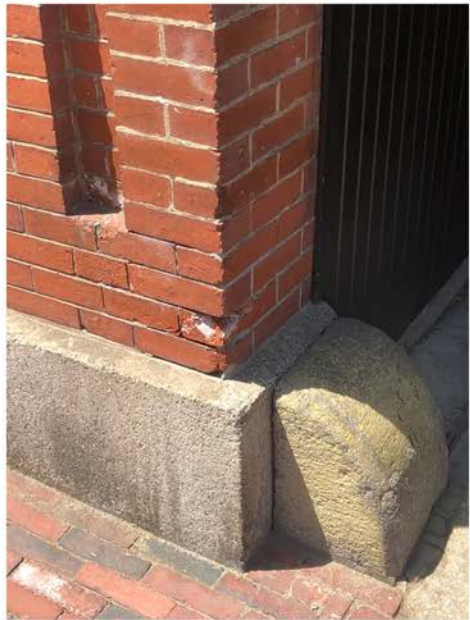
180526-IMG_8548.jpg

Chipped Brick at Chestnut Street Portico Opening; Granite Plinth and Wheel Guard

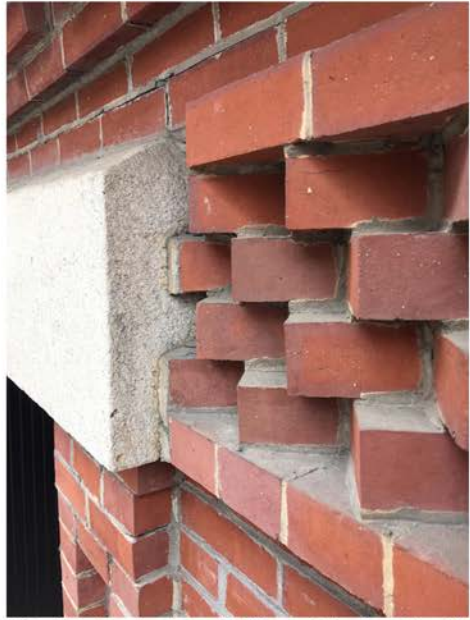
170608-IMG_6591.JPG

Rotated Bricks in Band Adjacent to Granite Lintel

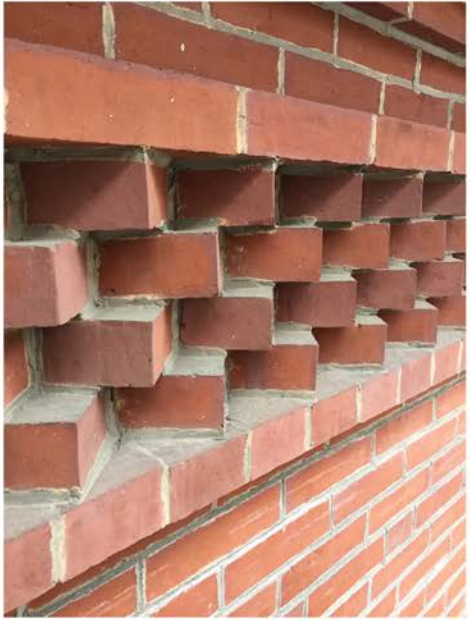
170608-IMG_6592.JPG

Rotated Brick Banding on Chestnut Street Facade

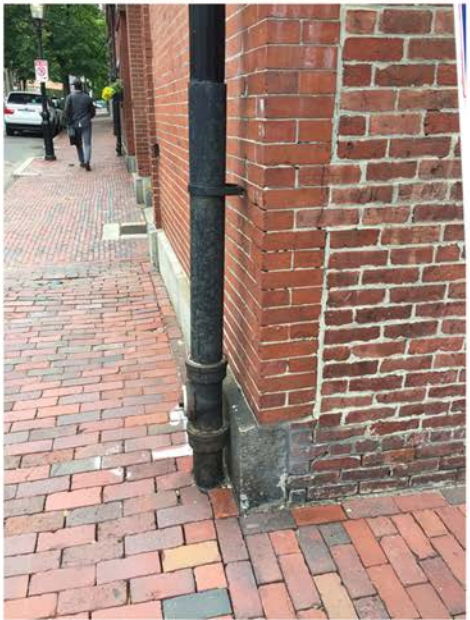
170608-IMG_6574.JPG

Southeast Corner at Brimmer & Chestnut Street; Front Facade Bricks Differs from Side Facade Bricks

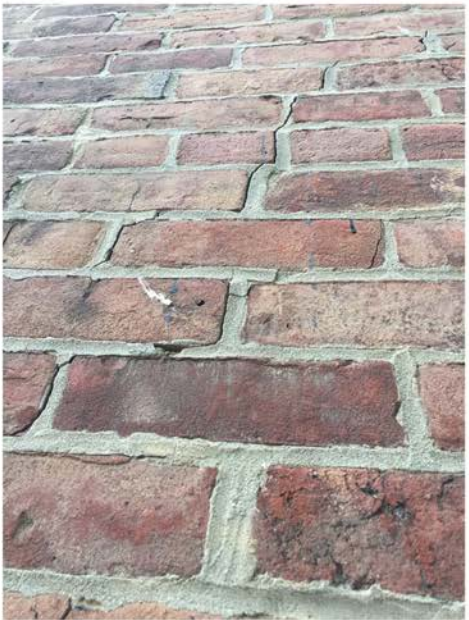
170608-IMG_6544.JPG

*Detail of Brimmer Street Brickwork Showing
Former Inappropriate "Scrub Coat" Repointing*

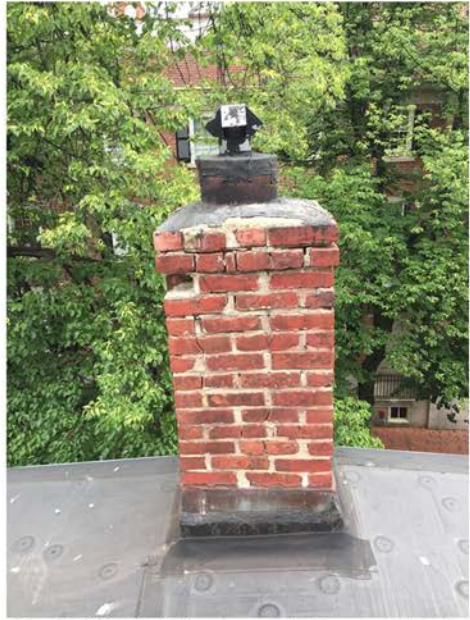
170608-IMG_6582.JPG

*Central Main Chimney on Brimmer Street;
Dryer Vent to be Removed & Clay Chimney Pot to be
Installed in its Place; Upper Portion to be Rebuilt*

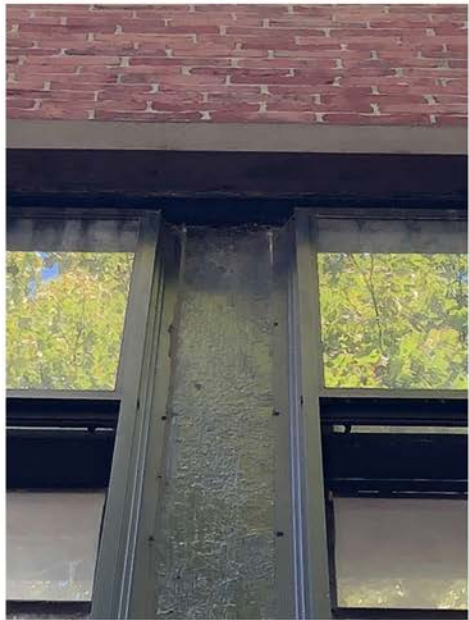
180712-IMG_8798.jpg

Brownstone Lintel, Wood Mullion and Exterior Storm Window at Second Floor 6-over-6 Sash

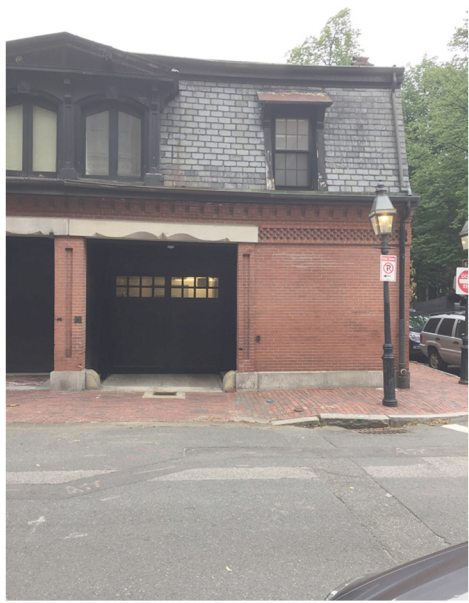
170608-IMG_6594.JPG

South Facade at Chestnut Street with Mansard Roof Above Brick Street Level Facade & Garage Portico; In-Kind Repair and Restoration Intended for Facade

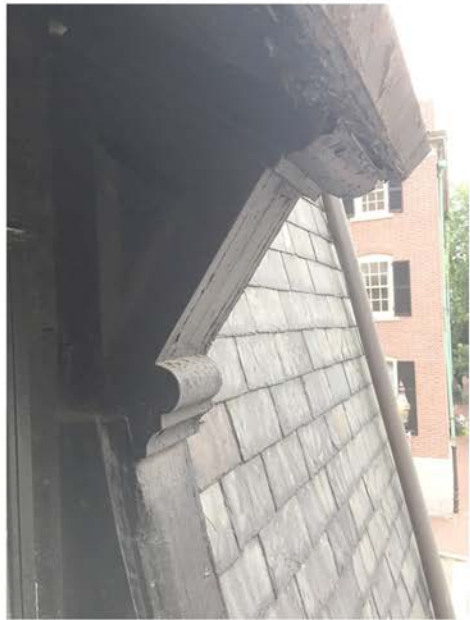
170608-IMG_6597.JPG

Bracket at Shed Dormer Roof with Slates Beyond

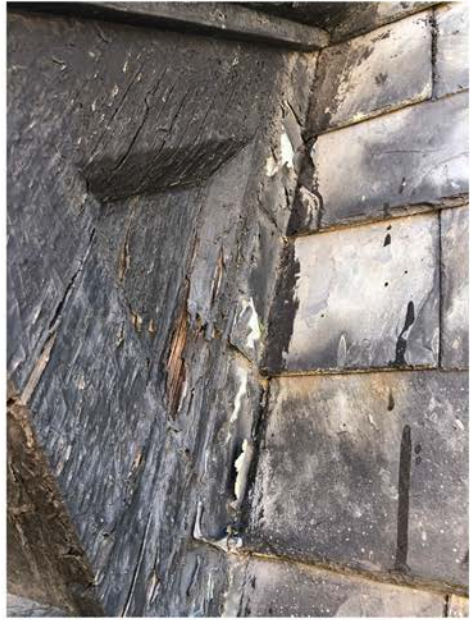
180712-IMG_8843.jpg

Side of Bracket at Shed Dormer with Roofing Cement to Slated Mansard; Wood to be Restored and Copper Step Flashing to be Provided to Dormer Woodwork

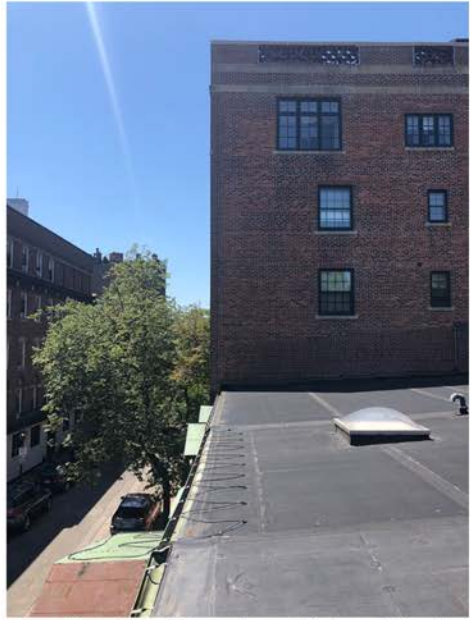
180718-IMG_8948.jpg

*Looking West From Front Edge of Roof;
Three Adjacent Properties with Same Roof Slope
with Five-Story Brick Building Beyond*

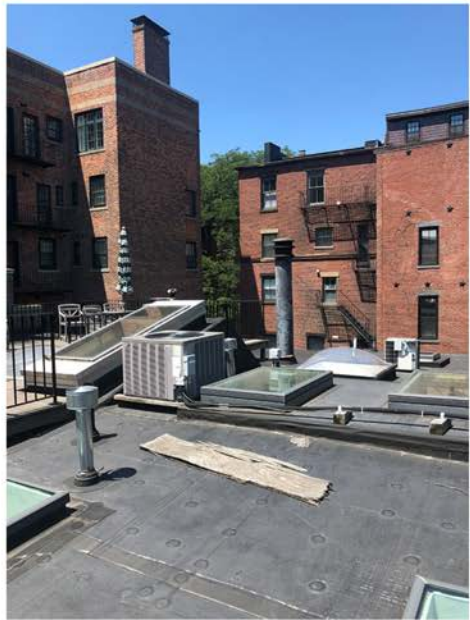
180718-IMG_8959.jpg

*57 Brimmer Street Air-Cooled Condensing Unit;
Skylight Hatch & Flue Beyond on Adjacent Property;
Five Story Brick Buildings Beyond*

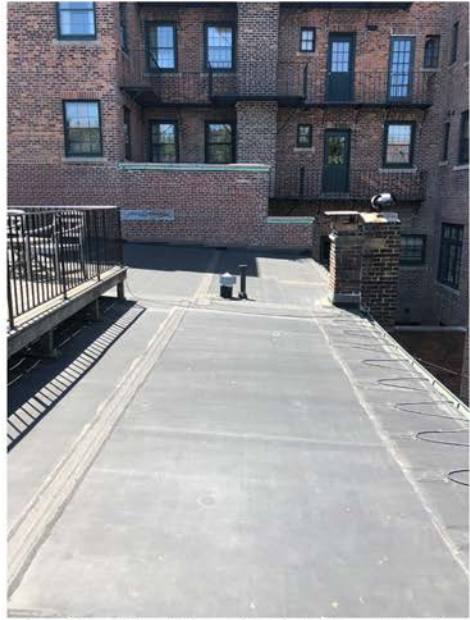
180718-IMG_8986.jpg

*Looking West From Back Edge of Roof;
Three Adjacent Properties with Same Roof Slope
with Five-Story Brick Building Beyond*

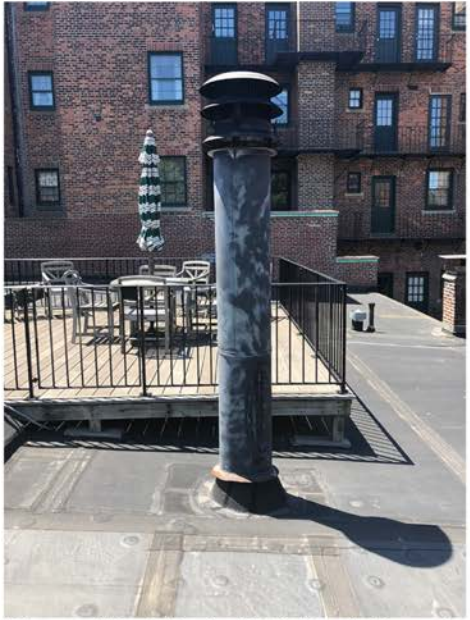
180718-IMG_8955.jpg

Flue and Roof Deck at Neighbor's Property

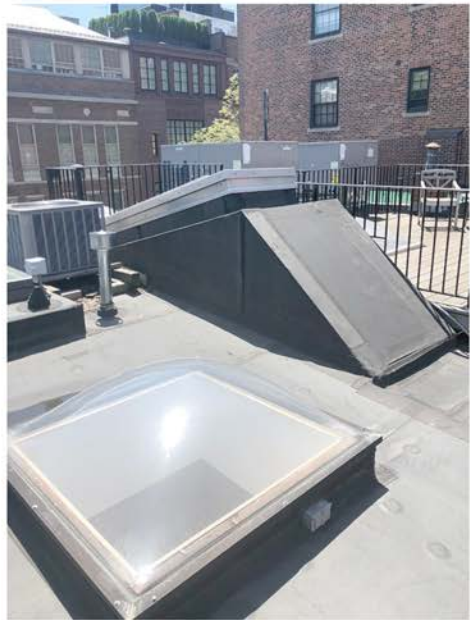
180718-IMG_8954.jpg

*Skylight in Foreground and ACCU at Left on
57 Brimmer Street Building; Raised Hatch, Roof Deck &
Air Handlers Beyond on Adjacent Building*

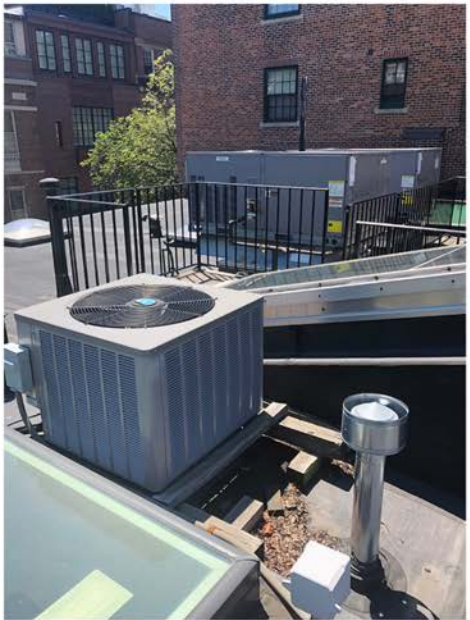
180718-IMG_8956.jpg

*ACCU for 57 Brimmer Street;
Air Handlers Beyond on Adjacent Building*

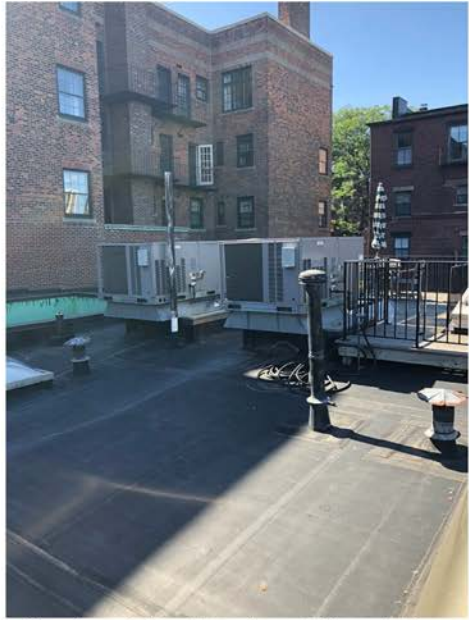
180712-IMG_8809.jpg

Air Handlers & Roof Deck on Adjacent Property

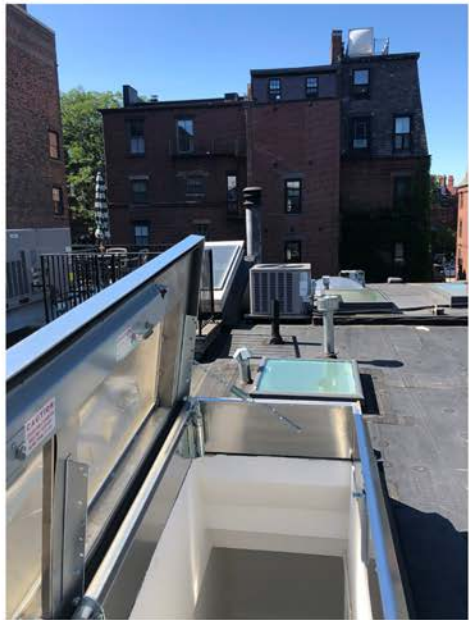
180712-IMG_8811.jpg

Skylight Roof Hatch at 57 Brimmer Street; Six-Story Building Beyond on Otis Street

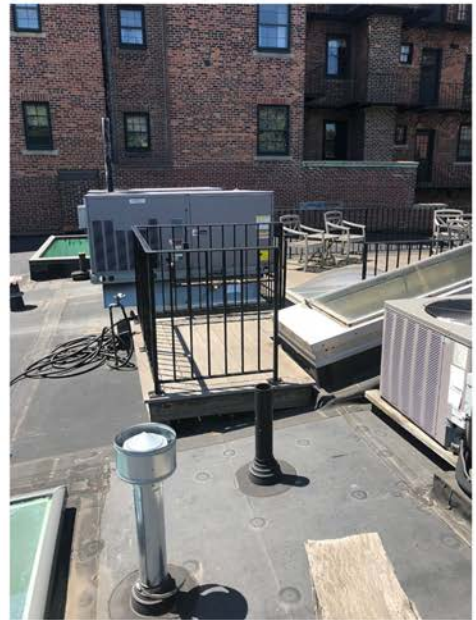
180718-IMG_8957.jpg

Roof Deck and Air Handlers at Adjacent Building; Brick Building Beyond on Chestnut Street
