*Aerial View of 55-57 Brimmer at
Northwest Corner of Brimmer and Chestnut Streets*

NEIGHBORHOOD CONTEXT

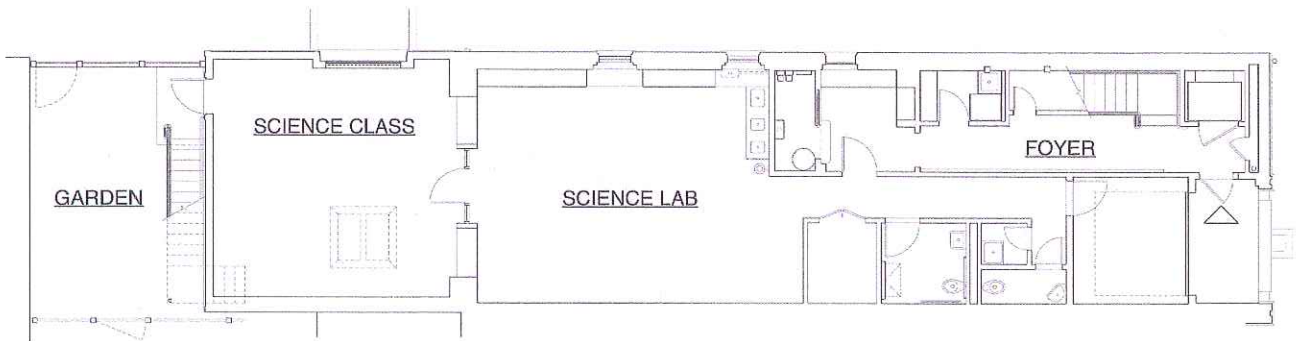
*EXISTING FIRST FLOOR (Chestnut Street at Right; Brimmer Street Above);
Chestnut Street Garage Portico and Interior Has Repaired Pile Foundations & Recently Constructed Wood-Framed Foyer;
Rear Garage Deteriorated with Cracked Slab, Sonotube Piers and Pressure-Treated Sills at Grade*

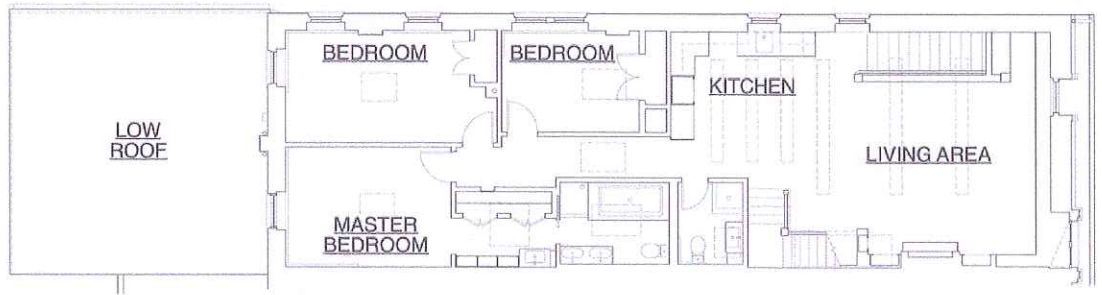
*PROPOSED FIRST FLOOR (Chestnut Street at Right; Brimmer Street Above);
Exterior Portico Unchanged at Chestnut Street with Exception of Passage Door Lowered for Outswing Accessible Entry;
Rear Garage Reconstructed for Pile Foundations, Rated Party Wall and Egress into Rear Yard Thru Former Door*

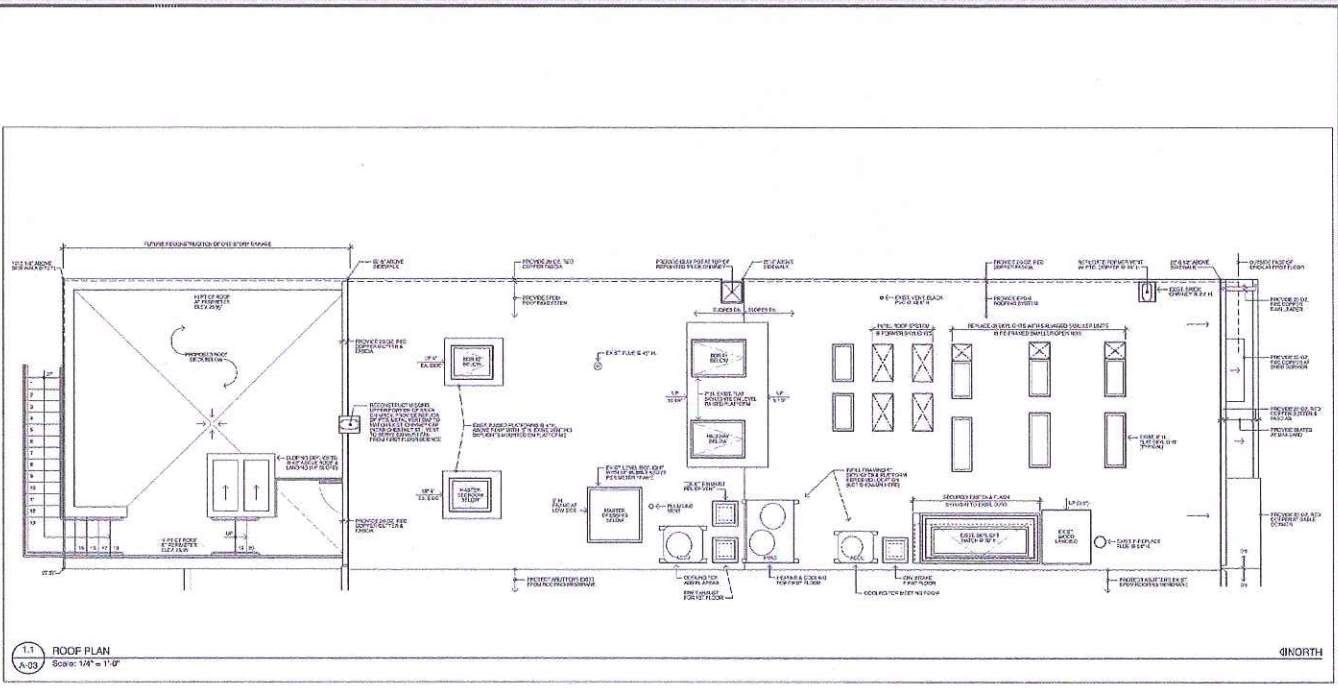
**EXISTING ROOF PLAN (Chestnut Street at Right; Brimmer Street Above);
 Most Skylights to Remain; Roof Hatch to Remain; ACCUs to be Replaced;
 Rear Garage to be Demolished for Reconstruction**

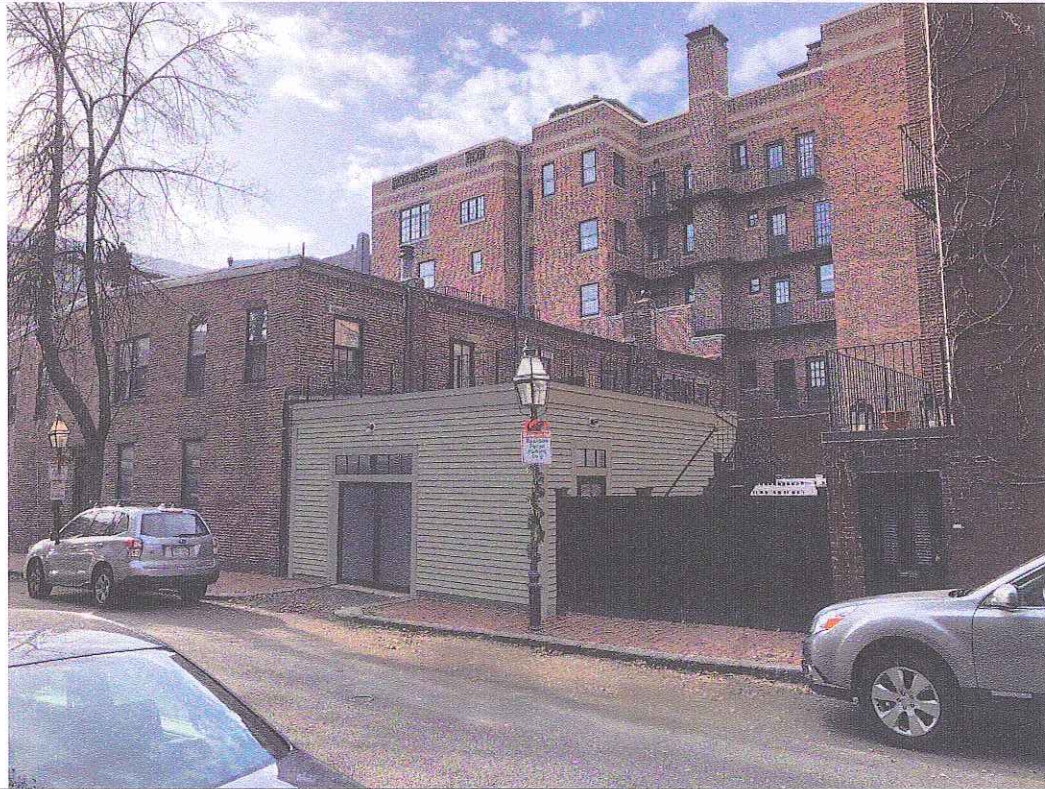
Photograph of Existing Conditions at Rear One-Story Structure

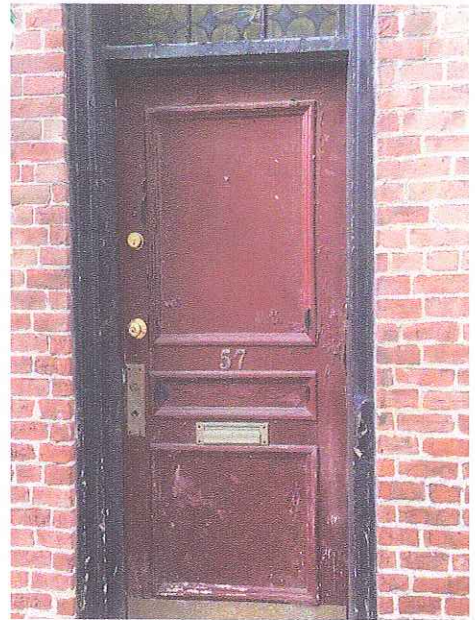
170608-IMG_6535.JPG

*Contemporary Hardware to be Removed; Door to be
Patched, Painted & Fixed in Place; Will not be
Used as an Entrance or Exit for the School*

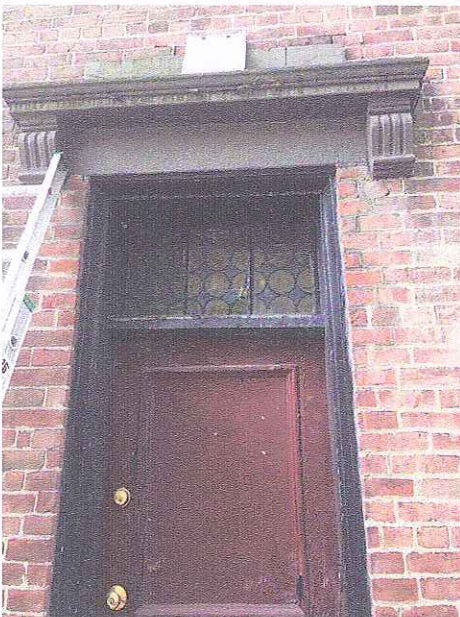
170608-IMG_6536.JPG

*Hooded Stone Lintel and Glass Transom Panel;
Door & Transom Frames to be Retained & Painted*

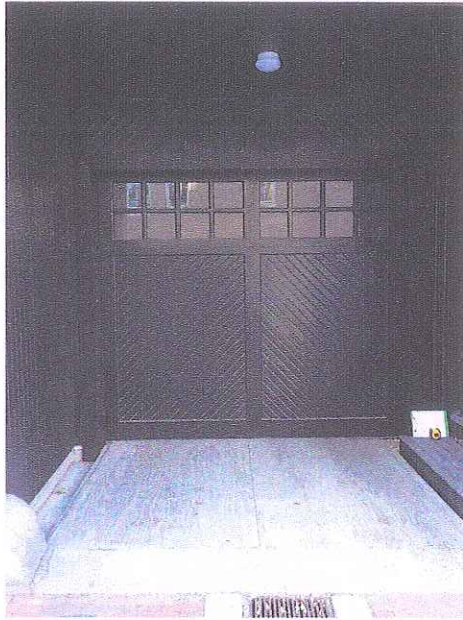
161209_IMG_5752.jpg

*Chestnut Street Garage Door with Upper Lights;
Plywood Floor Infill to be Removed for Brick Pavers;
No Other Changes to Door & Surround*

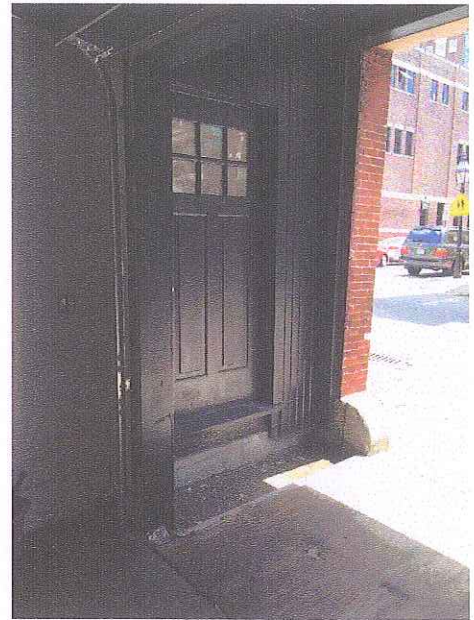
150522_IMG_2516.jpg

*Entrance Door at Garage Portico on Chestnut Street;
Door Threshold to be Lowered to Grade to Serve as
Accessible Entrance with Existing Door for Out-Swing*

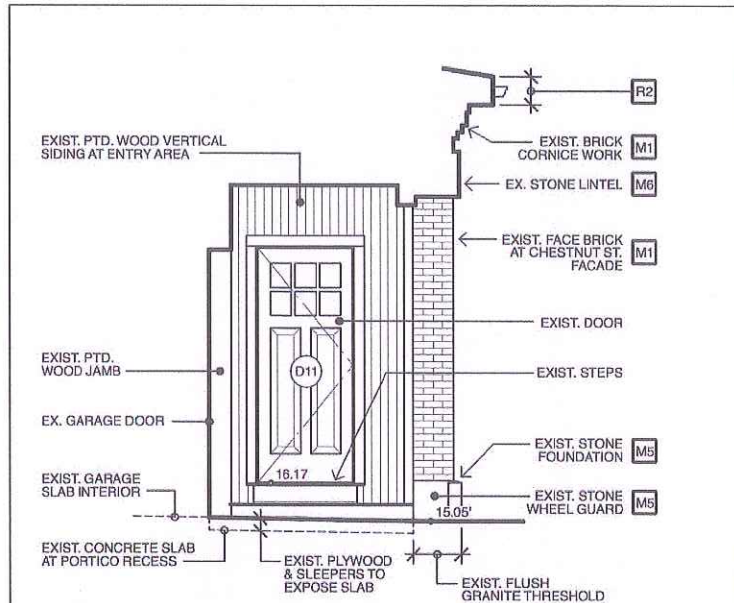
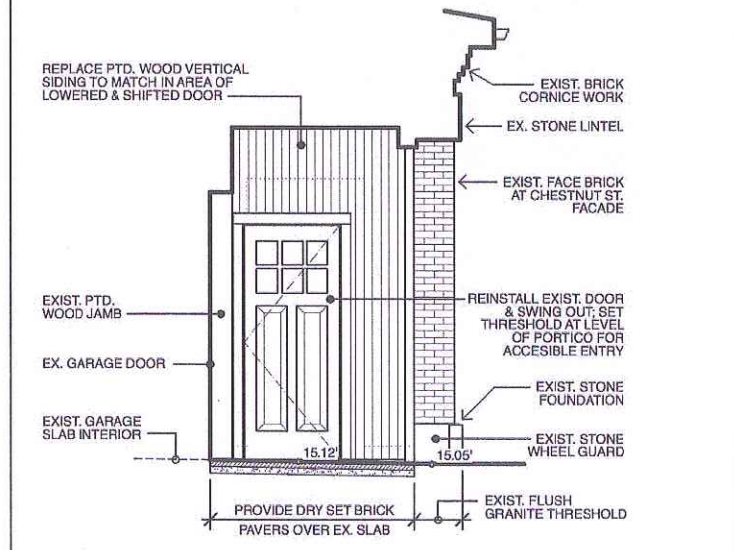
Existing and Proposed Elevations of Chestnut Street Entrance Door to be Reconfigured for Provision of an Accessible Entrance

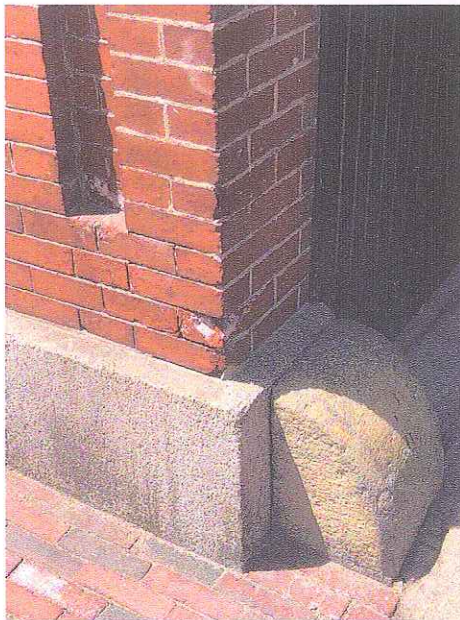
180526-IMG_8548.jpg

*Chipped Brick at Chestnut Street Portico Opening;
Granite Plinth and Wheel Guard*

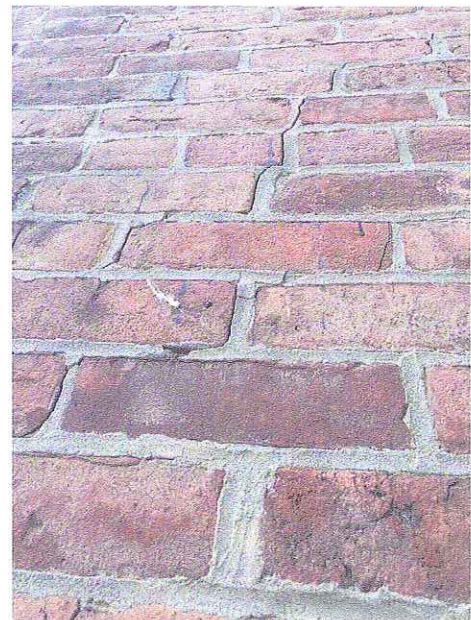
170608-IMG_6544.JPG

*Detail of Brimmer Street Brickwork Showing
Former Inappropriate "Scrub Coat" Repointing*

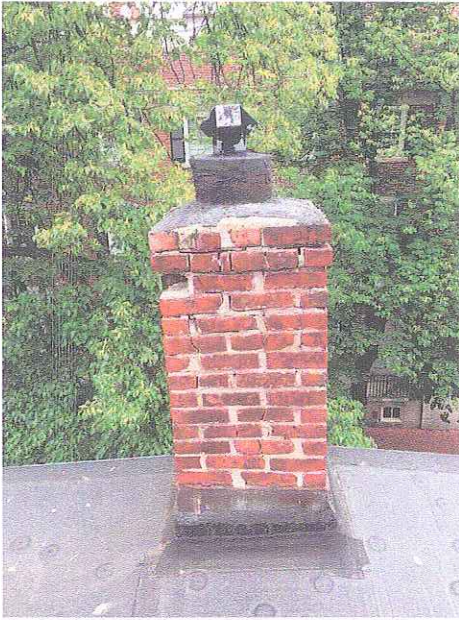
170608-IMG_6582.JPG

*Central Main Chimney on Brimmer Street;
Dryer Vent to be Removed & Clay Chimney Pot to be
Installed in its Place; Upper Portion to be Rebuilt*

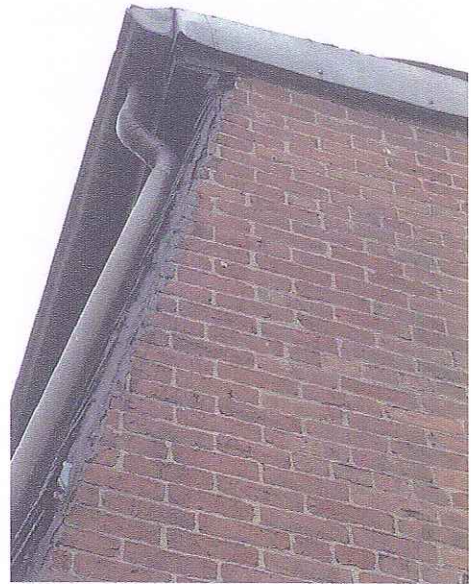
170608-IMG_6576.JPG

Southeast Corner Showing Transition from Mansard Roof Slope to Adjacent Brick; Roofing Cement to be Removed and Copper Flashing to be Installed

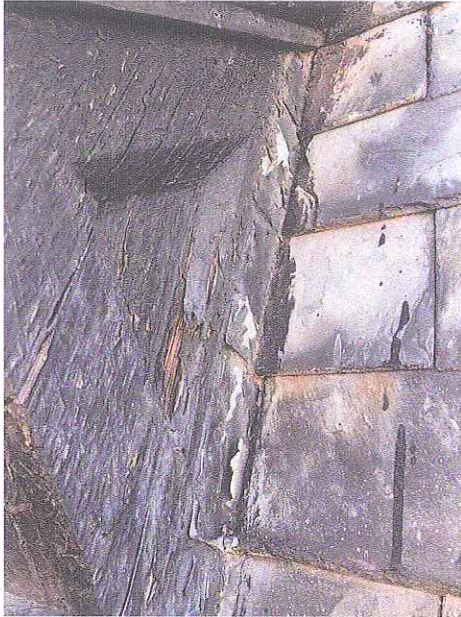
180712-IMG_8843.jpg

Side of Bracket at Shed Dormer with Roofing Cement to Slated Mansard; Wood to be Restored and Copper Step Flashing to be Provided to Dormer Woodwork
