Pier 4 Charlestown Navy Yard Culvert and Sinkhole Repairs Boston, Massachusetts

Re: **Notice of Intent**
Boston Planning & Development Agency
Pier 4 Culvert and Sinkhole Repairs
Charlestown Navy Yard
Boston, MA
(Pare Project No. 18228.00)

Re: **Charlestown Navy Yard Pier 4 Sinkhole Repairs
Investigation Findings Report
Boston, MA**
(Pare Project No.: 18228.00)

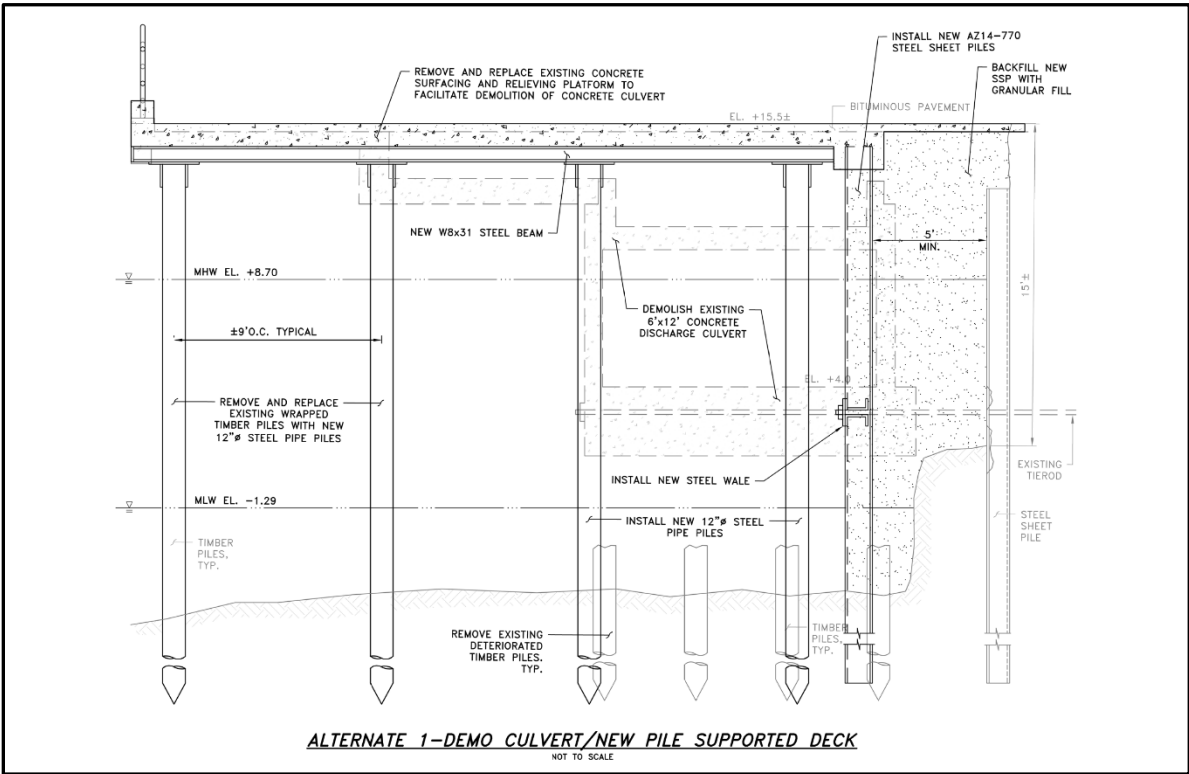
Alternative 1 Demolish Culvert and New Pile Supported Deck

The demolition option includes full removal of the existing structure, and would likely require partial demolition of the concrete slabs which are partly supported by the culvert. The installation of another support system, such as piles and beams, would be required to support the topside infrastructure. Temporary earth supports would likely be required in order to remove the steel sheet piles which extend through the culvert and a new steel wale would need to be installed for the tie rods which were cast into the base of the culvert. This option would still require the patching and filling of areas of subsidence in the new deteriorated bulkhead. The existing concrete culvert is integral to the surrounding infrastructure such as steel sheet pile walls, a concrete relieving platform, a granite block wall, and concrete abutments. Some components of the waterfront infrastructure, including the steel sheet pile walls which provide support for the earth-filled portion of the pier, were observed to be at the end of their useful service life with holes noted throughout. Demolition of the culvert may likely impact the integrity of the surrounding area. This condition, in conjunction with the estimated project cost of between \$2,030,000 and \$3,290,000 makes this alternative infeasible.

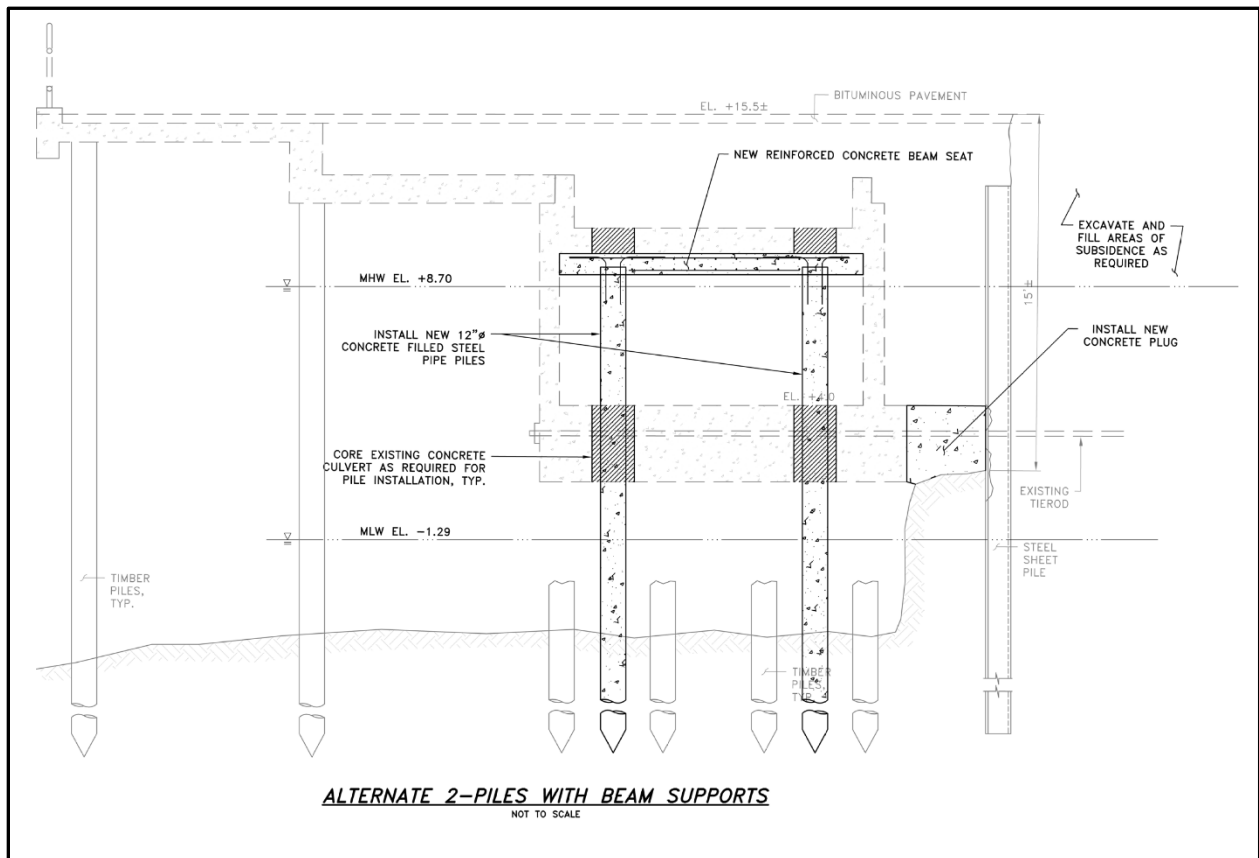
Alternative 2 Piles with Beam Supports

This option considered the installation of new piles and beams to support the existing concrete culvert in the long-term. Due to the existing stone, brick, concrete, and gravel plug located between the east side of the concrete culvert and the steel sheet pile bulkhead, piles would not be drilled in this area and would need to be driven through the concrete culvert. Installation of piles would require partial excavation of fill above the concrete culvert, and sawcutting of the existing concrete culvert and/or concrete slabs. It is anticipated that steel pipe piles could be driven with new concrete beams attached to the existing concrete culvert to hold the structure in place. This option would still require the patching and filling of areas of subsidence in the deteriorated bulkhead. In addition, a new concrete plug would be poured between the existing culvert and steel sheetpile bulkhead along the length of the structure to prevent additional loss of fill through the existing stone, brick, concrete, and gravel plug which has settled. This option has workplace safety concerns, and does not address other deteriorated infrastructure connected to the culvert, such as the steel sheet pile walls which were observed to be at the end of their useful service life. This option also considers the use of steel piles which have a shorter service life in the marine environment than concrete, therefore this option is not recommended.

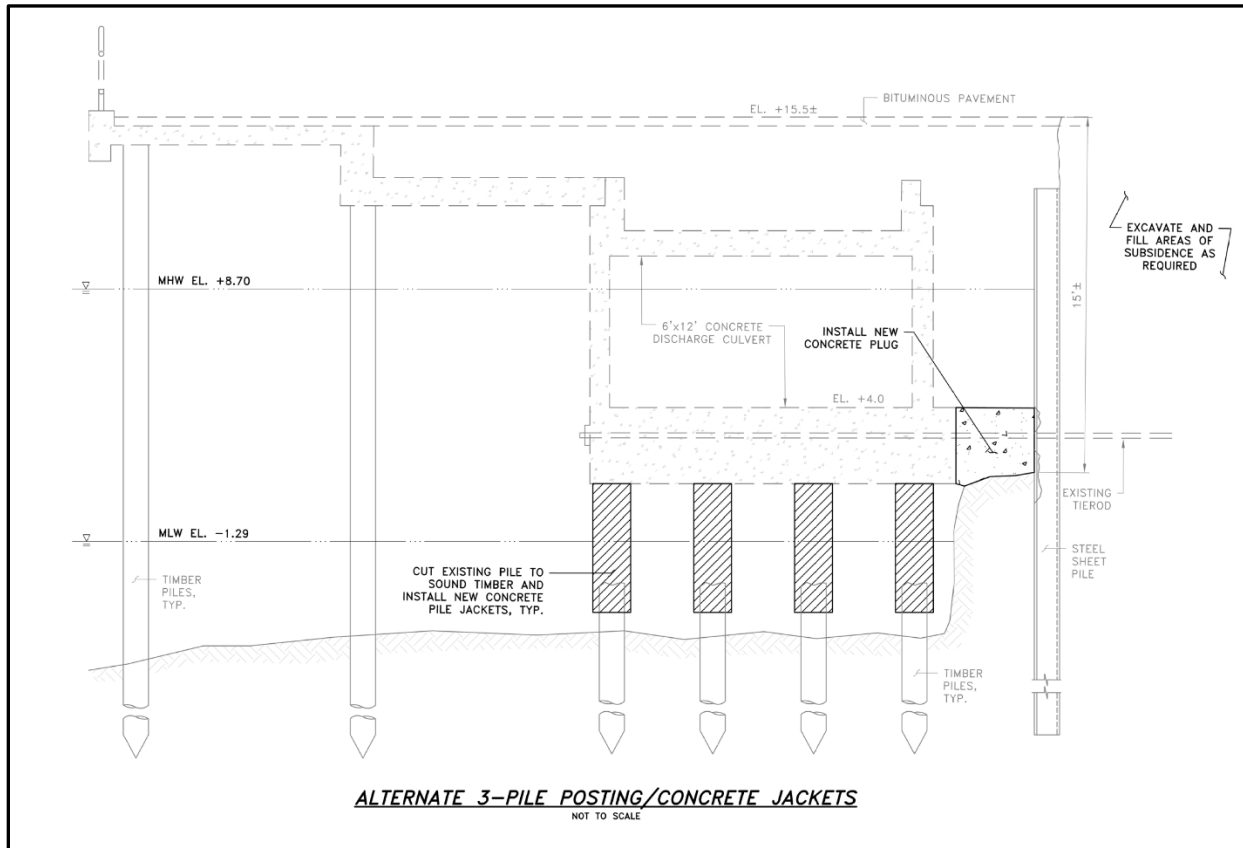
Alternative 3 Pile Posting/Concrete Jackets

This option considers the installation of fiberglass pile jackets on top of the existing deteriorated timber piles to support the concrete culvert. The pile jackets would be filled with reinforced concrete and extend below the mudline to sound timber. Due to the lack of intact timber piles that currently support the culvert and the amount of work that would be required beneath the structure, this option is not recommended because of safety concerns. In addition, the estimated cost of between \$2,528,000 and \$3,830,000 made this alternative infeasible.

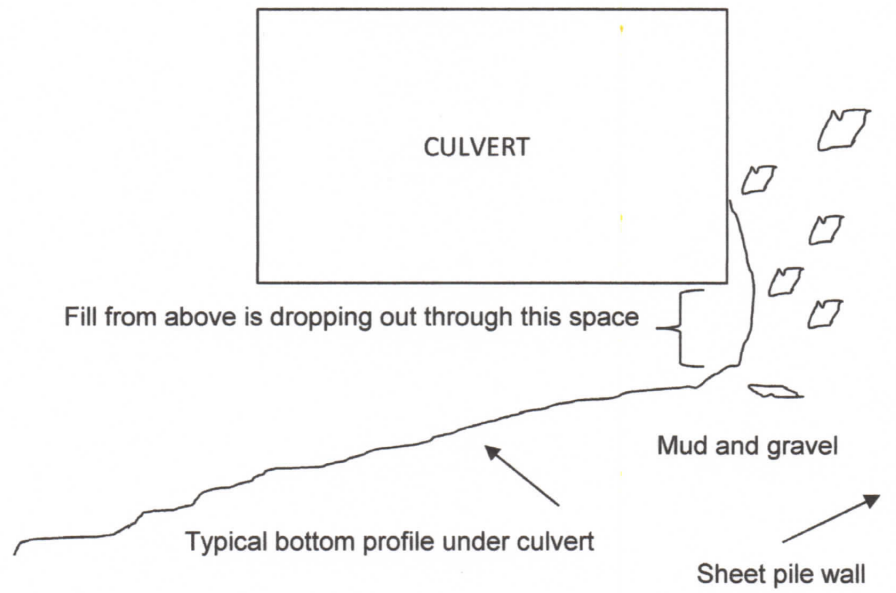
BOSTON NAVY YARD
X SECTION THROUGH DISCHARGE CULVERT
IN THE AREA OF FILL LOSS

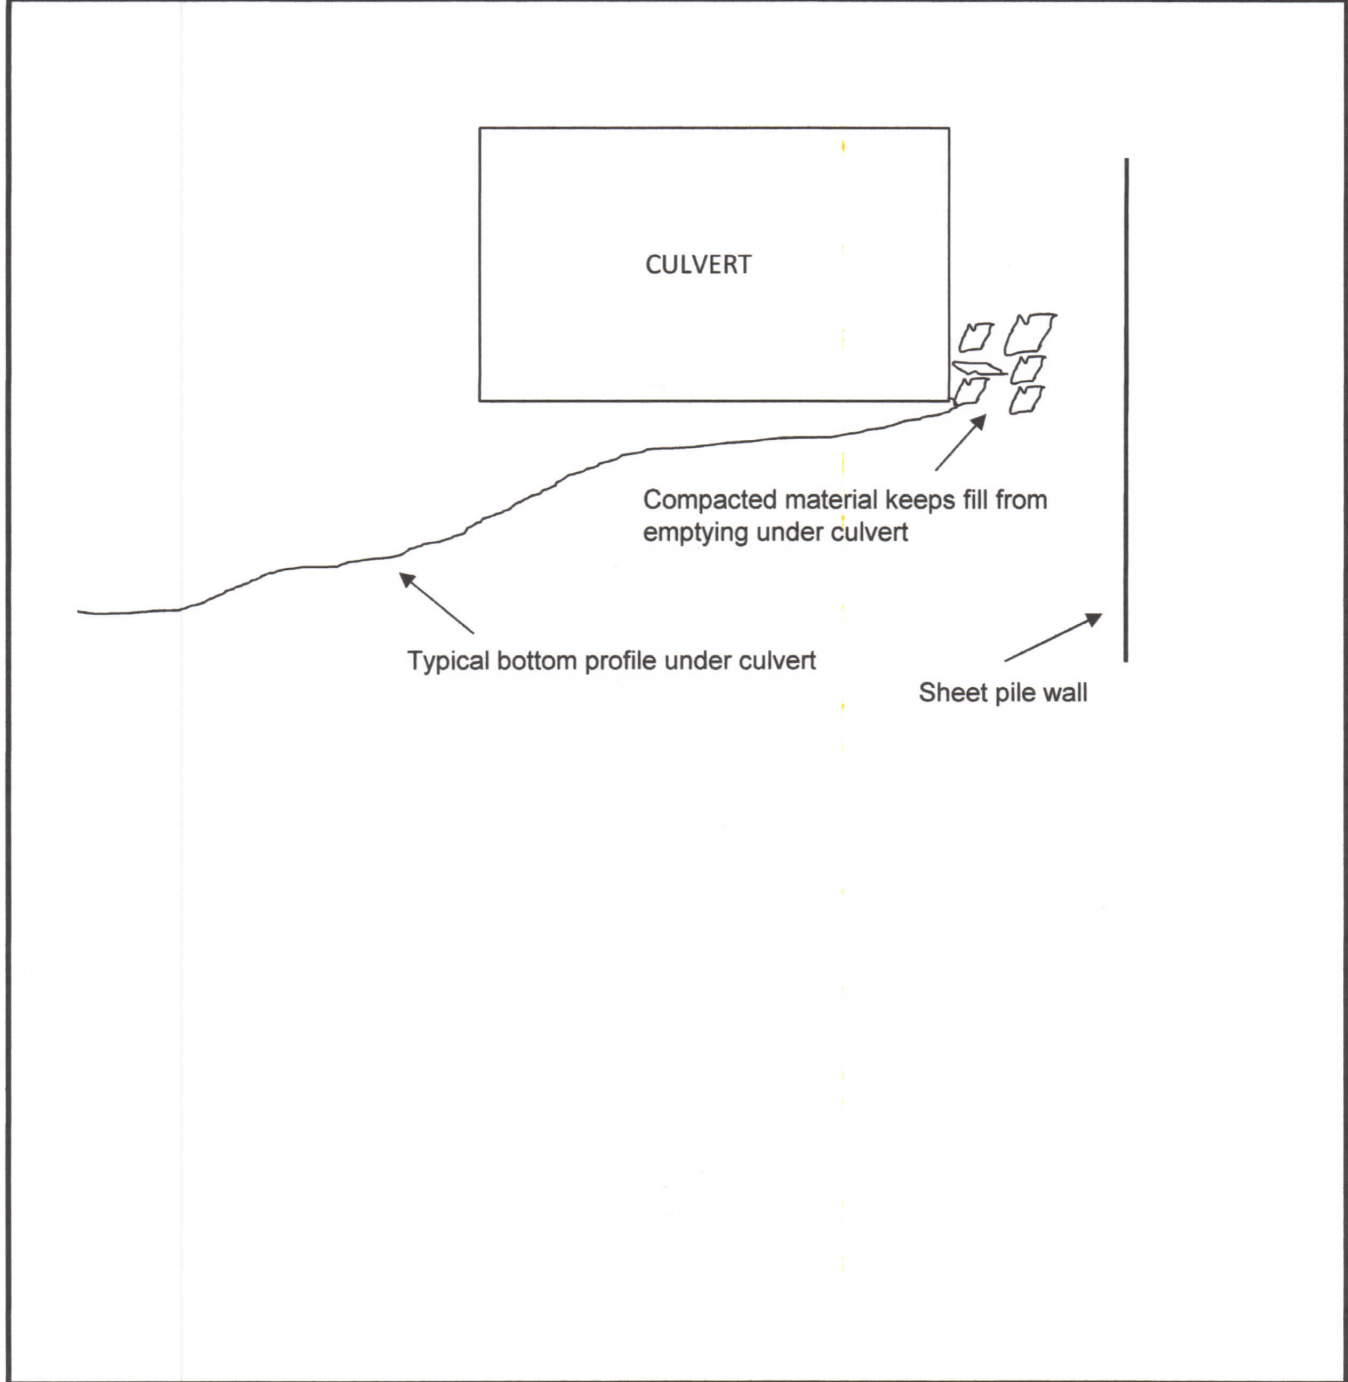
BOSTON NAVY YARD
X SECTION THROUGH DISCHARGE CULVERT
JUST NORTH OF AREA WITH FILL LOSS

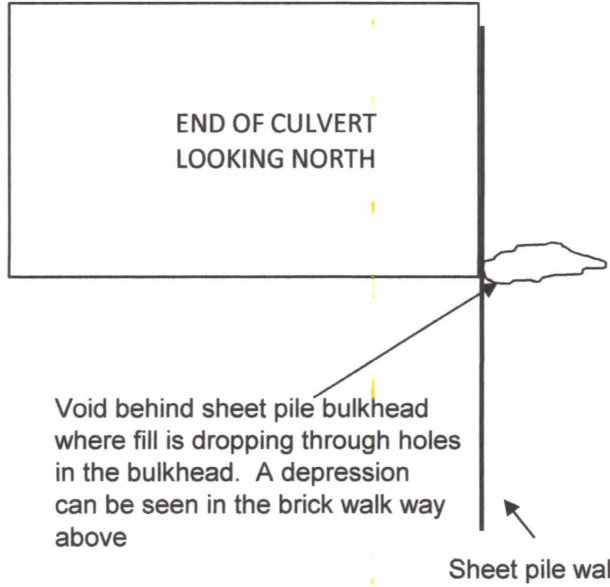
BOSTON NAVY YARD
X SECTION THROUGH END OF DISCHARGE CULVERT
JUST NORTH OF SHEET PILE BULKHEAD
ACROSS END OF CULVERT
NOT TO SCALE
