32-34 Hancock Street Condominiums

PART III - Appendix B: Supplemental Information for
Boston Landmarks Commission / Beacon Hill
Architectural Commission
Application for Certification of Appropriateness

23 FEBRUARY 2017

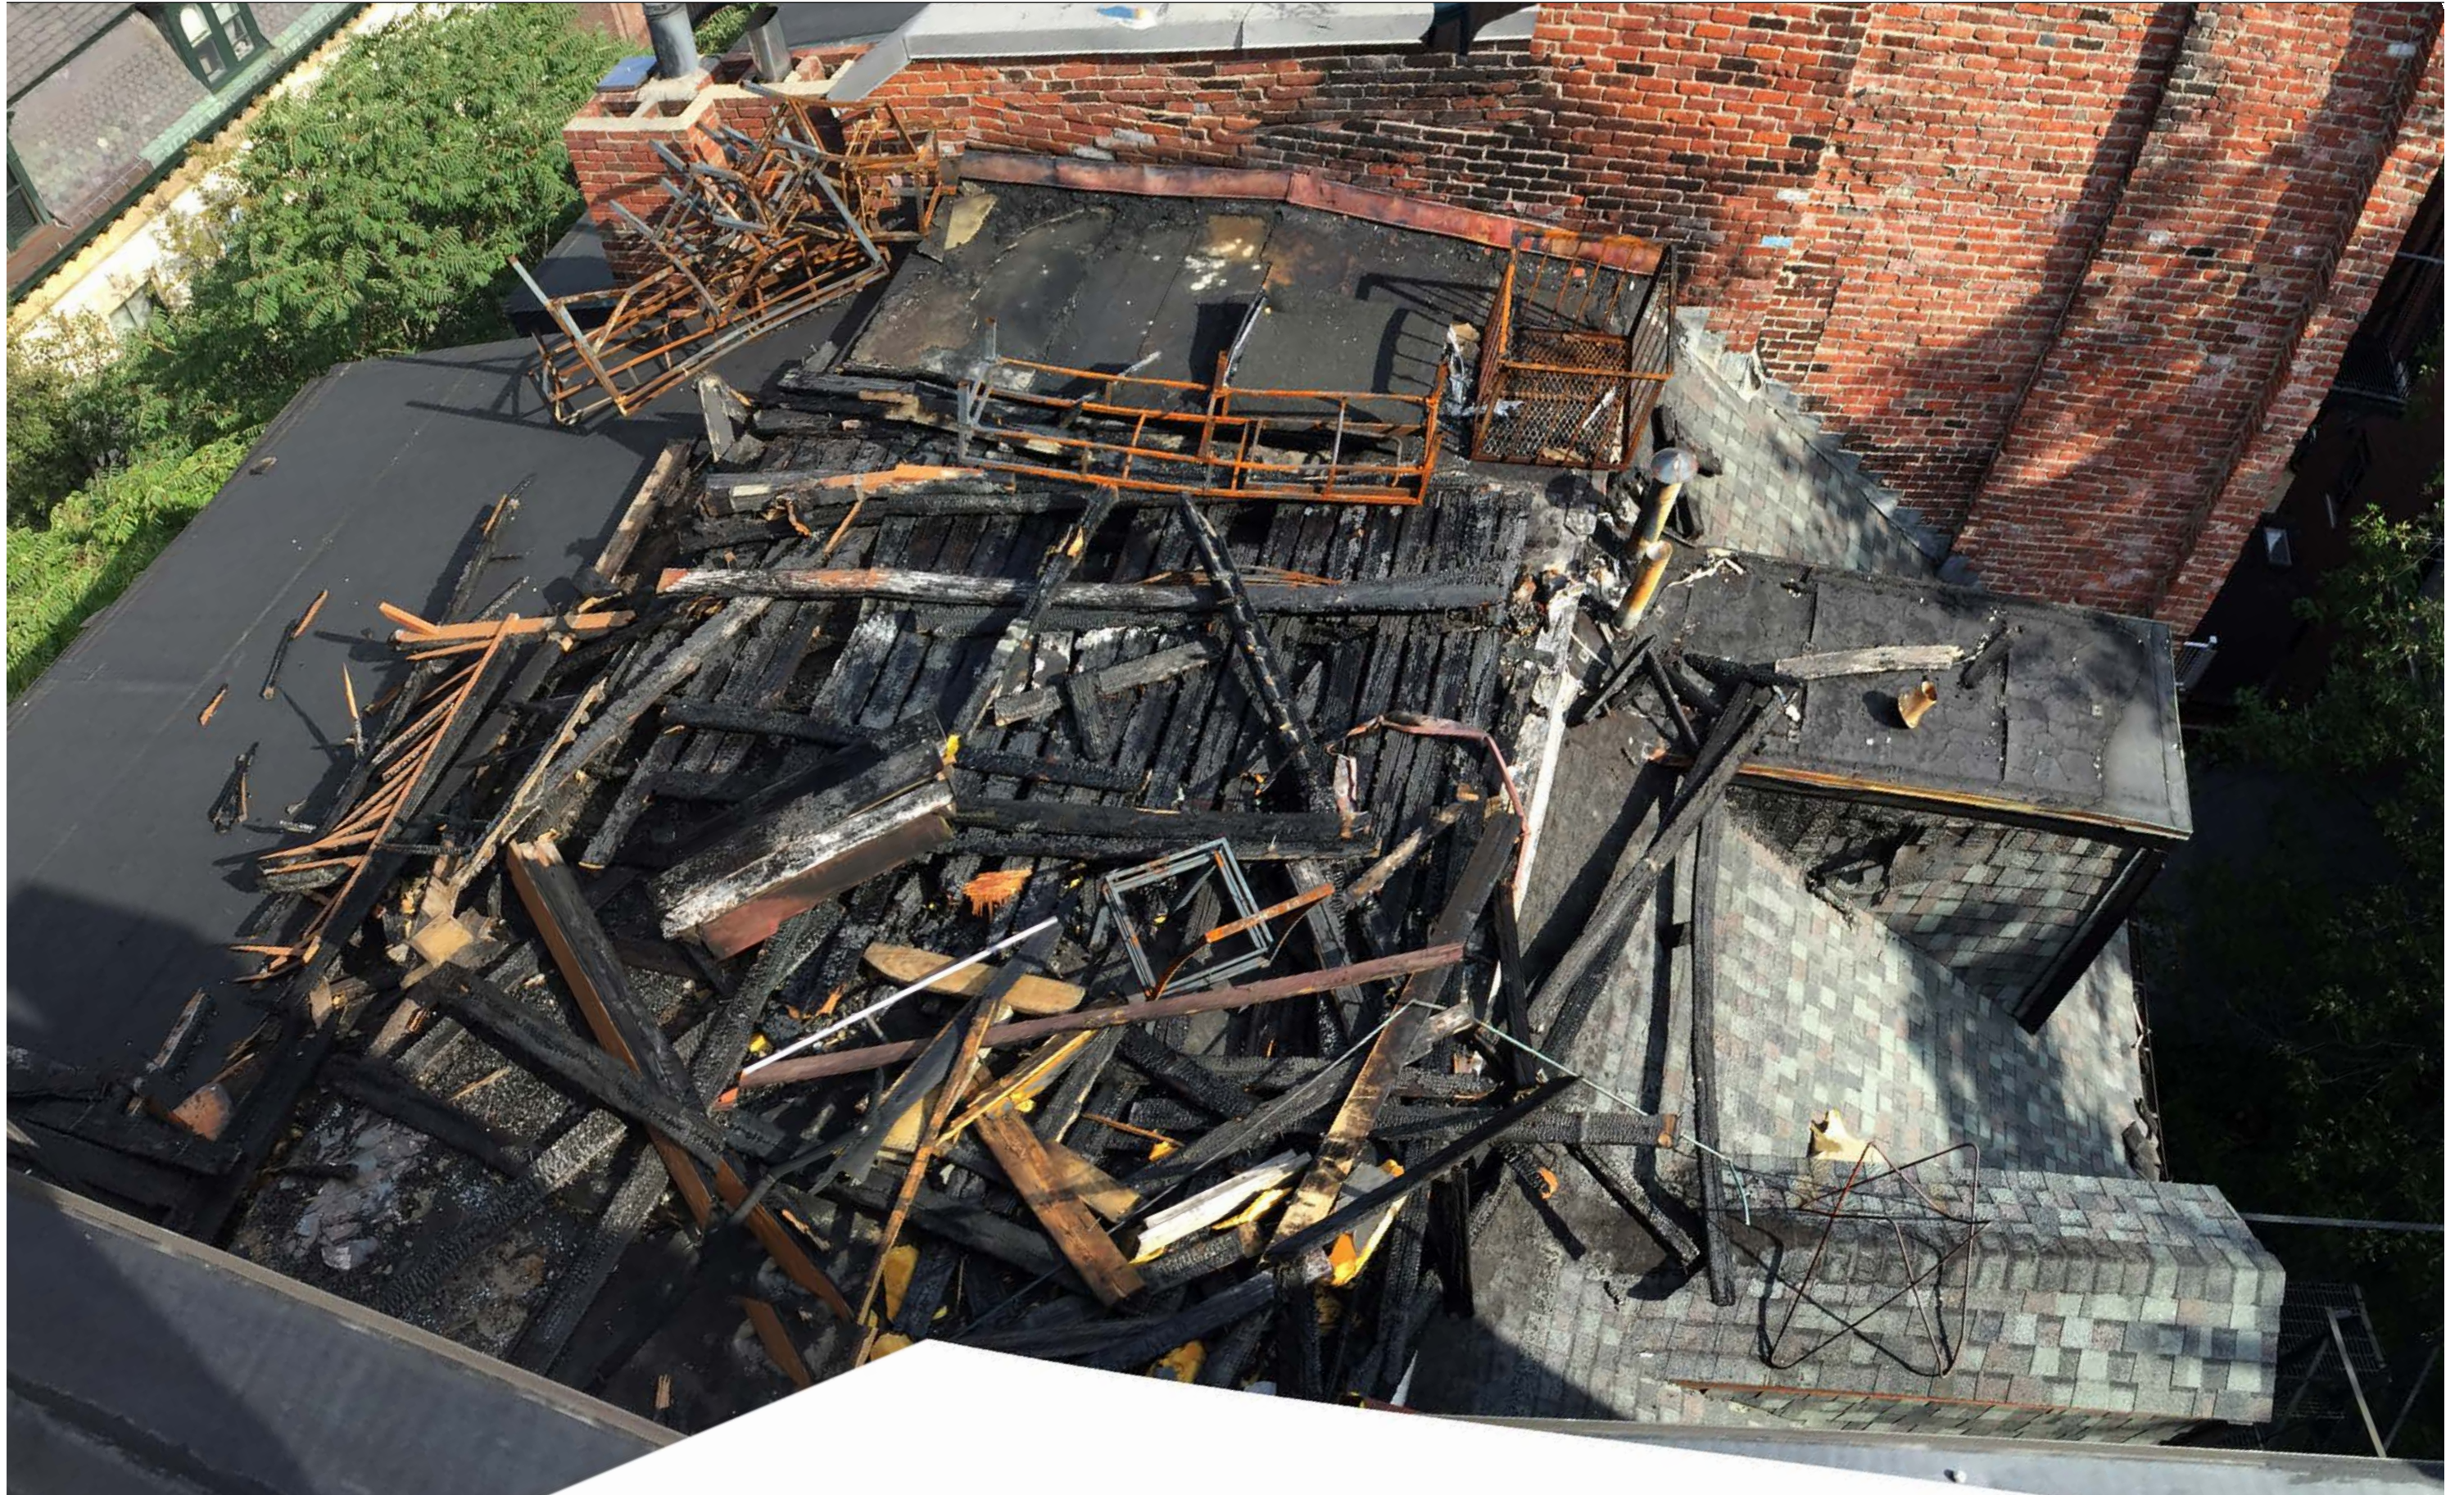
32 Hancock Street Fire Damaged Roof and Deck

In general, the majority of the roof framing system has been significantly damaged by the recent fire, particularly to the two primary supporting wood trusses and to the adjacent roof rafters and roof sheathing boards. Several of the structural elements have lost over 50% of their cross-sectional area, while other structural elements were observed to be substantially charred. Furthermore, the brick corbel that supported the end of the existing west roof truss has sheared-off from the brick bearing wall and is now being temporarily supported by recently installed emergency shoring posts, as directed by ST&P. Finally, we observed some structural conditions where the existing roof framing was severely rotted and deteriorated from over-exposure to moisture over time.

In light of the above, we strongly recommend the existing roof framing system of Unit 5B to be removed in its entirety and be replaced with all new roof framing and new plywood roof sheathing. All new construction shall conform to the requirements of the MSBC, 8th Edition, for new construction.

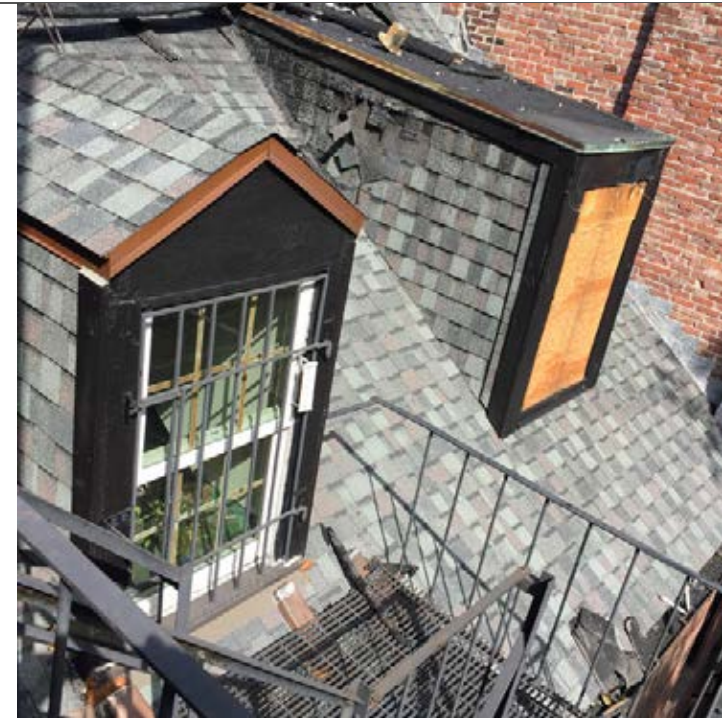
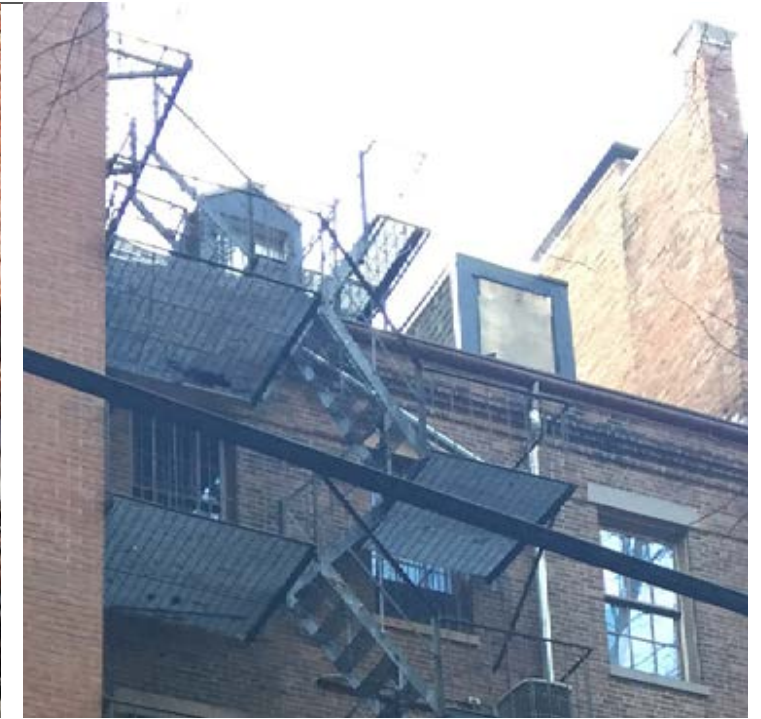
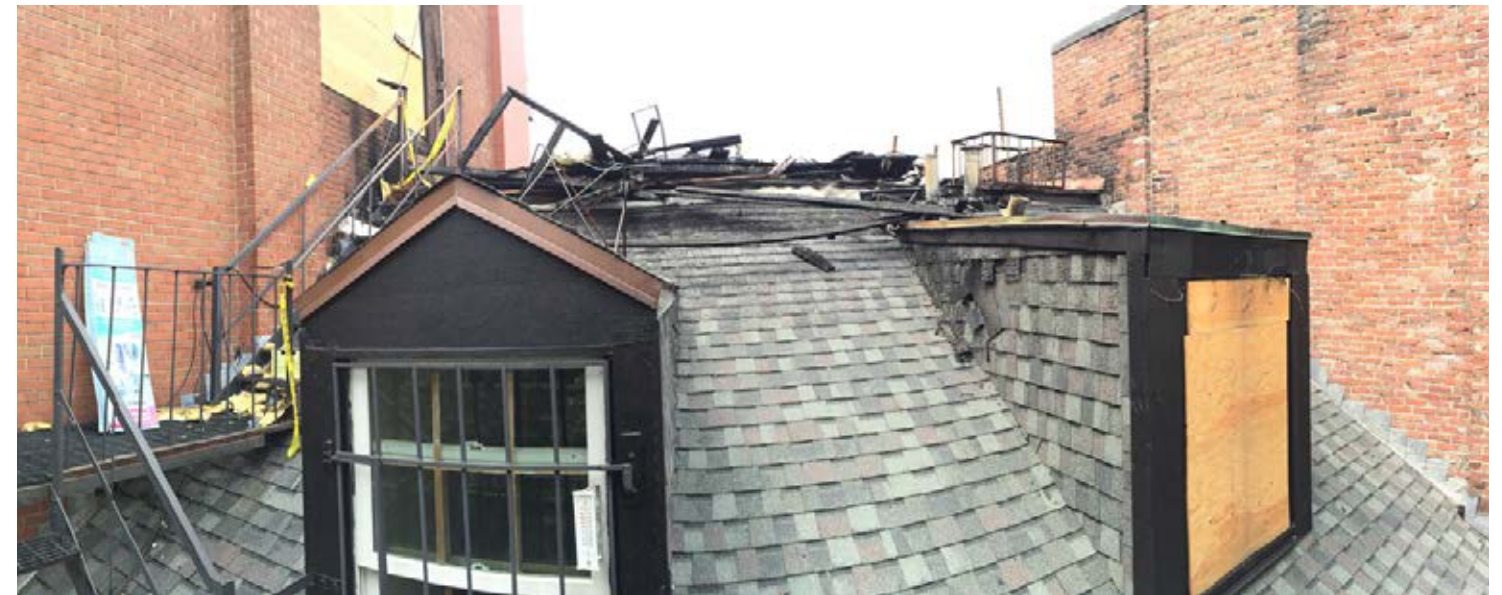
Unit 5B dormers, existing damaged fire escape and Unit 8A Roof Deck

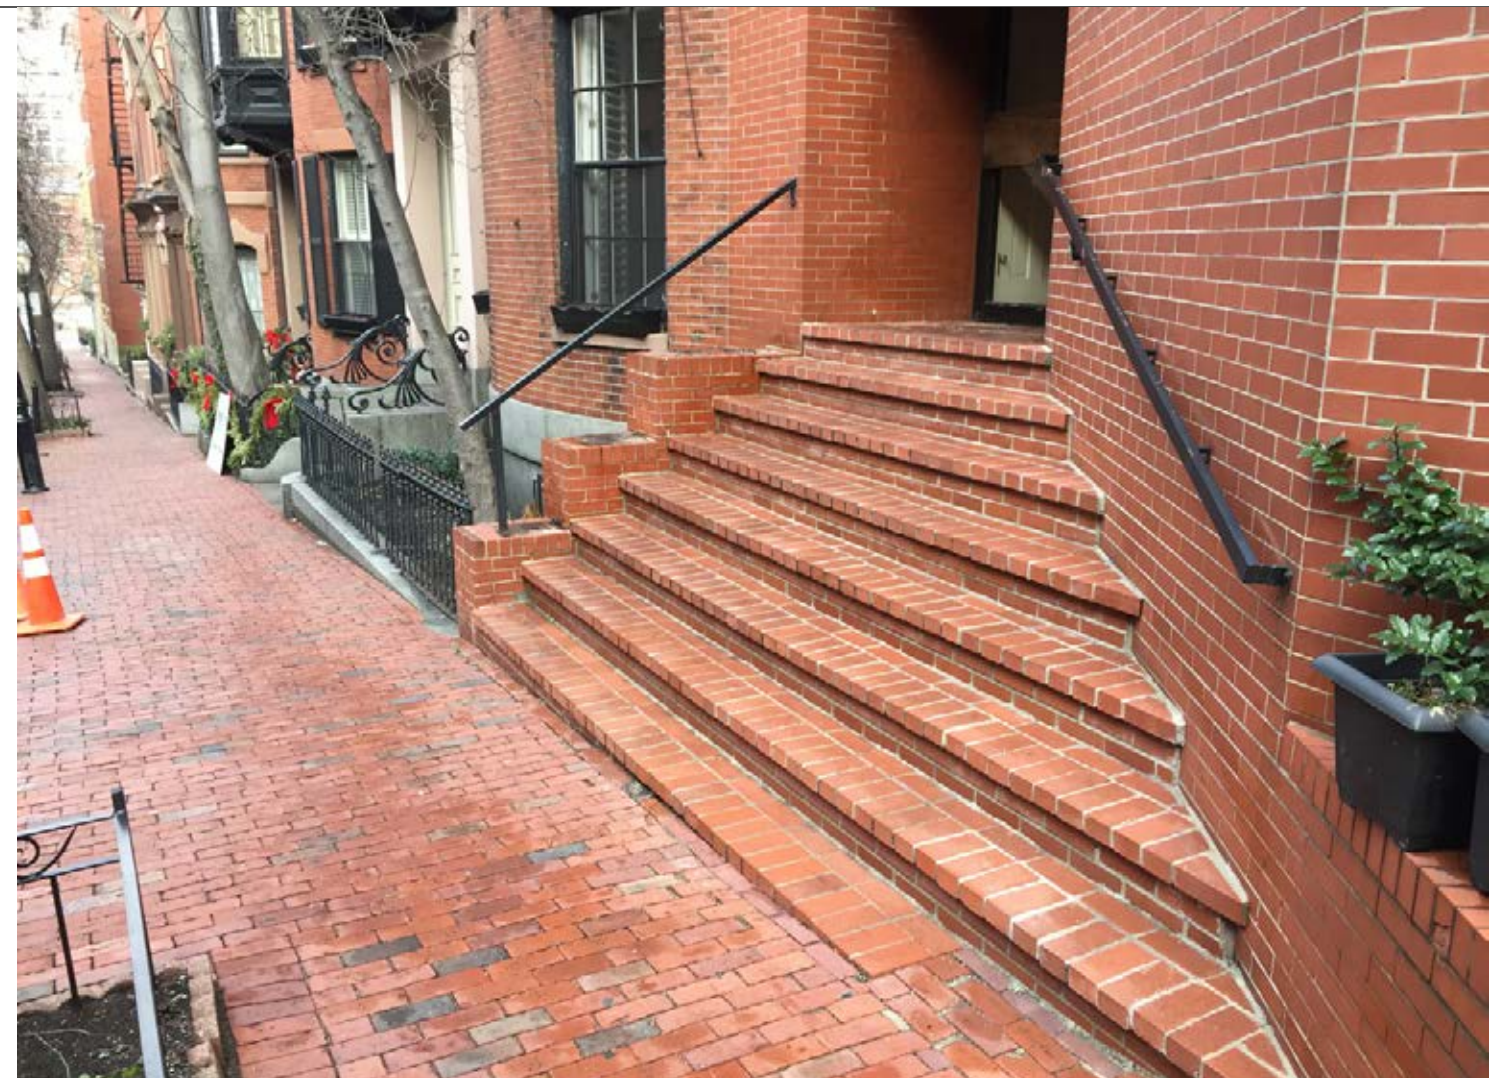
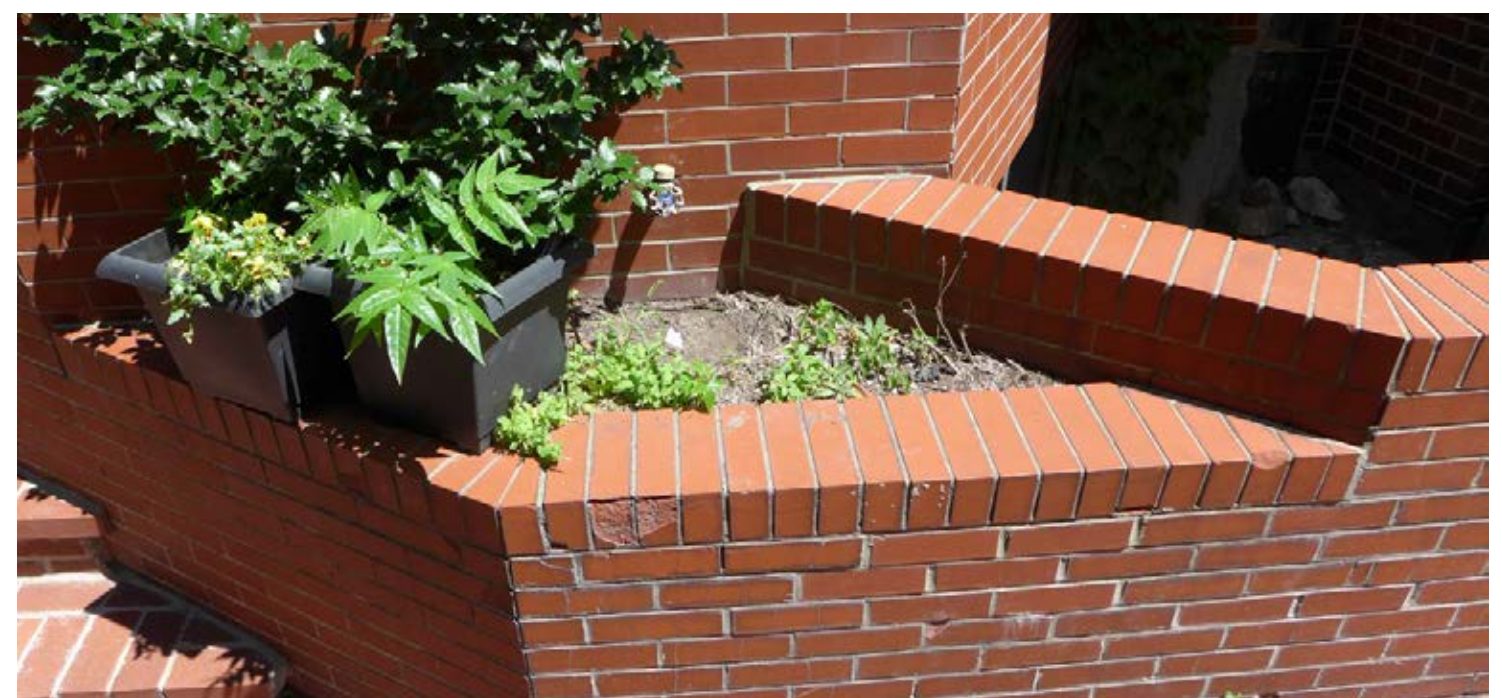
Proposed Entry Looking North

Existing entry looking north and planter at proposed pump valve.

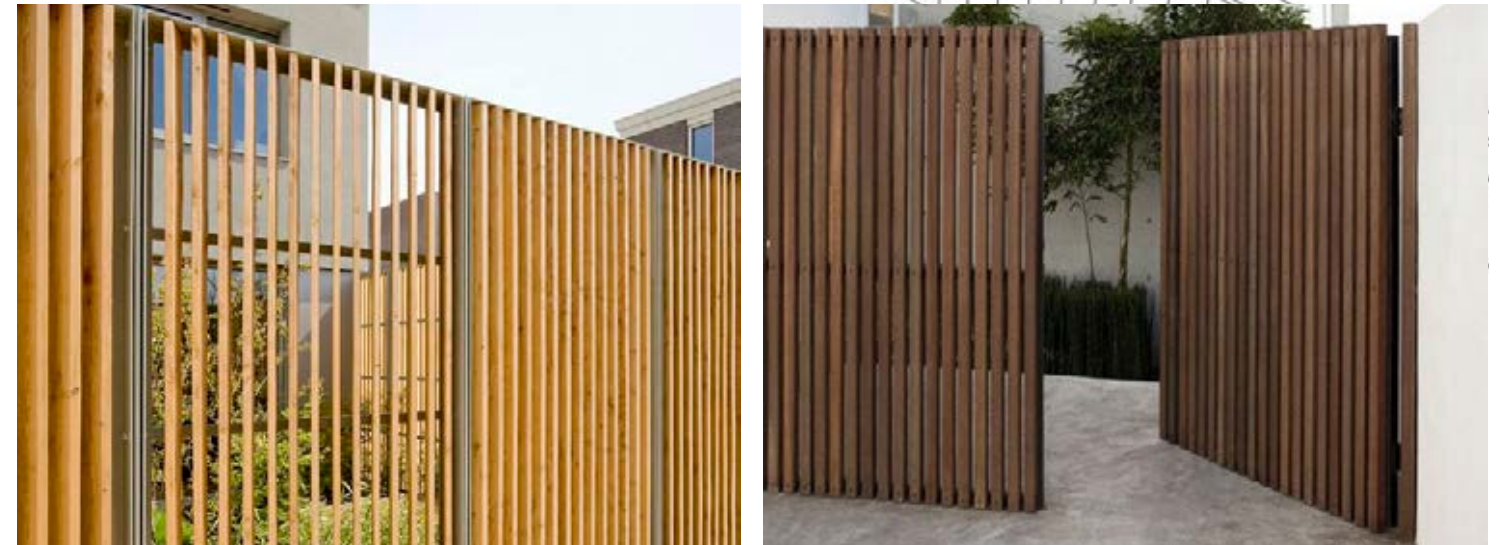
Proposed fence precedents and 3d model

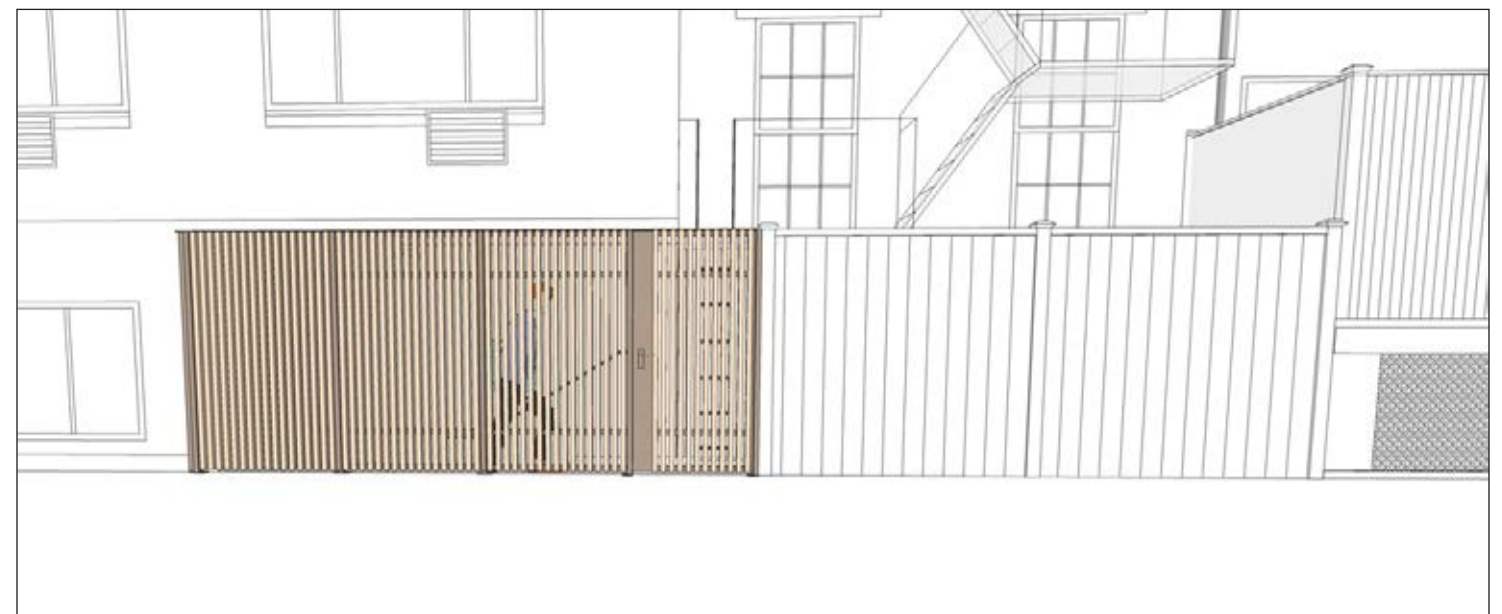
Proposed fence and door

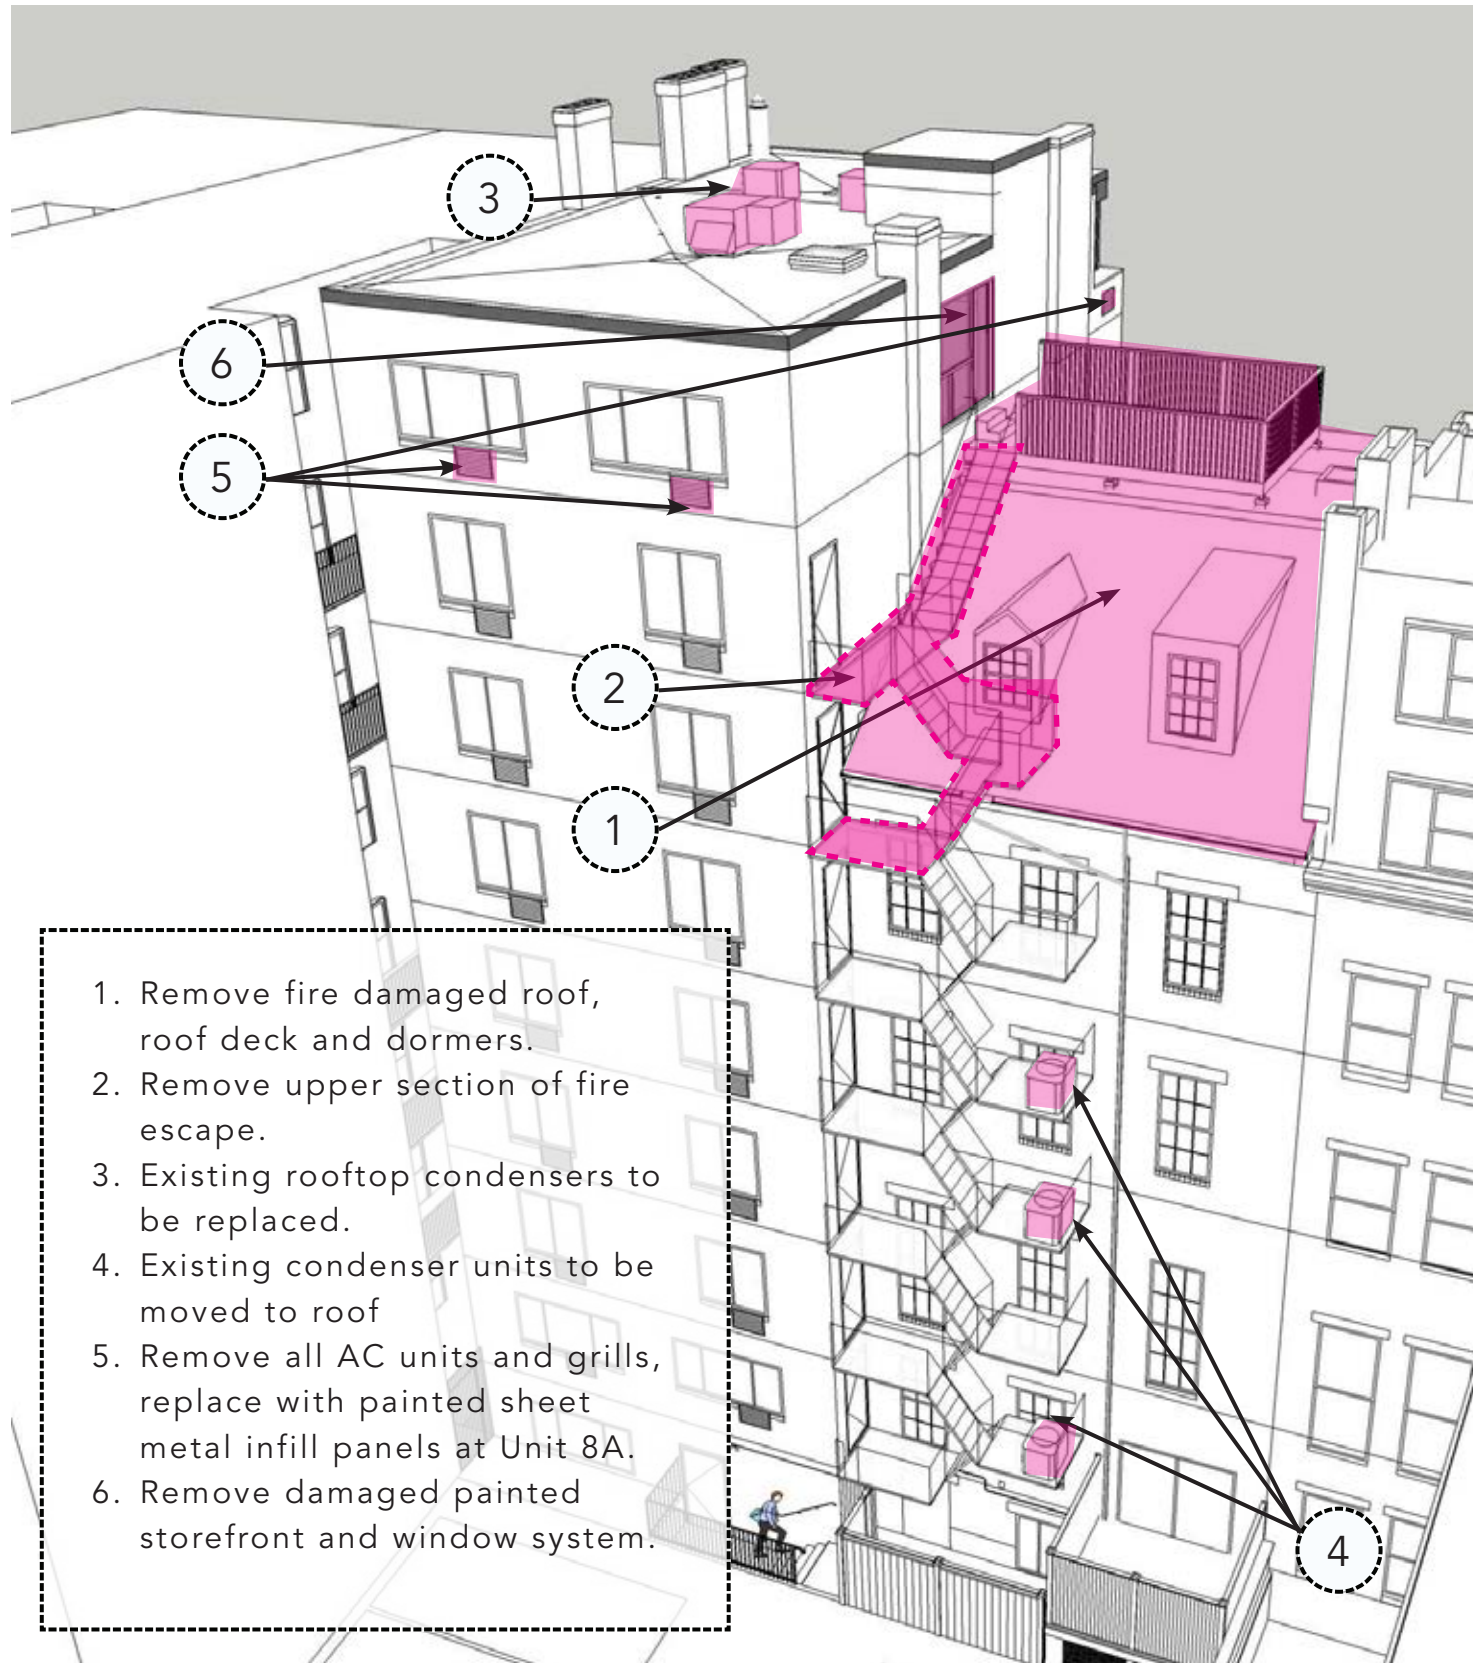
- 1. Remove fire damaged roof, roof deck and dormers.
- 2. Remove upper section of fire escape.
- 3. Existing rooftop condensers to be replaced.
- 4. Existing condenser units to be moved to roof
- 5. Remove all AC units and grills, replace with painted sheet metal infill panels at Unit 8A.
- 6. Remove damaged painted storefront and window system.

- 5. Proposed location of MEP condensers
- 6. Proposed painted sheet metal clad enclosure for MEP equipment refrigerant lines and vent re-routing.
- 7. Replacement rooftop deck
- 8. Rebuild dormers
- 9. Proposed over flow downspout
- 10. Proposed reconfigured upper fire escape.
- 11. Replacement storefront door and window.

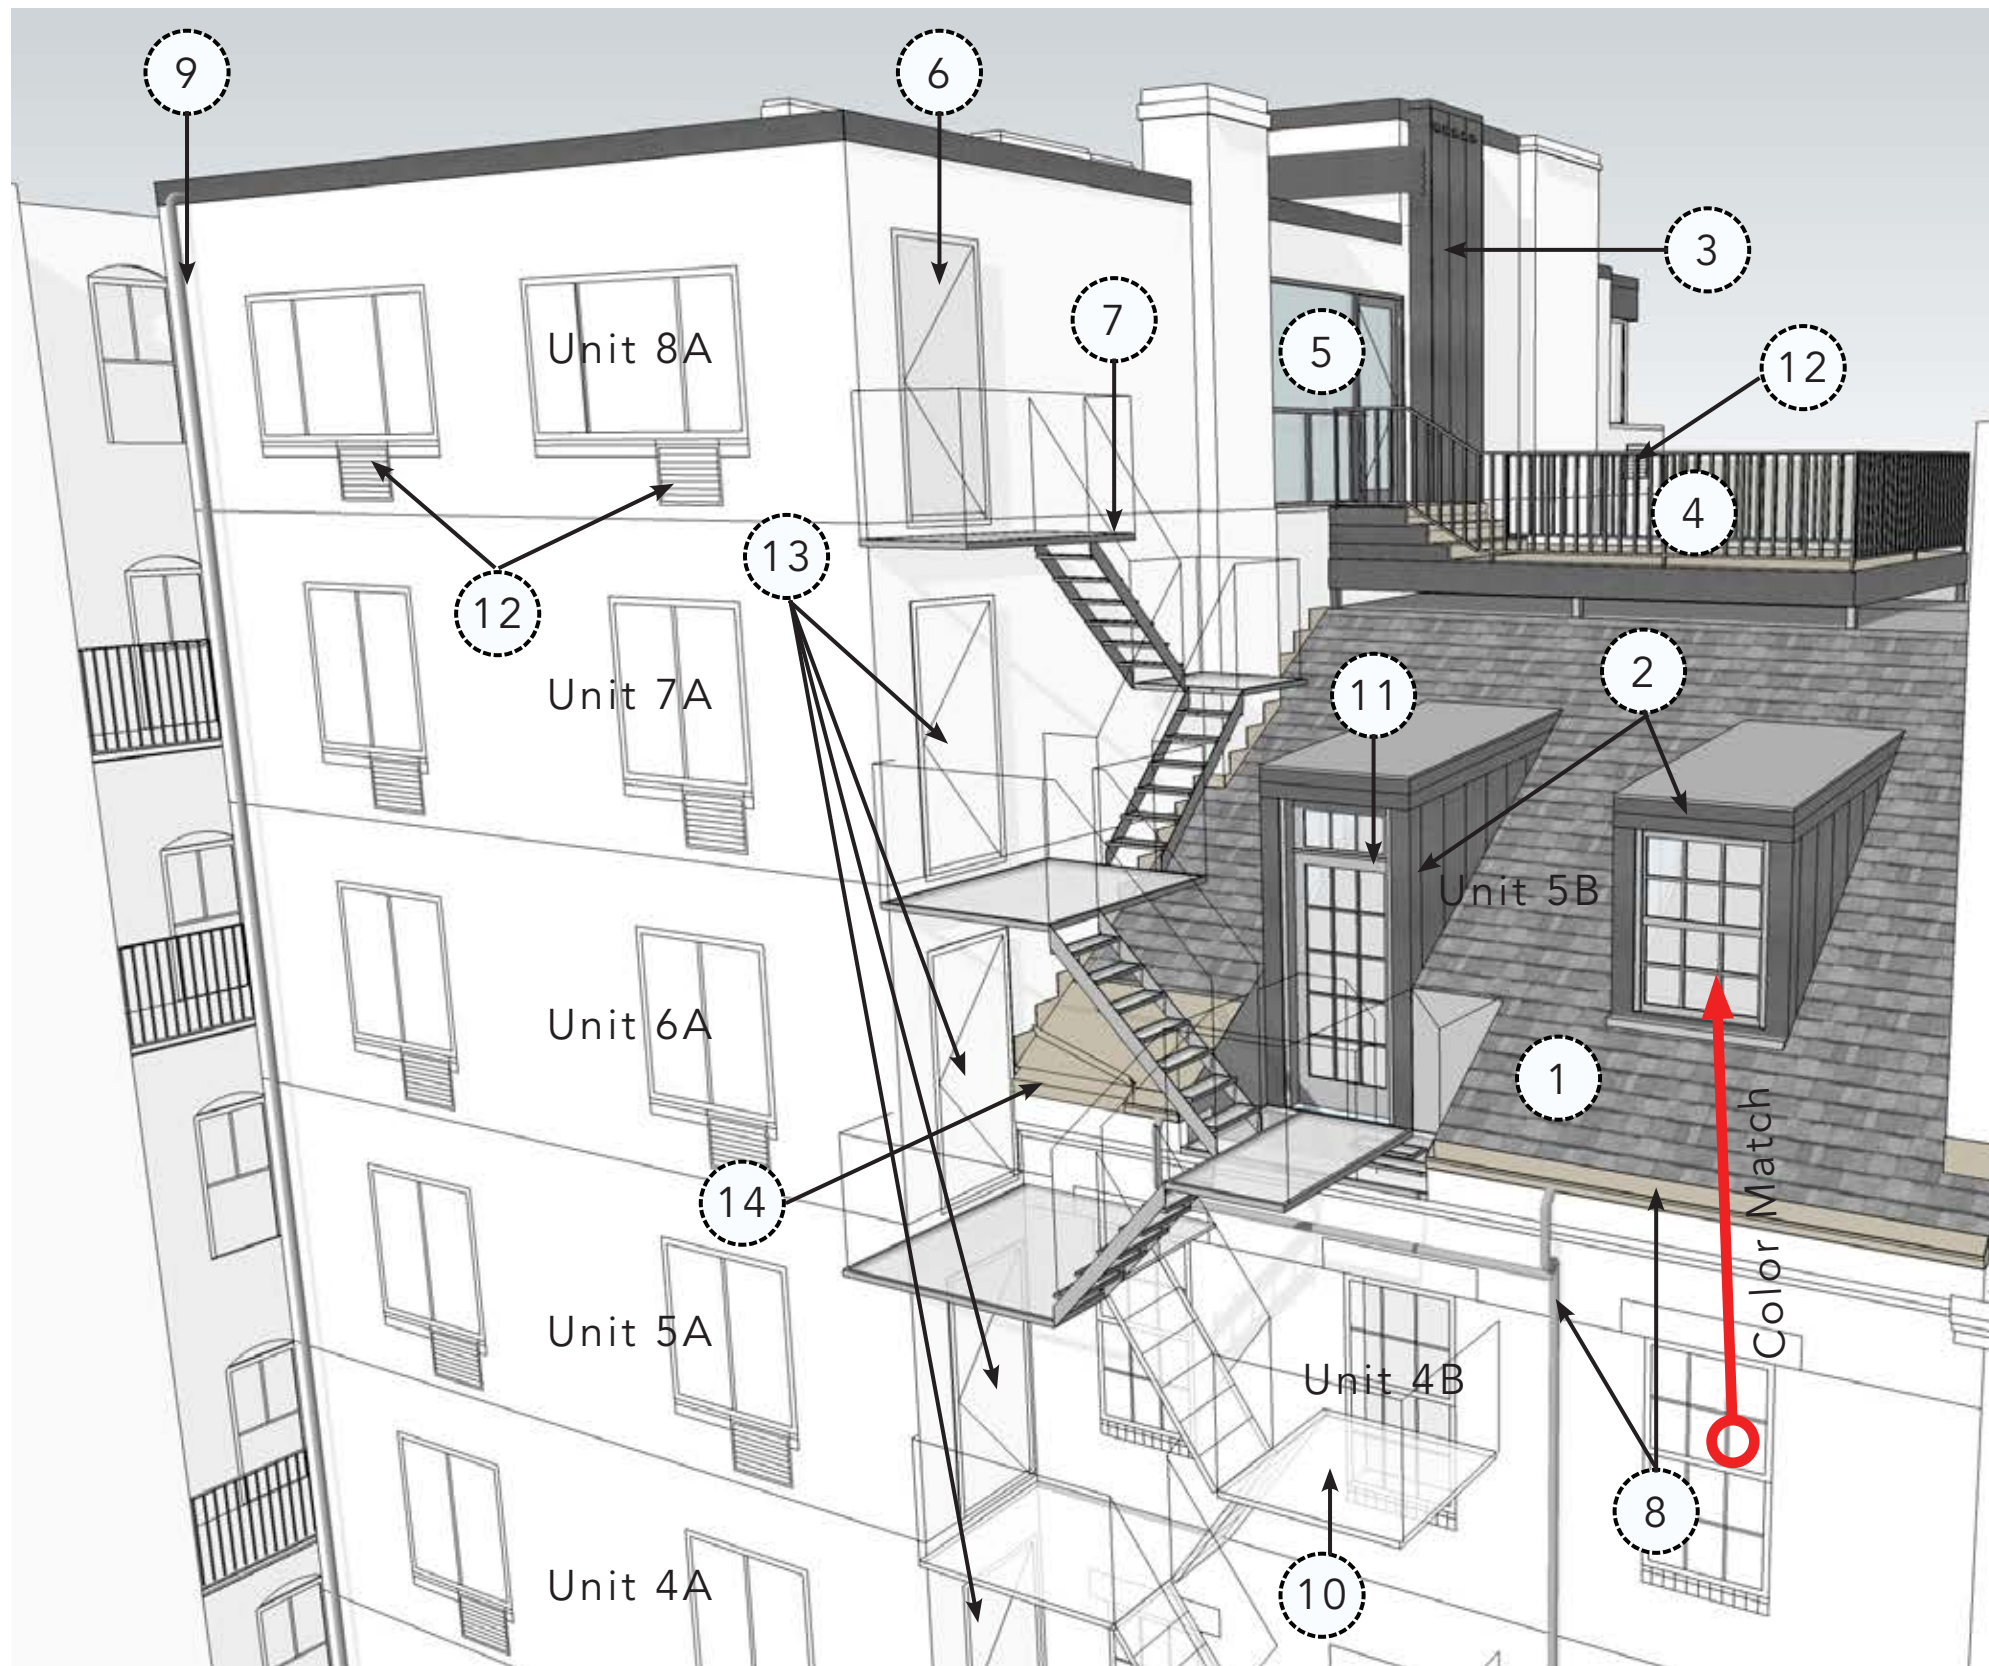
Proposed Exterior - From Ridgeway Lane

1. Replacement asphalt shingle roof.
2. Replacement shed dormers with painted metal panel siding and painted fiber cement trim. Replacement Double hung window and Egress door with transom to fire escape.

3. Proposed painted sheet metal clad enclosure for MEP equipment refrigerant lines and vent re-routing.
4. Replacement Unit 8A roof deck with painted wood fascia and painted metal guard rail.

5. Replacement painted metal storefront door and window.
6. Provide new masonry opening and new fire escape egress door to Unit 8A.
7. New fire escape to egress door at Unit 8A.

8. New copper gutter connected with new downspout segment to existing galvanized downspout. Reconfigure gutter to avoid interfering with fire escape.
9. New copper downspout from roof overflow drain to ground.

10. All existing fire escape landings and stairs to remain below this point.
11. Egress door to fire escape
12. Remove all AC units and grills, replace with painted sheet metal infill panels at Unit 8A.

13. Replacement fire escape egress doors. All fire escape doors to be replaced.
14. Modify gutter to avoid obstruction egress door clear opening.

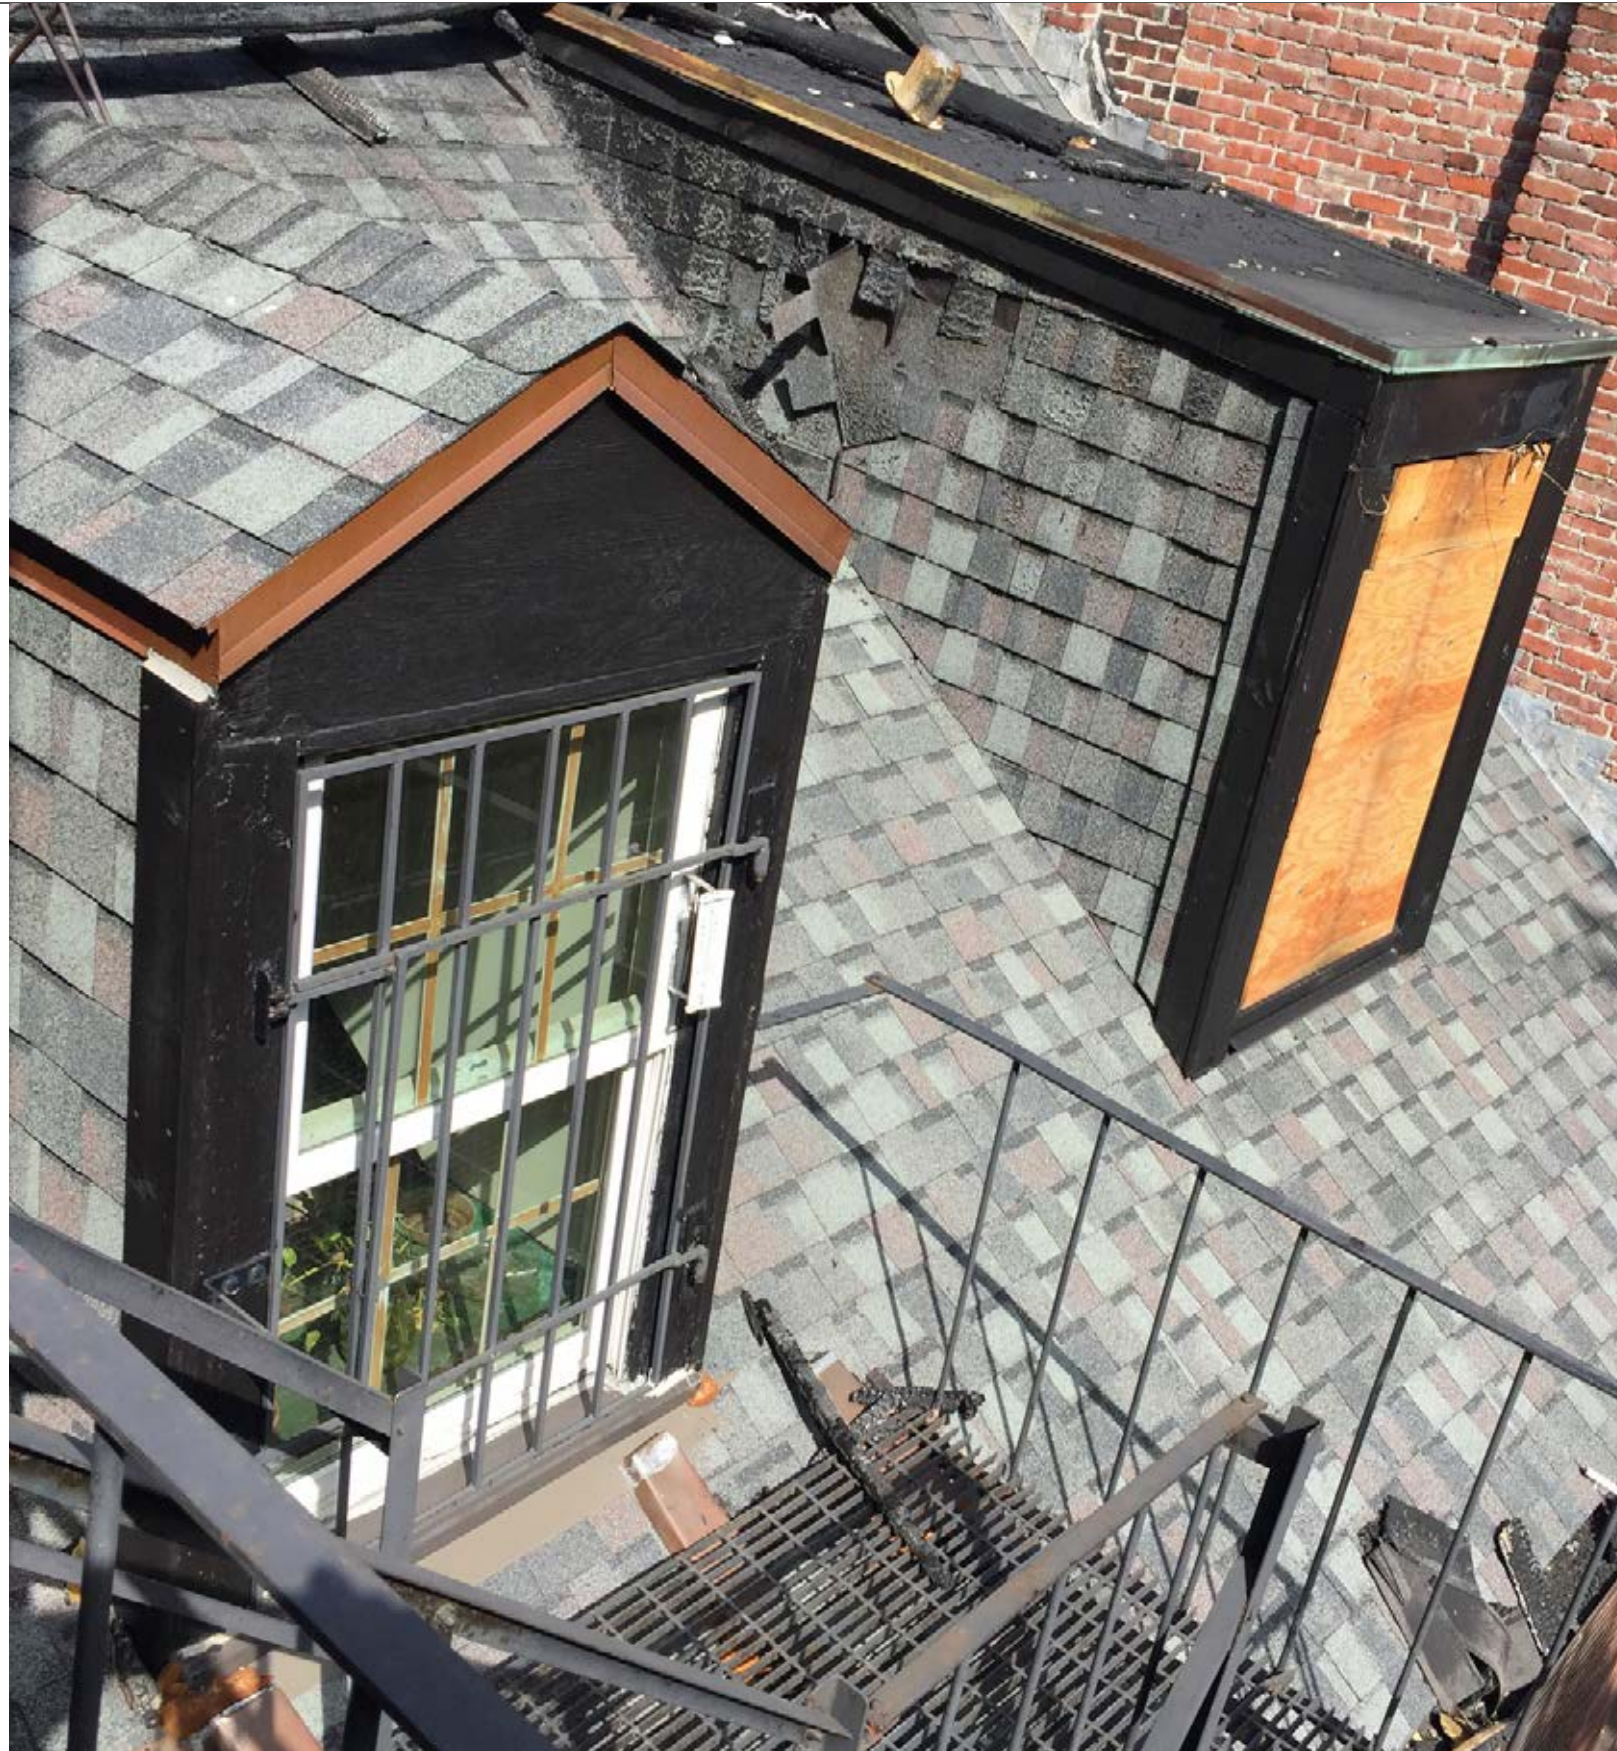
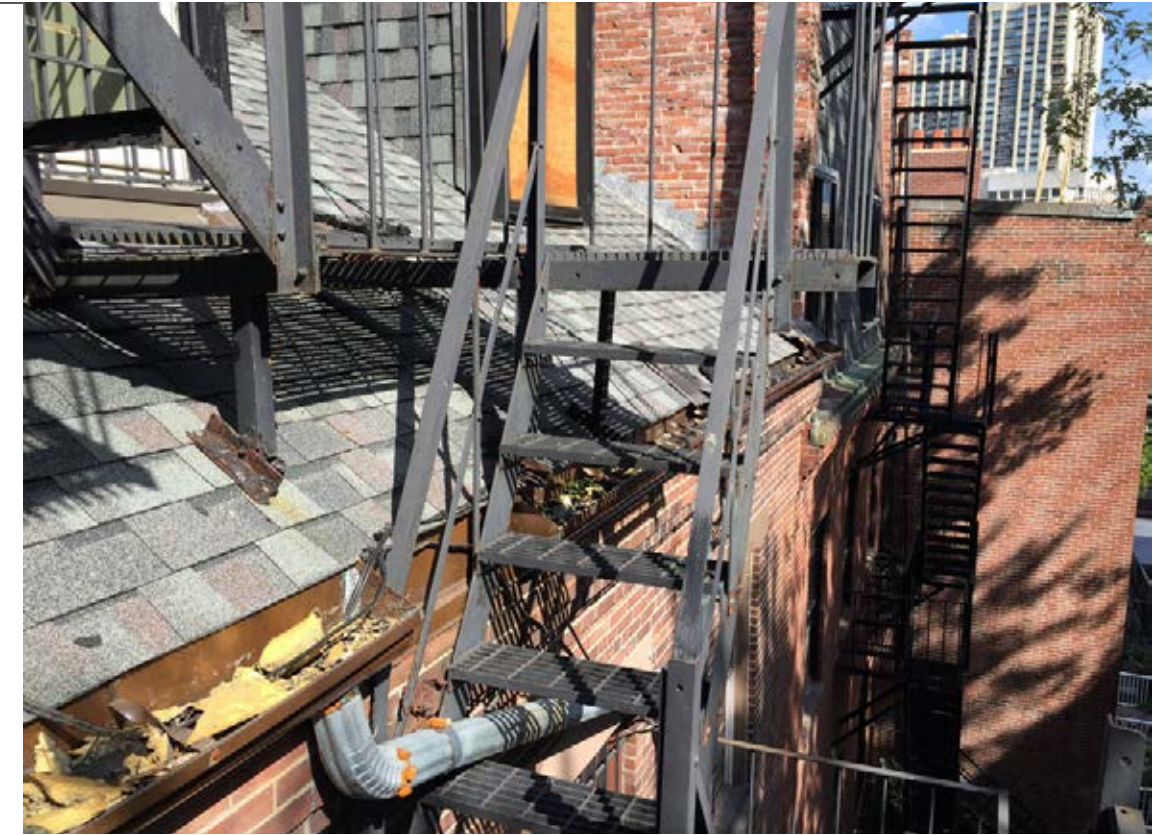
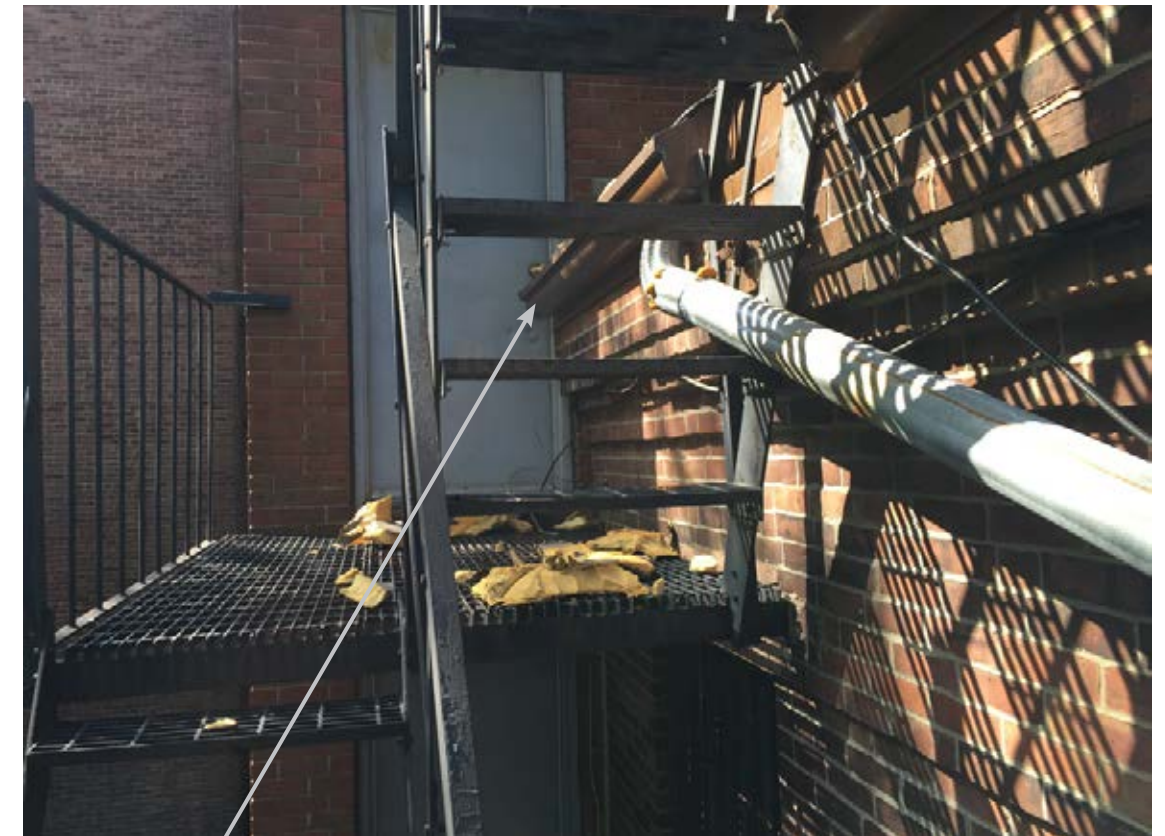
32 Hancock Street Unit 5B Dormers and Fire Escape Condition

Existing gutter impedes code required clear egress door width.
