32-34 Hancock Street Condominiums

PART III - Appendix B: Supplemental Information for
Boston Landmarks Commission / Beacon Hill
Architectural Commission
Application for Certification of Appropriateness

23 FEBRUARY 2017

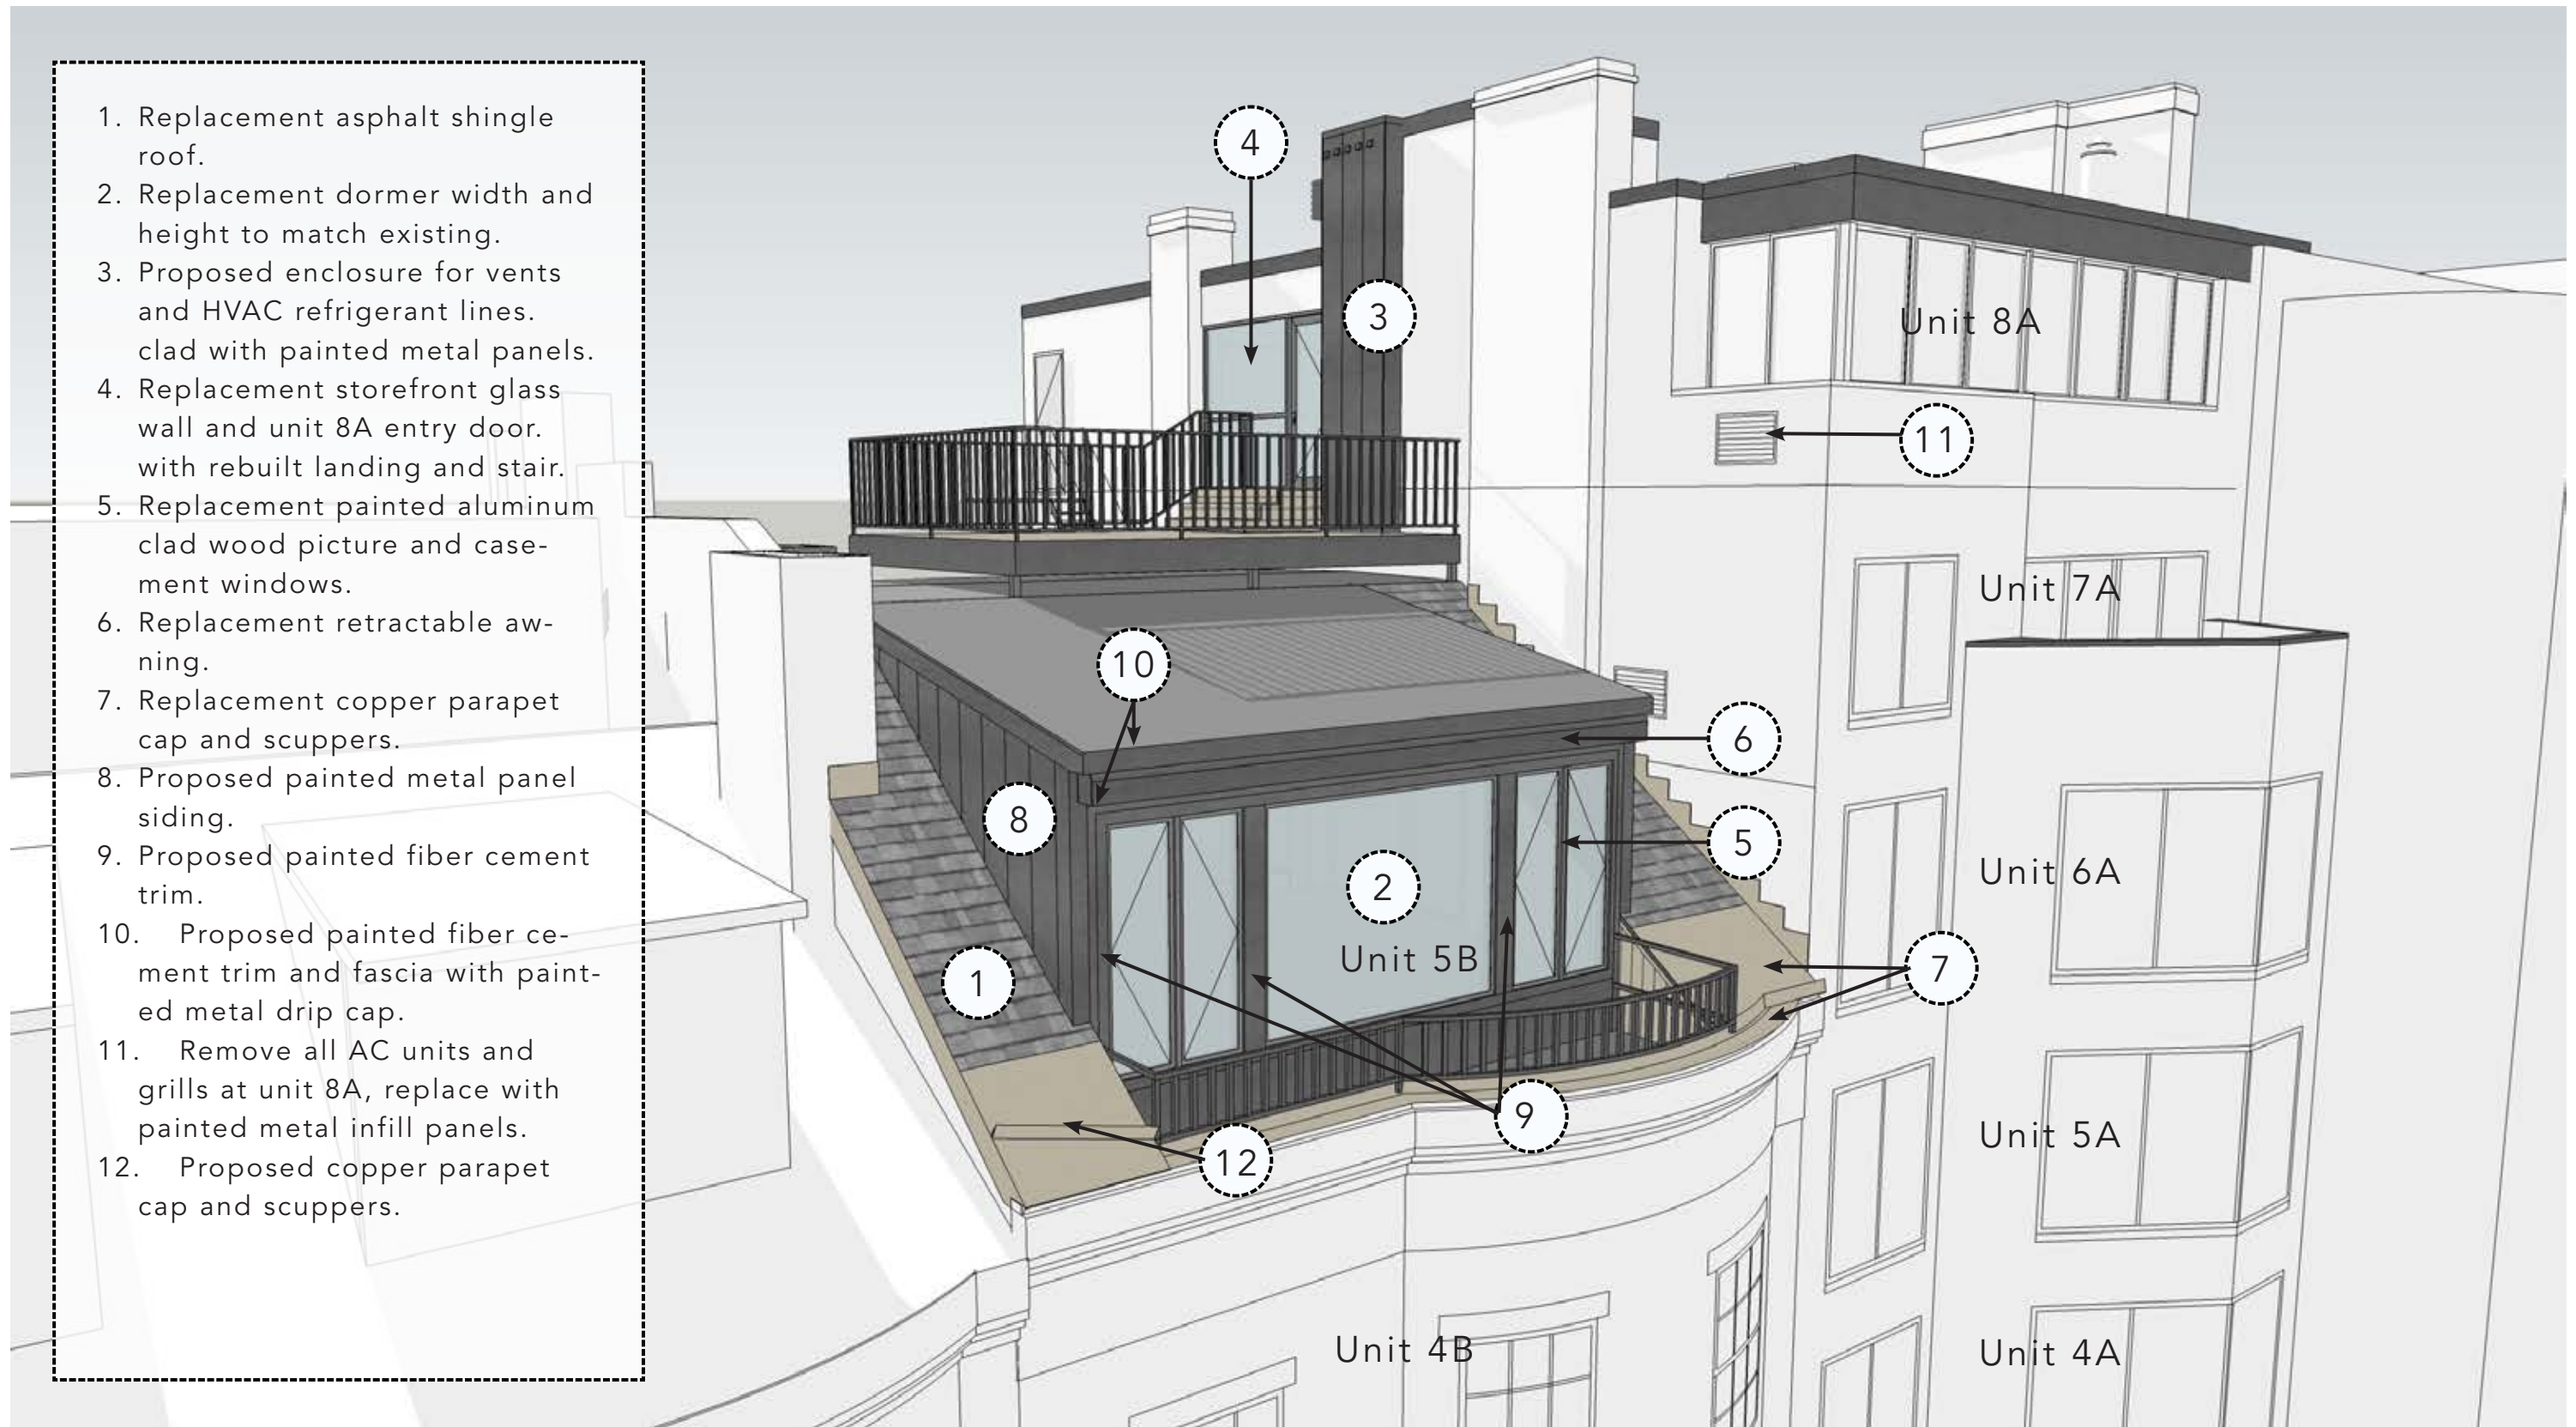
Proposed Dormer - From Hancock Street

1. Replacement asphalt shingle roof.
2. Replacement dormer width and height to match existing.
3. Proposed enclosure for vents and HVAC refrigerant lines, clad with painted metal panels.
4. Replacement storefront glass wall and unit 8A entry door, with rebuilt landing and stair.
5. Replacement painted aluminum clad wood picture and casement windows.
6. Replacement retractable awning.
7. Replacement copper parapet cap and scuppers.
8. Proposed painted metal panel siding.
9. Proposed painted fiber cement trim.
10. Proposed painted fiber cement trim and fascia with painted metal drip cap.
11. Remove all AC units and grills at unit 8A, replace with painted metal infill panels.
12. Proposed copper parapet cap and scuppers.
