GARCELON'S PARK STABLES

NEIGHBORHOOD CONTEXT

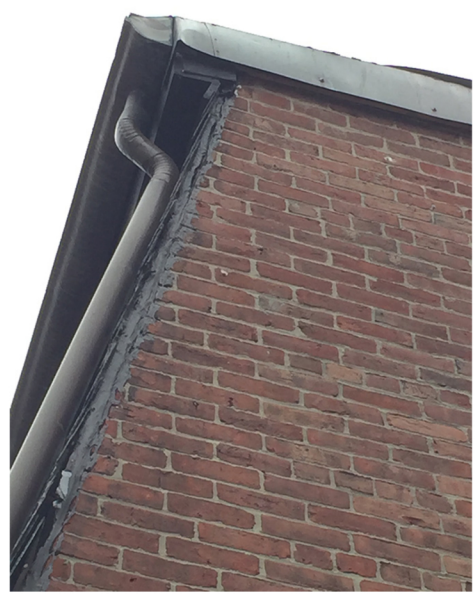
170608-IMG_6576.JPG

Southeast Corner Showing Transition from Mansard Roof Slope to Adjacent Brick; Roofing Cement to be Removed and Copper Flashing to be Installed

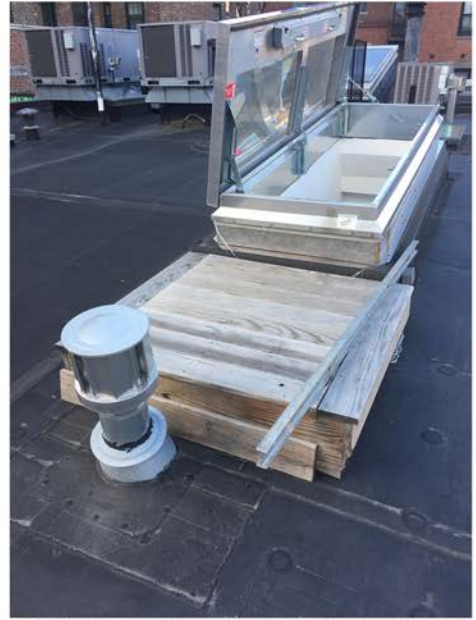
161227-IMG_5969.jpg

Skylight Roof Hatch for 57 Brimmer Street
